STORAGE TANK ROOF REPAIRED USING BELZONA

Petroleum Company, Egypt.

Heavy slops tank

Several holes in the tank roof.

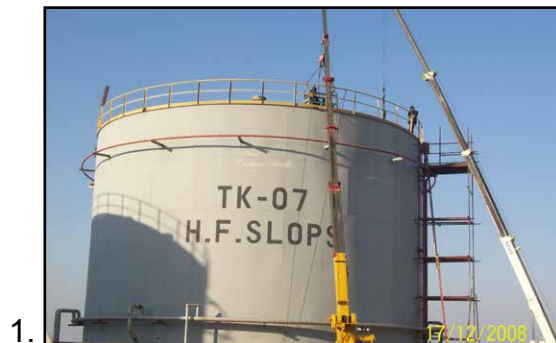
1. General view of the tank
2. The holes in the roof tank
3. Using two winches to carry the metal sheets & technicians
4. Application completed
