Understanding Morandi - Part 1 - The Prestressed Concrete Cable Stays

I'd like to explain a bit from what I understood so far about the (in)famous Morandi prestressed concrete cable stays. This is an evolving and frequently updated article (initial version 17.8.2018) I'd like to share for your interest, challenge and discussion.

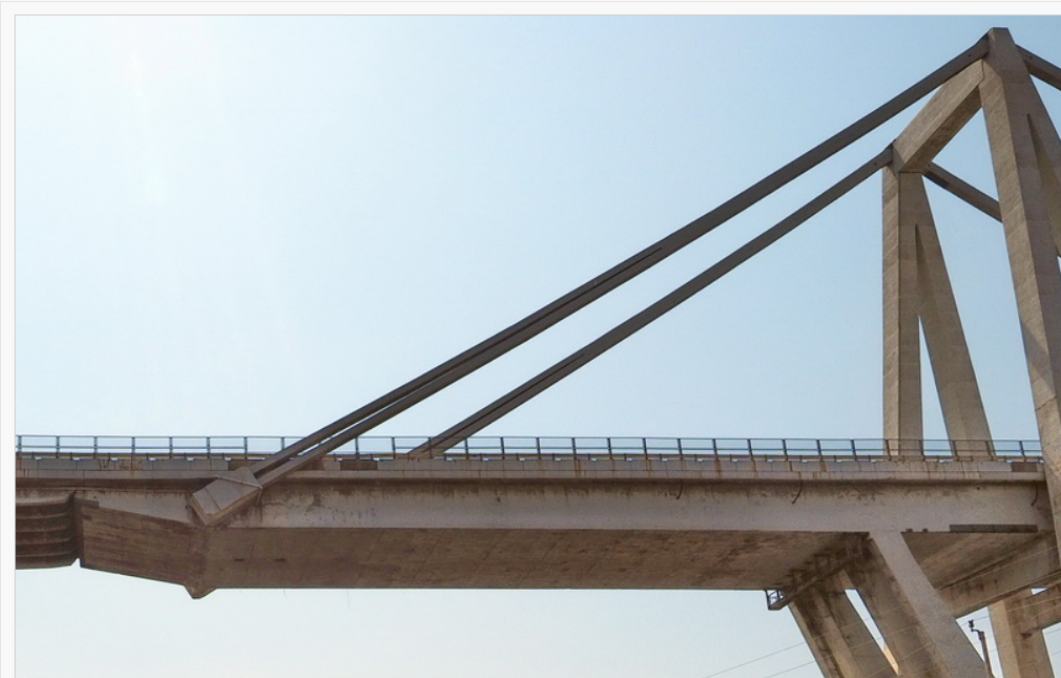
Pylon 9: The cable stay consists of two distinct stays in their lower part which merge half way up towards the tower (Hasen 2015)

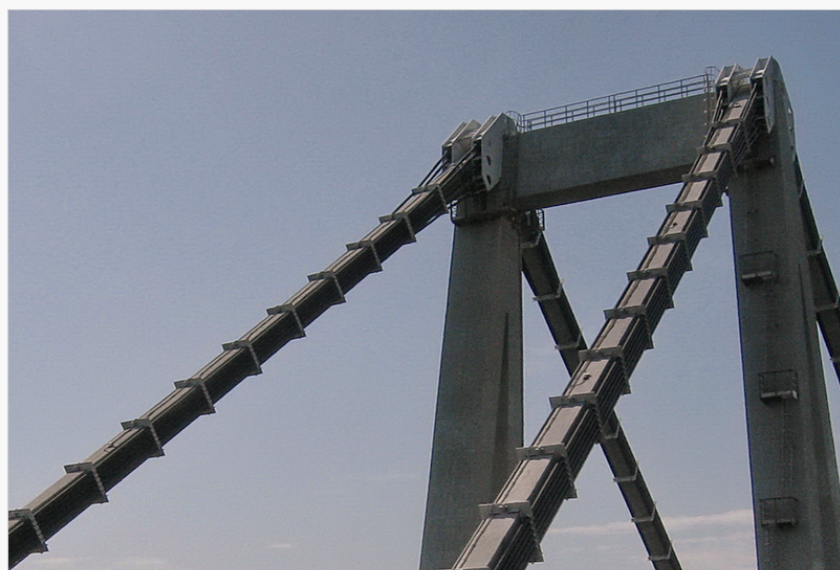
Pylon 11: External reinforcement cables installed 1992-1994. (Hasen 2007)

Around 1993 pylon 11 received twelve additional external reinforcement cables to mitigate some of the above issues:

One major problem was that the tension applied to those additional cables should not increase the total combined compression of the thin concrete beam. Applying additional pressure would have been likely to damage the thin concrete beam structure. The successfully applied solution could be summarized as extremely complex: It consisted in cutting a section of the old concrete beam to also cut the old cables inside while subsequently applying more tension to the new external cables.
