From : Acting Production Eng. Coordinator
Date : 27/01/2014
Subject : **Floating Roof sinking Failure report of
Condensate Tank 5E-220-TB002A**

With The Reference to the sinking problem of the Floating roof of stabilized condensate tank 5E- 220- TB002A dated on 25th Jan. 2014, the problem has been assessed as described below.

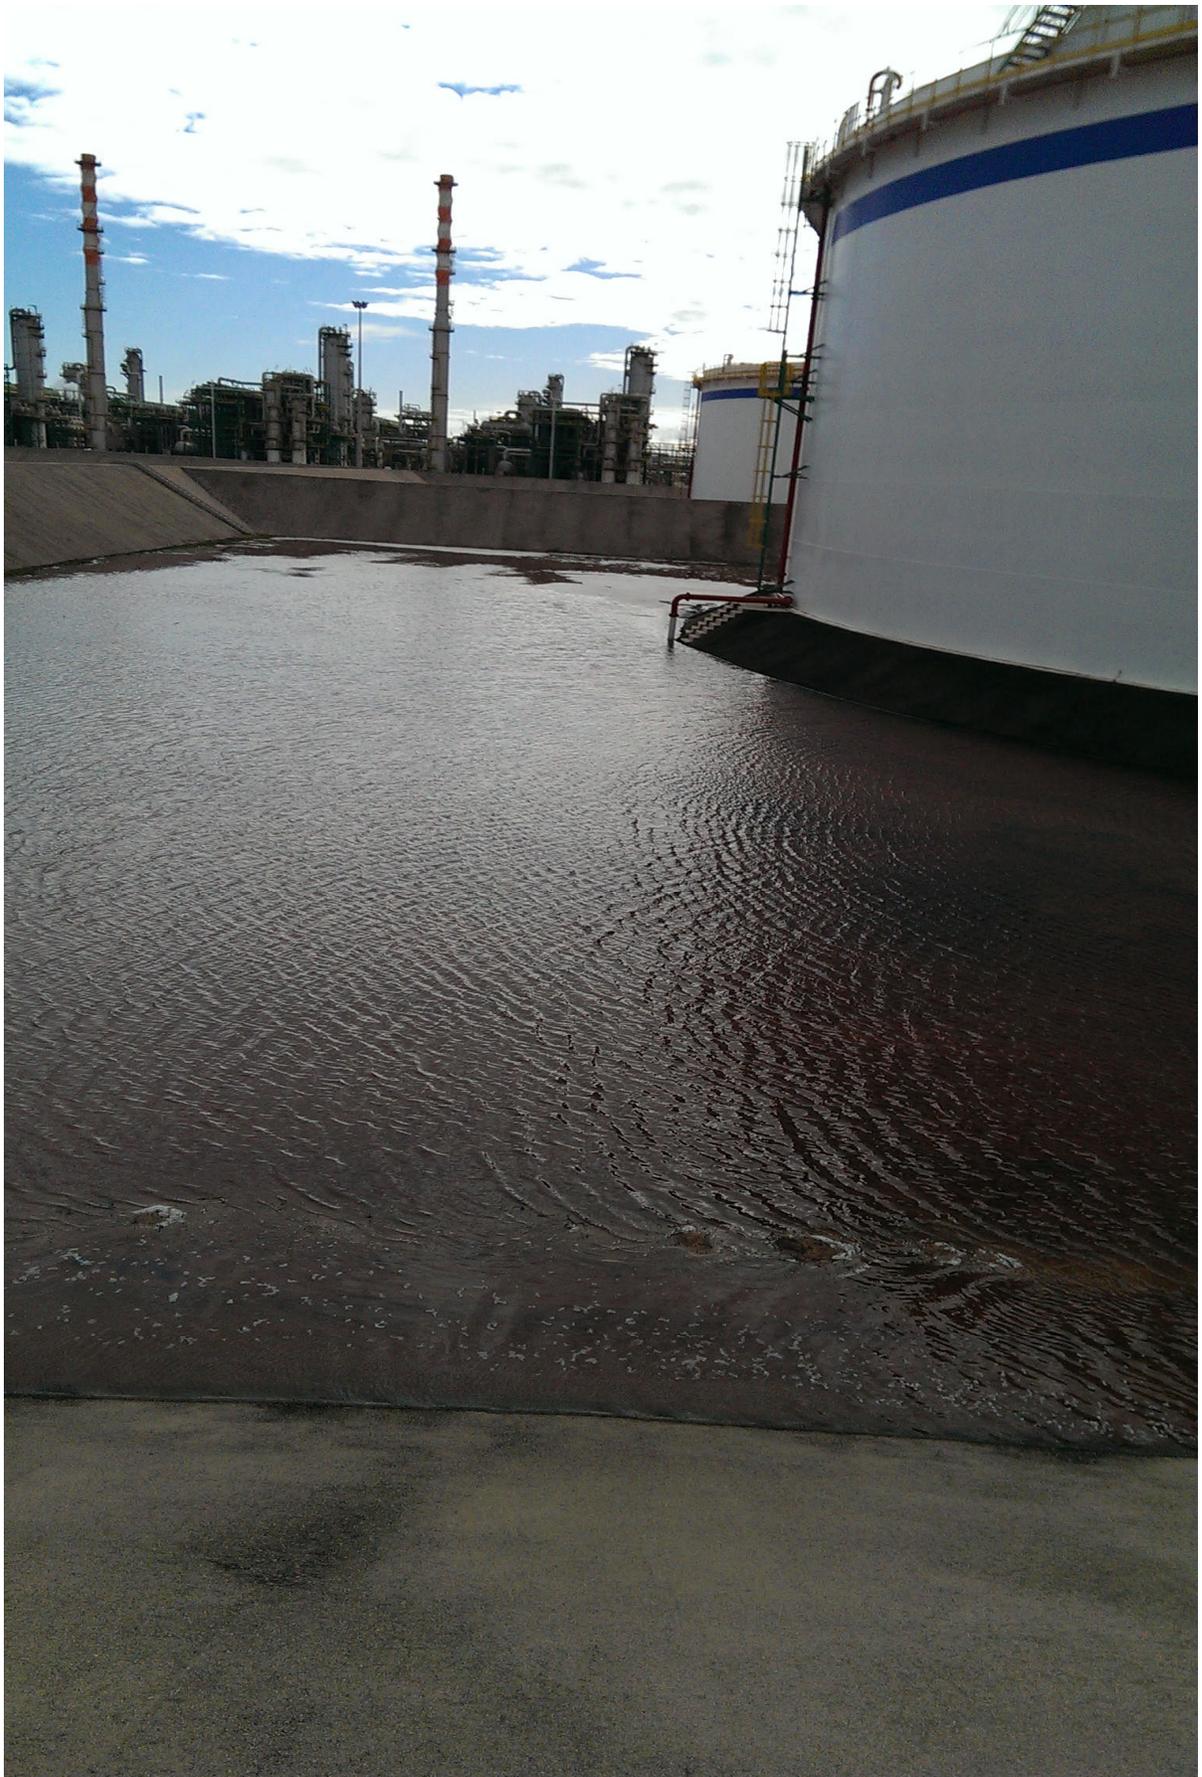
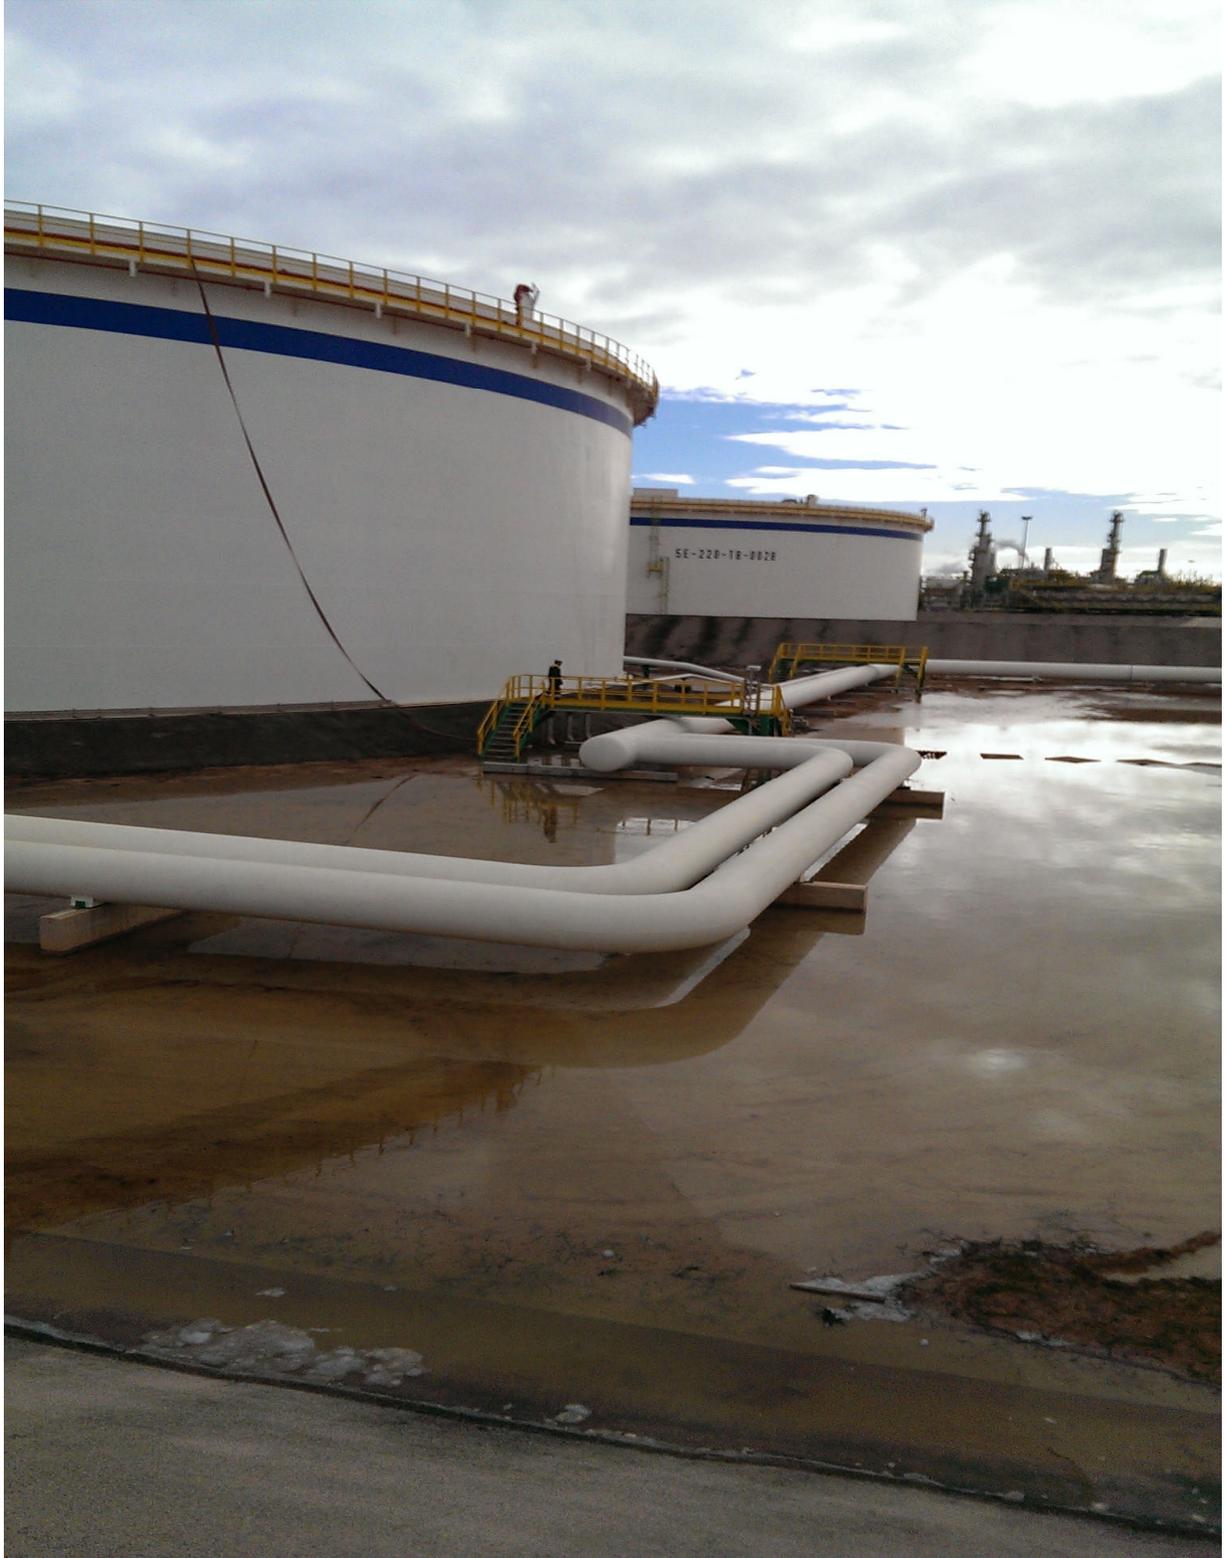
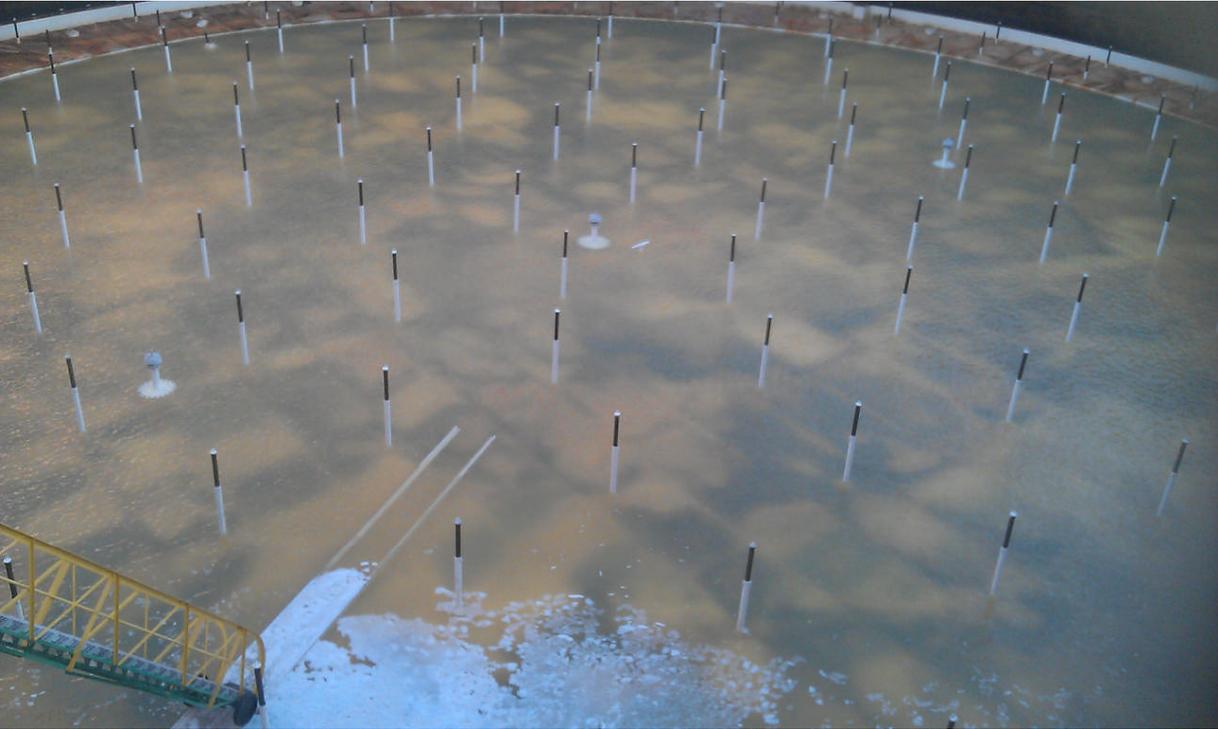
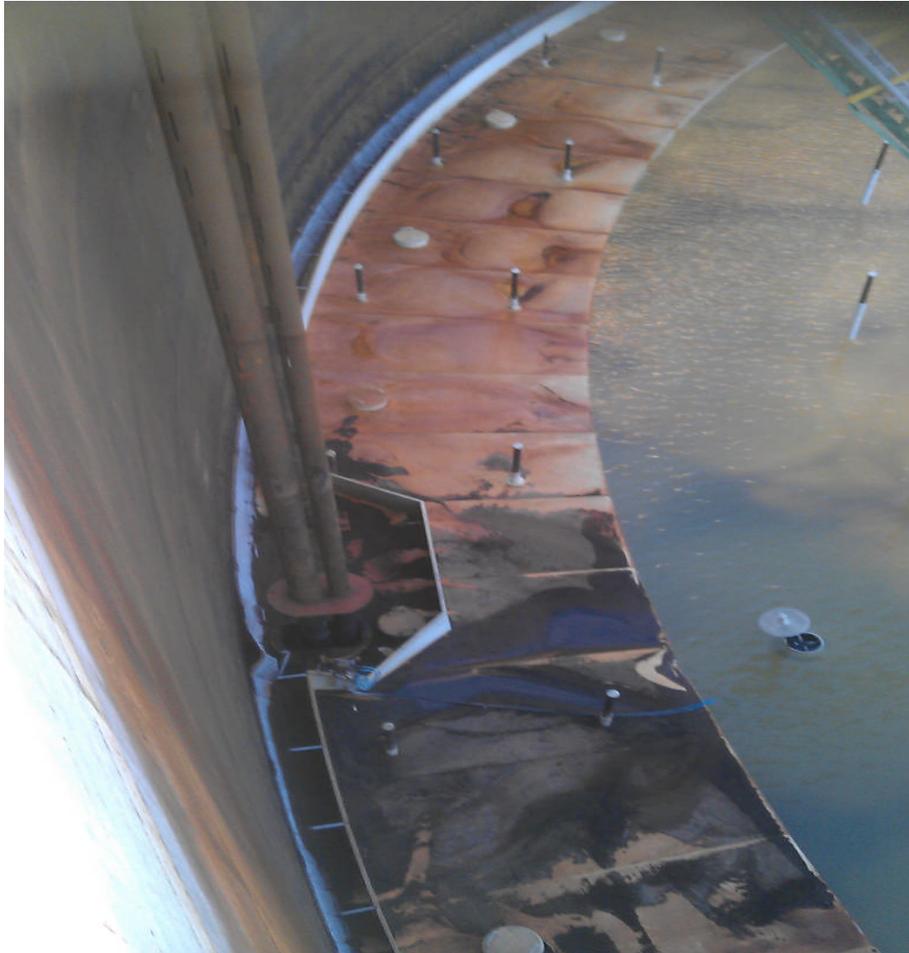
On 25th Jan. 2014 the floating roof sank into of the stabilized condensate tank 5E-220-TB002A at Mellitah complex. due to the heavy fire water / foam , which continued for more than 5 hours , the floating roof sank into the stabilized condensate , the causes of the sinking are that a large amount of fire water / foam remained on the pontoon side , maybe the roof drain sump mouth was blocked with dust and the water entered to one of the two pontoons more than the other side , and an abnormal load was put on the one side of the pontoons or could be Both sides , which was caused an Inclination of the roof , which is led the stabilized condensate liquid moved above the roof , consequently the huge amount of contaminated condensate with water spillage out of the tank through the roof drain as per attached pictures , the estimated quantity of condensate spillage down into the dock area is about 500 to 700 barrels ,

It was observed that all fire fighting pumps were started which is indicted that a large amount of fire water remained on the roof and seems to be the roof drain sump mouth was blocked with dust Water got into the pontoons located at the north side and an abnormal load was put on the roof and it sank into the condensate. The main cause of the accident seems to the cleaning of the floating roof upper surface was insufficient. And there is no normal routine check of the tanks during that day.

- 1- To check and repair the functionality of heat sensitive cable 50-700 TB018A/B which is the main cause of deluge system activation.
- 2- To remove the condensate above the roof ASAP, water wash is required to inspect the floating roof. Because it seems that the roof legs set were not touched the bottom side of the tank and the seal is twisted.
- 3- Improvement in the function of roof drain facilities
