FAILURE REPORT NO: GMS-ME-FR-183

Failure Report

Toromont Compressor 52-340-KC-001B

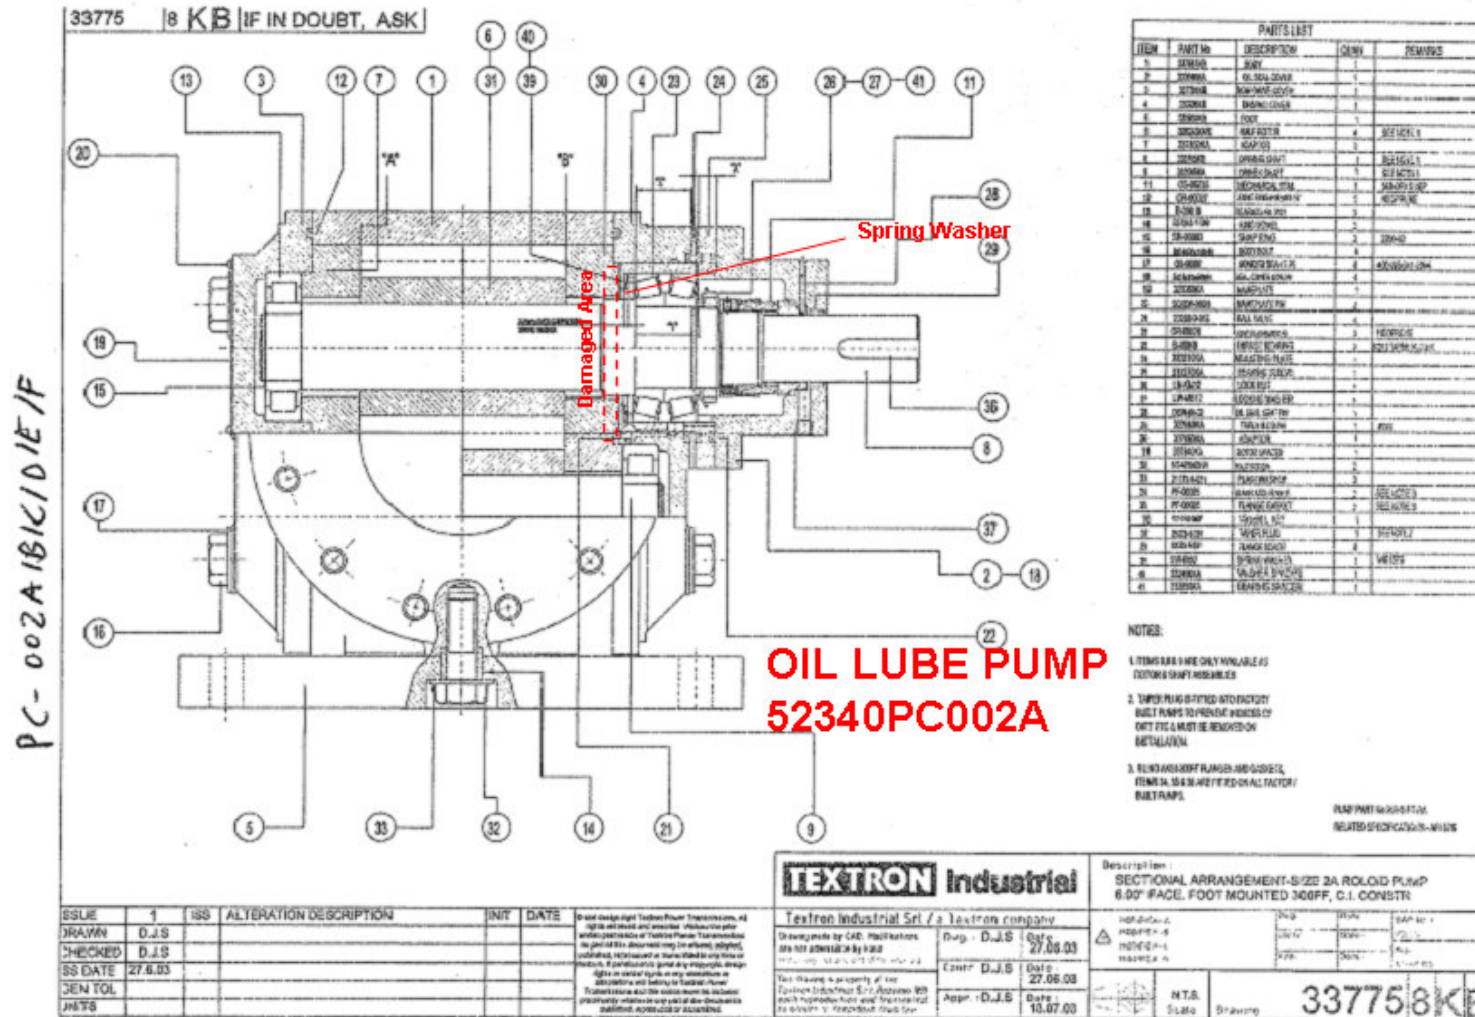
SCHEMATIC VIEW OF SPRING WASHER AND ROLLER BEARING

Pumps tagged as 52340PC002A and B were damaged by the horizontal sliding movement of the roller type bearings attached to both rotors. In pump “A” the damage was very severe, causing the lateral bearing covers to break releasing the rollers from the inner race. These elements were crushed by the rotors, which also slid against the pump’s casing. The lateral movement of the rotor assembly described before also originated contact between it and the adaptors. This issue can be observed through the radial markings carved on the adaptors’ surfaces. All the facts already mentioned could have been triggered by a gradual decrease in compression load of the curved plates that makes up the spring washers. As the proper load lowered its value, the axial forces would drive the bearings against the adaptors surface without opposition from the spring washers; therefore the axial equilibrium was lost. The continuous pounding destroyed the bearings.

- Take oil samples from similar compressors and their associated lube oil filters in order to detect any metal particles.
- Contact the compressor’s vendor company to communicate the problem related to the roller bearing and spring washers and ask for alternative equipment that incorporates a different bearing assembly design.
- Pump PC002D should be replaced and PC002C could be repaired by changing the spring washer assembly.
