# UPTHRUST PROBLEMS ON MULTISTAGE VERTICAL TURBINE PUMPS

**Donald R. Smith**

**Stephen Price**

Engineering Dynamics Inc.

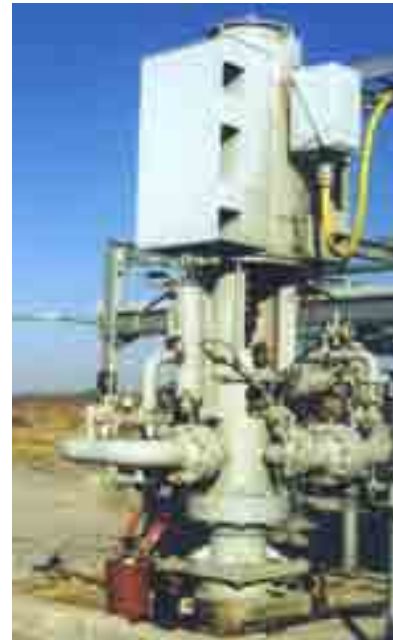
Figure 4. Installation at Pipeline Pump Station.

Three vertical turbine pumps were installed at a pipeline pump station (Figure 4). The pumps were referred to as pumps A, B, and C. The pumps were originally designed for gasoline service (specific gravity of 0.688) at a suction pressure of 100 psig and a discharge pressure of approximately 2130 psig. The pump configuration is shown in Table 1.

When pumps A and B were run with ethane, the vibration levels at the top of the motor and at the top of the pump thrust stand (bottom of the motor) were approximately 1 in/sec zero-to-peak, which exceeded the API 610 (1995) vibration limit. Pump B was tested with the motor running solo and the vibration levels were also considered to be high, even in the solo condition. Impact tests indicated a minor structural natural frequency slightly above the pump running speed of 60 Hz. The pump manufacturer felt that the structural natural frequency contributed to the vibration levels.
