# UPTHRUST PROBLEMS ON MULTISTAGE VERTICAL TURBINE PUMPS

**Donald R. Smith**

**Stephen Price**

Engineering Dynamics Inc.

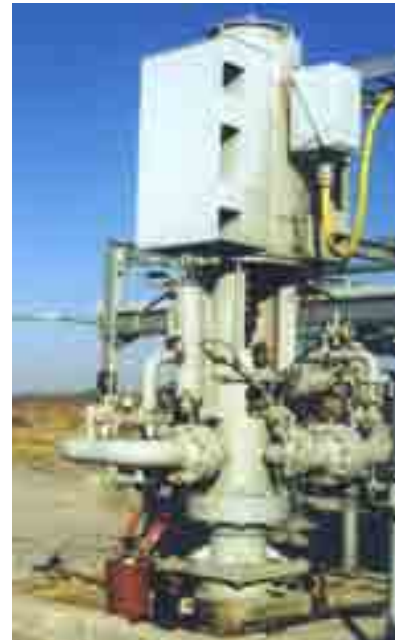
Figure 4. Installation at Pipeline Pump Station.

Three vertical turbine pumps were installed at a pipeline pump station (Figure 4). The pumps were referred to as pumps A, B, and C. The pumps were originally designed for gasoline service (specific gravity of 0.688) at a suction pressure of 100 psig and a discharge pressure of approximately 2130 psig. The pump configuration is shown in Table 1.

When pumps A and B were run with ethane, the vibration levels at the top of the motor and at the top of the pump thrust stand (bottom of the motor) were approximately 1 in/sec zero-to-peak, which exceeded the API 610 (1995) vibration limit. Pump B was tested with the motor running solo and the vibration levels were also considered to be high, even in the solo condition. Impact tests indicated a minor structural natural frequency slightly above the pump running speed of 60 Hz. The pump manufacturer felt that the structural natural frequency contributed to the vibration levels.

The ODS indicated that the motor was “rolling” or “wobbling” on top of the thrust stand. In addition, slipping was observed between the flanges connecting the discharge head to the barrel. Subsequent to the ODS testing, several of the flange bolts were determined to be loose and were tightened; however, tightening the bolts did not reduce the vibration to acceptable levels.

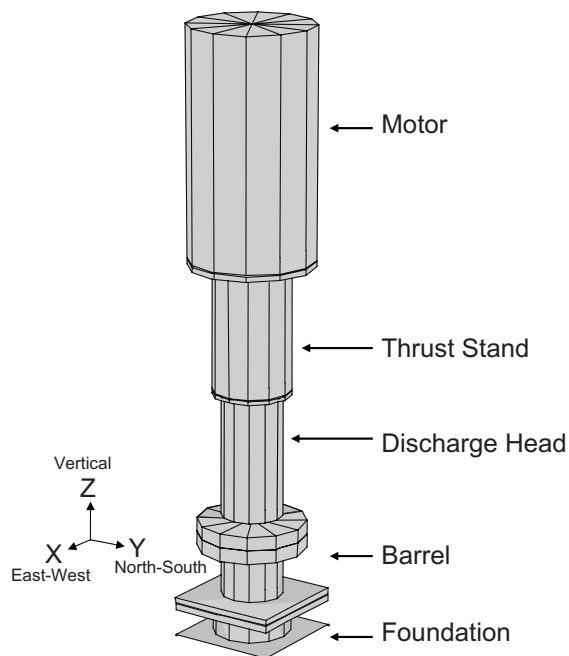
Figure 5. Pump/Motor ODS Model.

The ODS model is shown in Figure 5. A selected single frame of the vibration animation at  $1\times$  running speed is shown in Figure 6. Note that the vibrations are exaggerated in the plot to allow the ODS to be easily visualized. As shown in the ODS, the maximum vibration levels were measured near the top of the motor in the N-S direction. The maximum vibration levels were approximately 6.3 mils peak-to-peak (1.2 in/sec zero-to-peak).
