TPO WEATHERING TEST ROOF IN LAS VEGAS, NEVADA.

Seven-Year TPO Report

An Update on Western States Roofing Contractors Association's TPO Weathering Farm Project

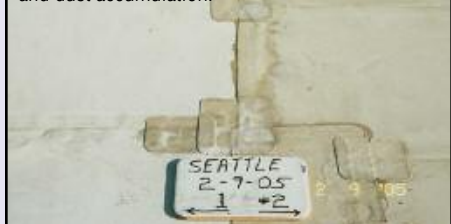
Photo No. 25 is from the Seattle roof during the fifth-year inspection. Photo 26 is from a nearby location on the same roof during the seventh-year inspection. Both photos show Roof Area 1 on the left and Roof Area 2 on the right. Note that in the 30 days prior to the date of the fifth year inspection, there was approximately 3.16 inches total precipitation in the Seattle area, which was similar to previous years. That rainfall was relatively evenly distributed over that time period with the most rain in any one day measured at 0.22 inches. Similar conditions existed prior to the seventh year inspection, with 3.53 inches of precipitation in the 30 days preceding the inspection and that was also relatively evenly distributed

Photo 25. Depicts Roof Areas 1 and 2 of the Seattle, Washington test roof. Photo taken on February 9, 2005 during the third year inspection. Note the beige color of the Roof Area 2 membrane on the right side of the photo, due to airborne dirt and dust accumulation.

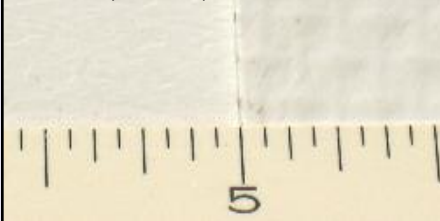
Photo No. 27 is a close-up of unexposed membrane samples for Roof Areas 1 and 2, compared side by side, with Area 1 membrane on the left and Area 2 membrane on the right. Area 2 membrane appears rougher and of a slightly darker shade. Photos 28 and 29 show comparisons between unexposed Area 1 membrane and unexposed Areas 3 and 4 membranes respectively. Each unexposed membrane sample has its own uniqueness in color as well as surface texture. Note that the unexposed samples were taken from new rolls during original installation of the membranes and have been stored at Building Envelope Technology & Research's office. Similar samples are also stored at the offices

Photo 29. Depicts an unexposed sample from the material that was installed on Roof Area 4 on the right side of the photo compared to the Roof Area 1 unexposed sample on the left.

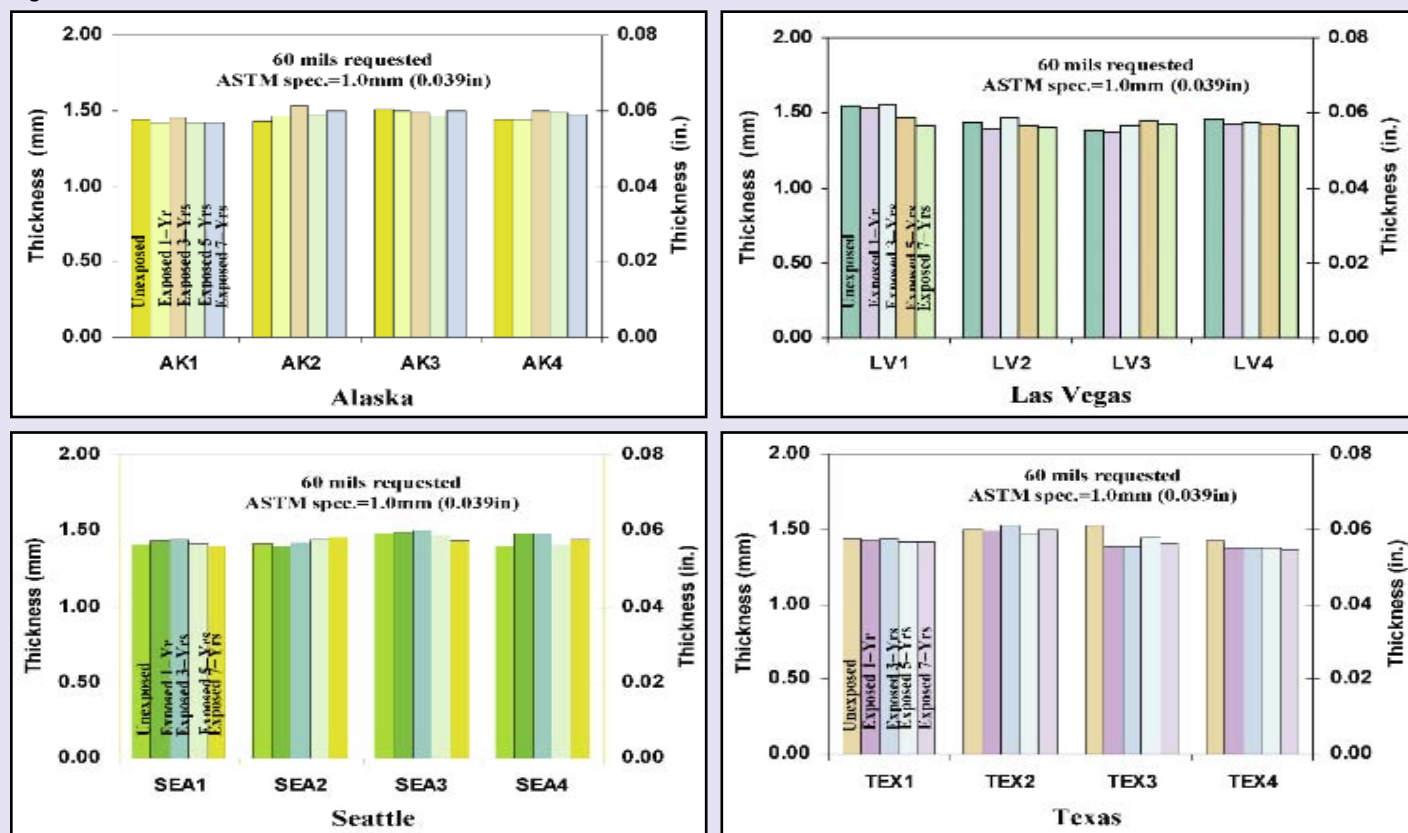
Figure 4. Overall Thickness

One of the tests performed is a measurement of the overall thickness of the membrane. All membranes were approximately 0.060 inches or "60 mils" nominal thickness when initially installed. To monitor potential changes, we measured samples of the test cuts in the laboratory. So far, the overall mil thickness of the sheets has varied a bit, as they continue to weather in the diverse climates. Measurements have been recorded greater than 0.060 inches, and others less than the specified as-new thickness. Thickness measurements are illustrated in Figure 4.

surements are thought to be due to variations in the manufacturing process and the sampling procedures. However, these variations are within the tolerances for overall thickness as specified in ASTM 6878, Standard

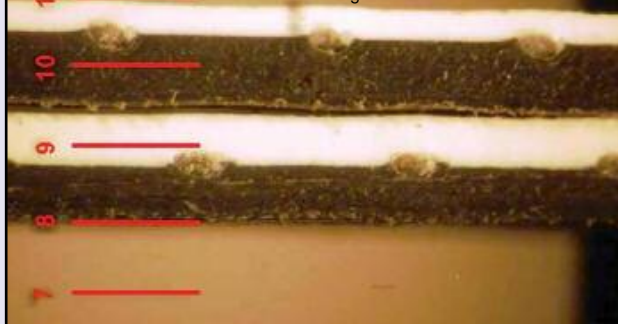
Microscopic examination of the Seattle sample in Building Envelope Technology & Research's laboratory found that at this particular location the membrane had a thicker bottom layer than that observed in previous samples. (See microscopy image comparison in Photo 32.) The layer above the scrim was indeed thinner than measured on previous samples, but with the fact that the under layer is thicker came the thought that the thinness above the scrim may be an anomaly created during the manufacture of the membrane rather than definitive indication of a loss of material due to weathering.

Photo 32 was taken in BET&R's laboratory with a digital camera

Photo 32. Photo taken through microscope. The microscope was set at 15X magnification. However, the actual scale changes depending on the size of the printed image. Therefore the scale can be determined by the millimeter reticule scale used in the image.

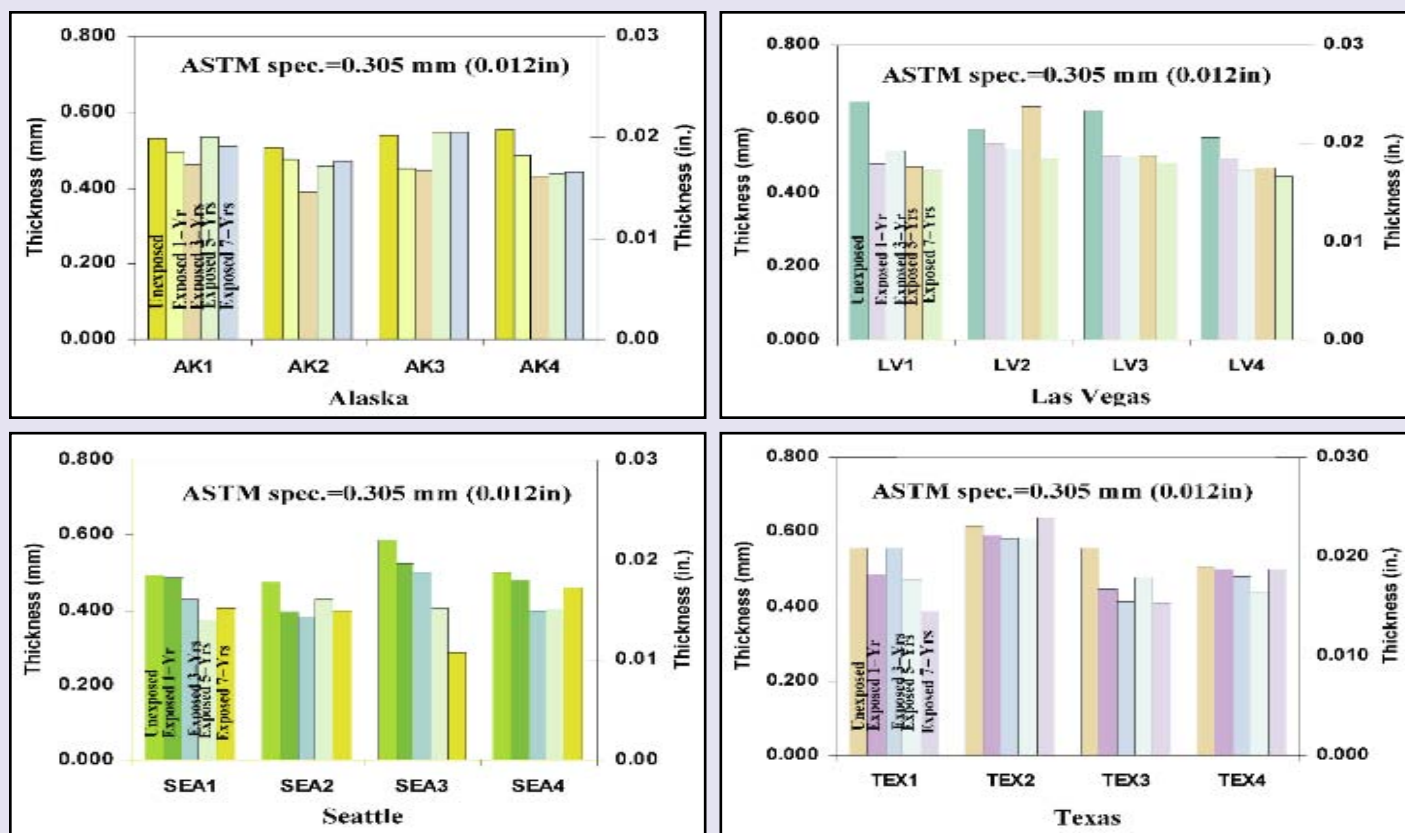
Figure 5: Thickness, coating over scrim.

and again the measurement may be indicating a variation in how the sheet was manufactured rather than evidence of thickness loss due to weathering. In all the comparative microscopic review, only the Seattle Roof Area 3 measurement fell below the ASTM standard of 12 mils over the scrim after 7 years of weathering. It should be noted that test cuts are

It may be important to note that even though thicknesses have differed from some of the membrane test cuts, the measurements, with the one exception, fall within the ASTM standard, D6878-03. 2 (See Figure 5). However, note that this standard is not specific to thicker TPOs such as the 60

mil products. This WSRCA TPO Task Group and WSRCA's Low-Slope Committee recommend that the ASTM consider changing this standard to provide different classifications for each product thickness category.

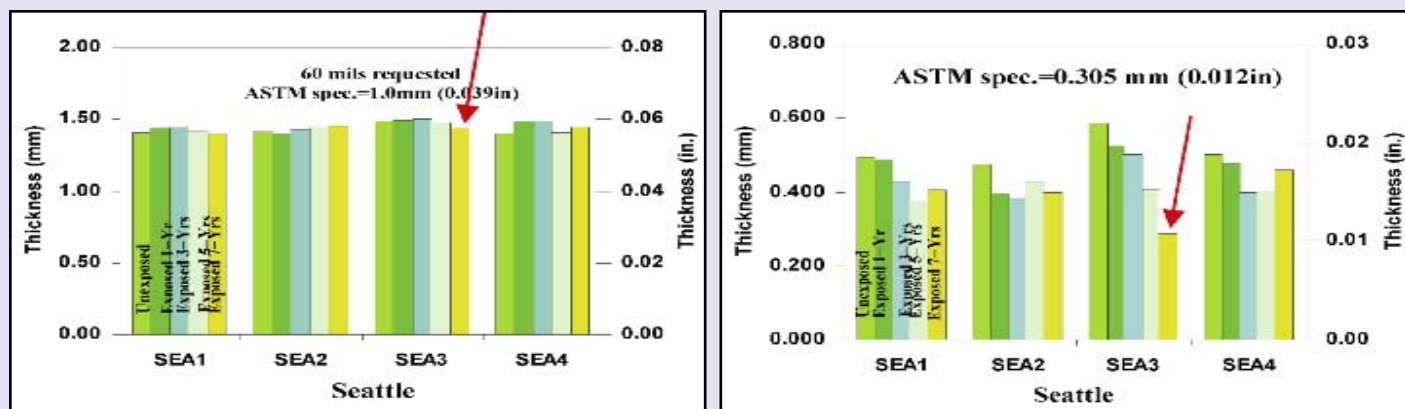
Figure 6. Comparison of thickness overall and thickness over scrim.

The charts in Figure 6 show a comparison between overall thickness and thickness over scrim with arrows added to indicate Roof Area 3's seventh year data at the Seattle site.

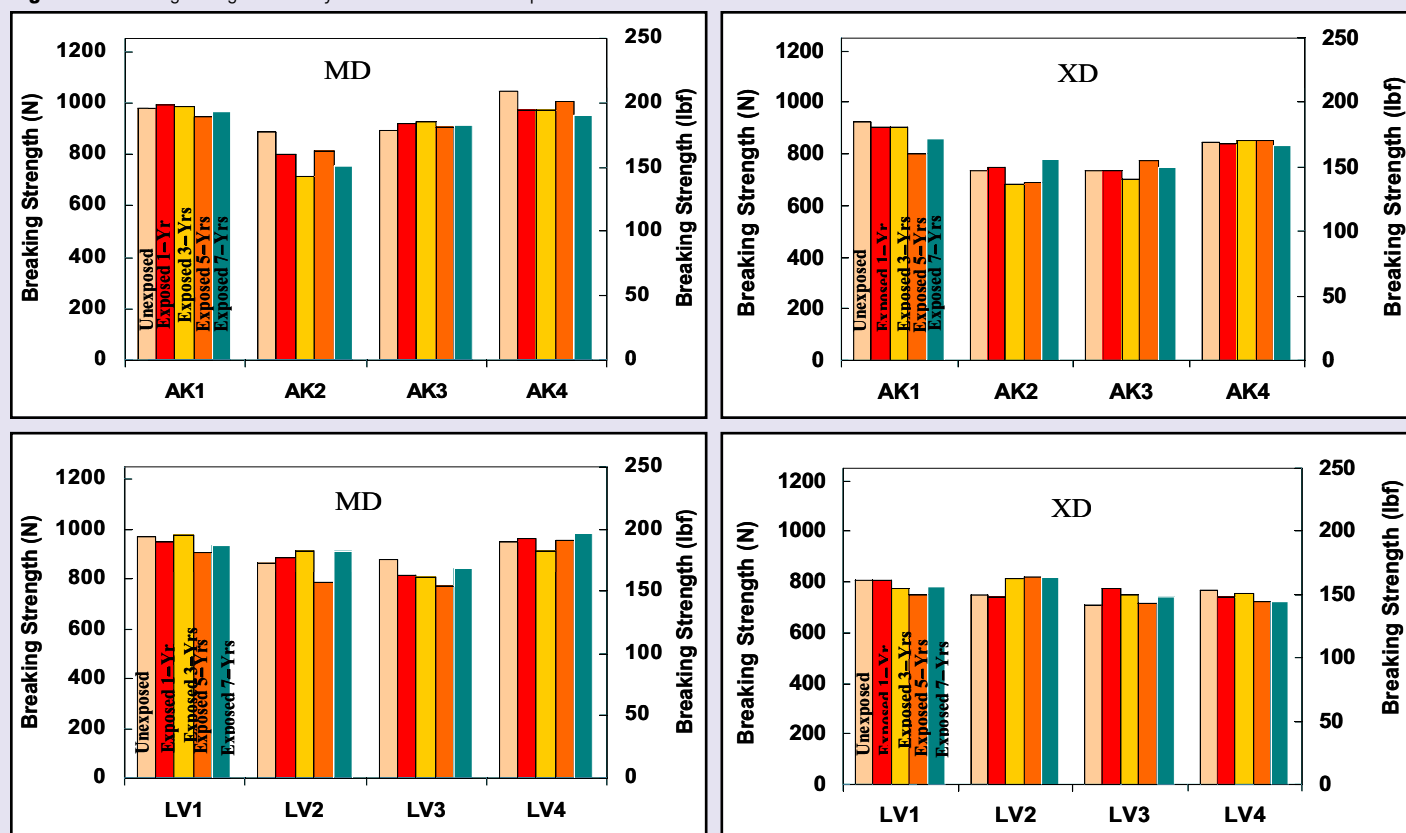
Figure 7. Breaking strength for 0-7-years for AK and LV samples – MD and XD.

the locations tested. Test results for breaking strength are illustrated in Figures 7 and 8.
