MEASUREMENT POINT	OVERALL LEVEL	HFD / VHFD
-----		
BO.3151.02 - GRATE Preheat Off-Gas Fan		(31-May-16)
	OVERALL LEVEL	1K-20kHz
M1H	.163 mm/Sec	.391 G-s
M1V	.223 mm/Sec	.378 G-s
M1A	1.12 mm/Sec	.632 G-s
M2H	.217 mm/Sec	.233 G-s

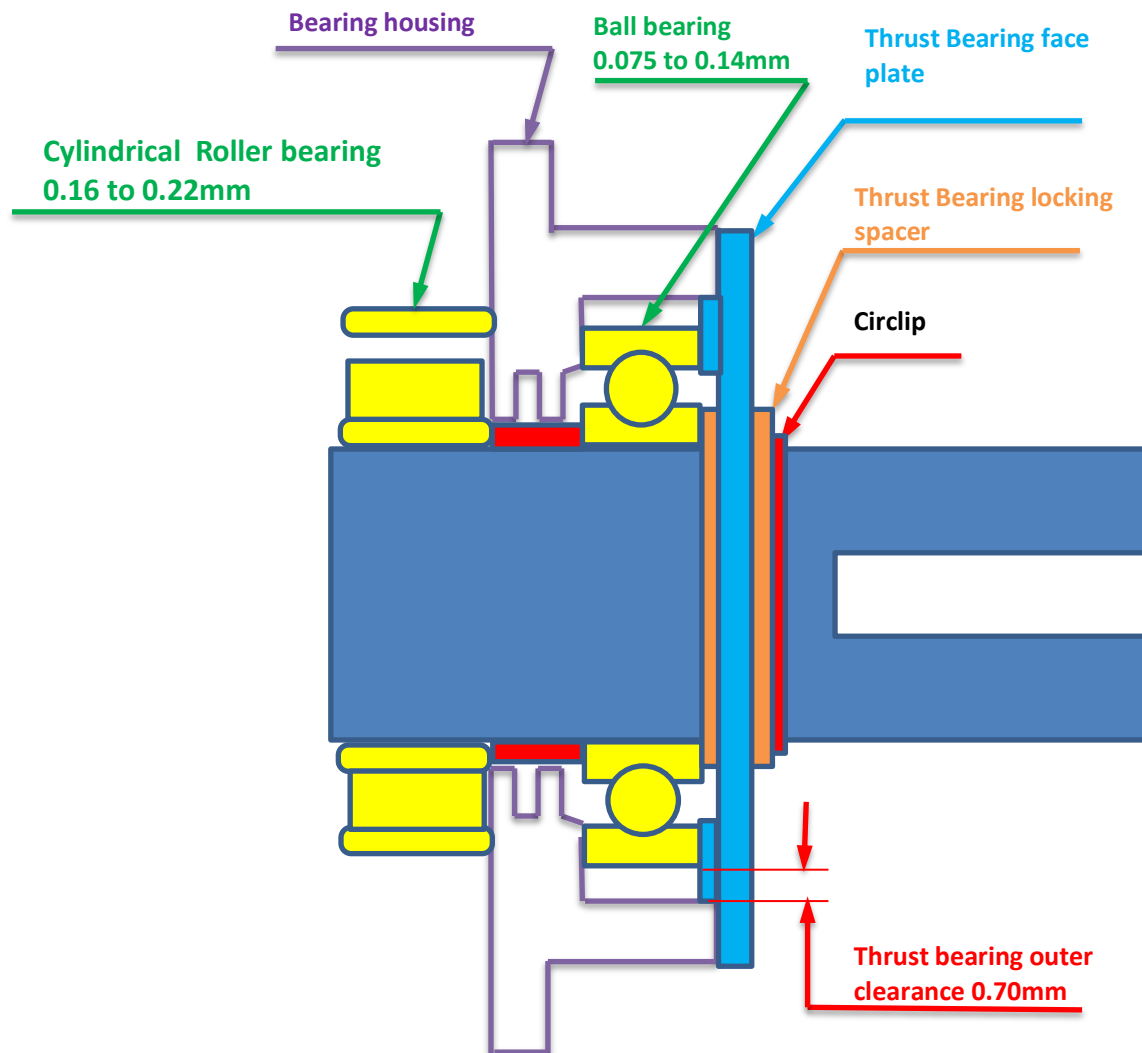
## Bearing Arrangements

Location Of Bearing	Bearings	ID	OD	Width	Internal Radial Clearance
Motor Thrust Bearing	6044M/C3 Ball Bearing	220mm	340mm	56mm	0.075 to 0.14mm
Motor Radial bearing	NU1044M/C3 Cylindrical Roller Bearing	220mm	340mm	56mm	0.16 to 0.22mm
Fan Fixed Bearing	RTL 10 Sleeve Bearing With Thrust Collar	250mm	--	450mm	0.27 to 0.40mm
Fan Free Bearing	RTL 10 Sleeve Bearing	250mm	--	450mm	0.27 to 0.40mm
