Event Report

FHWA Office of Bridges and Structures

Subject: Closure of I-276 Delaware River Bridge (PA Turnpike and NJ Turnpike)

Date of Event: January 20, 2017

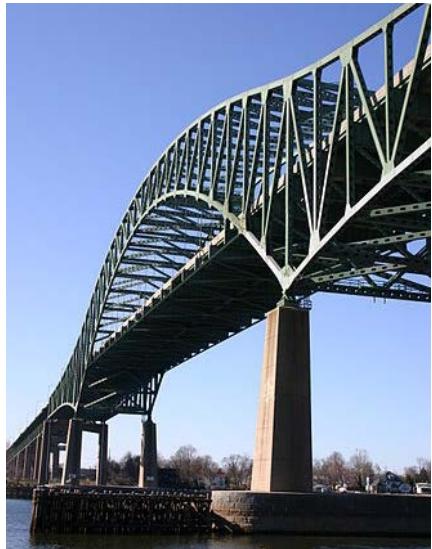
Figure 1 Main river span

The bridge has 31 spans, with a total structure length of 6,751' and a main river span of 682'. The overall deck width is 80'. As shown in Figure 1, the main river span is a distinctive arch-shaped through truss, with suspended deck and vertical clearance of 135'.

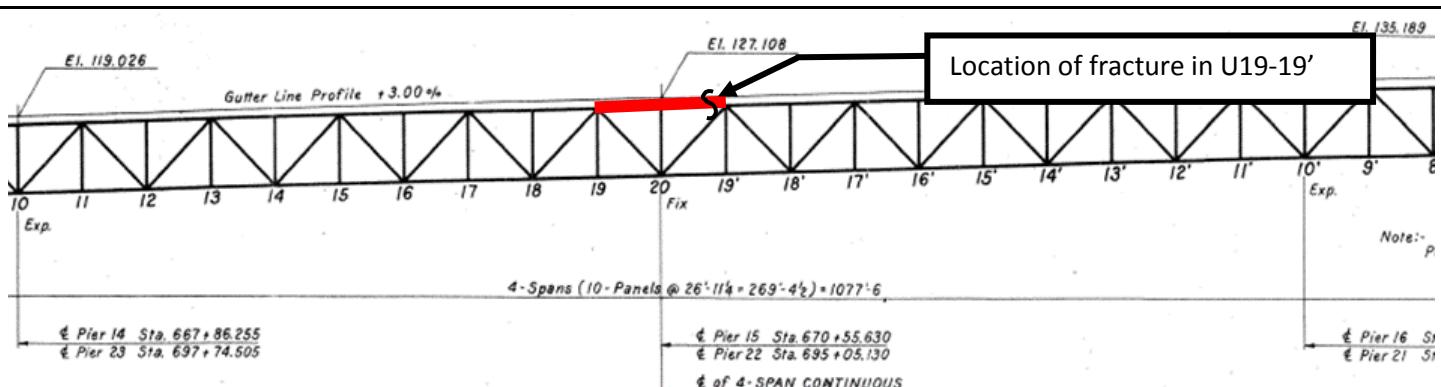
Figure 2 Deck Truss elevation view, Spans 15 and 16 (as-built). East to the right, north into the page.

leading up to the arch. The center two spans of the 4-span continuous unit are shown in Figure 2 on
