What prompted the collapse of the Chirajara Bridge ?

Ing. JAIME SUAREZ DIAZ

**Why the pylon (tower)
failed at Chirajara?**

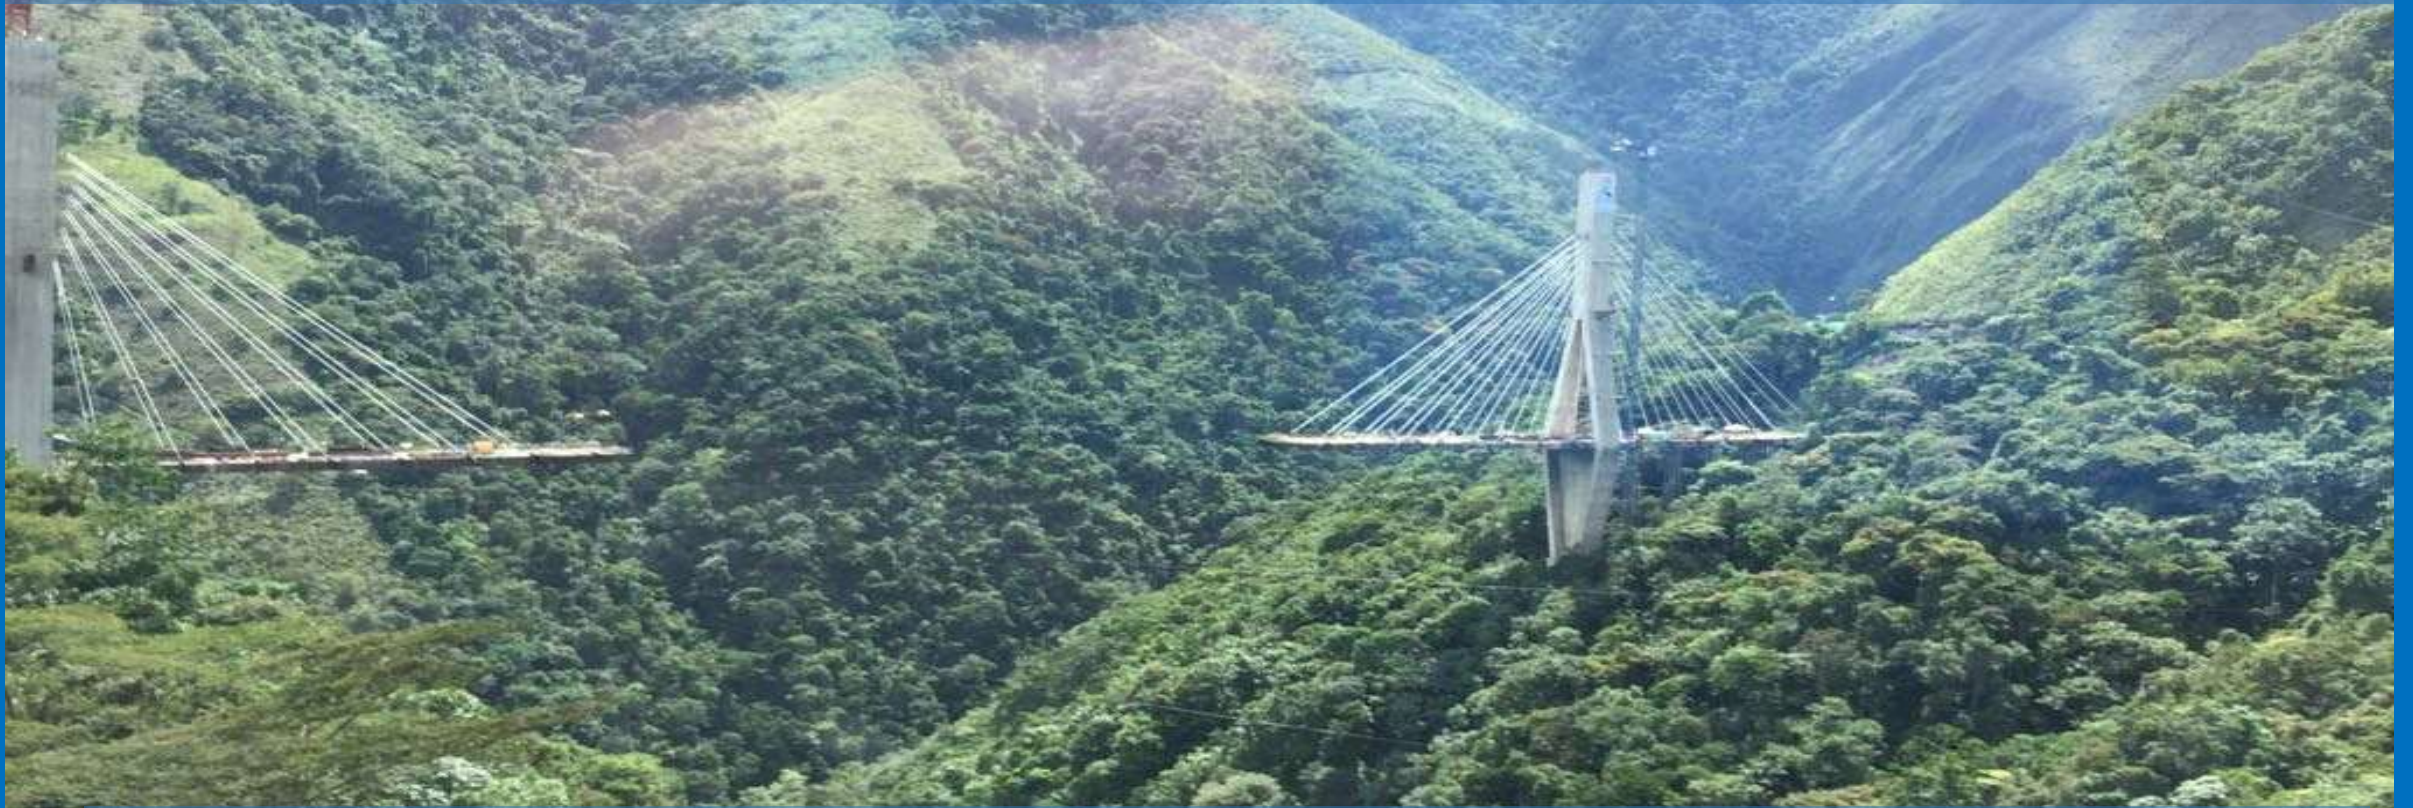
It was an engineering challenge to effectively support the bridge towers on highly sloped hillsides and geologically complex stratum.

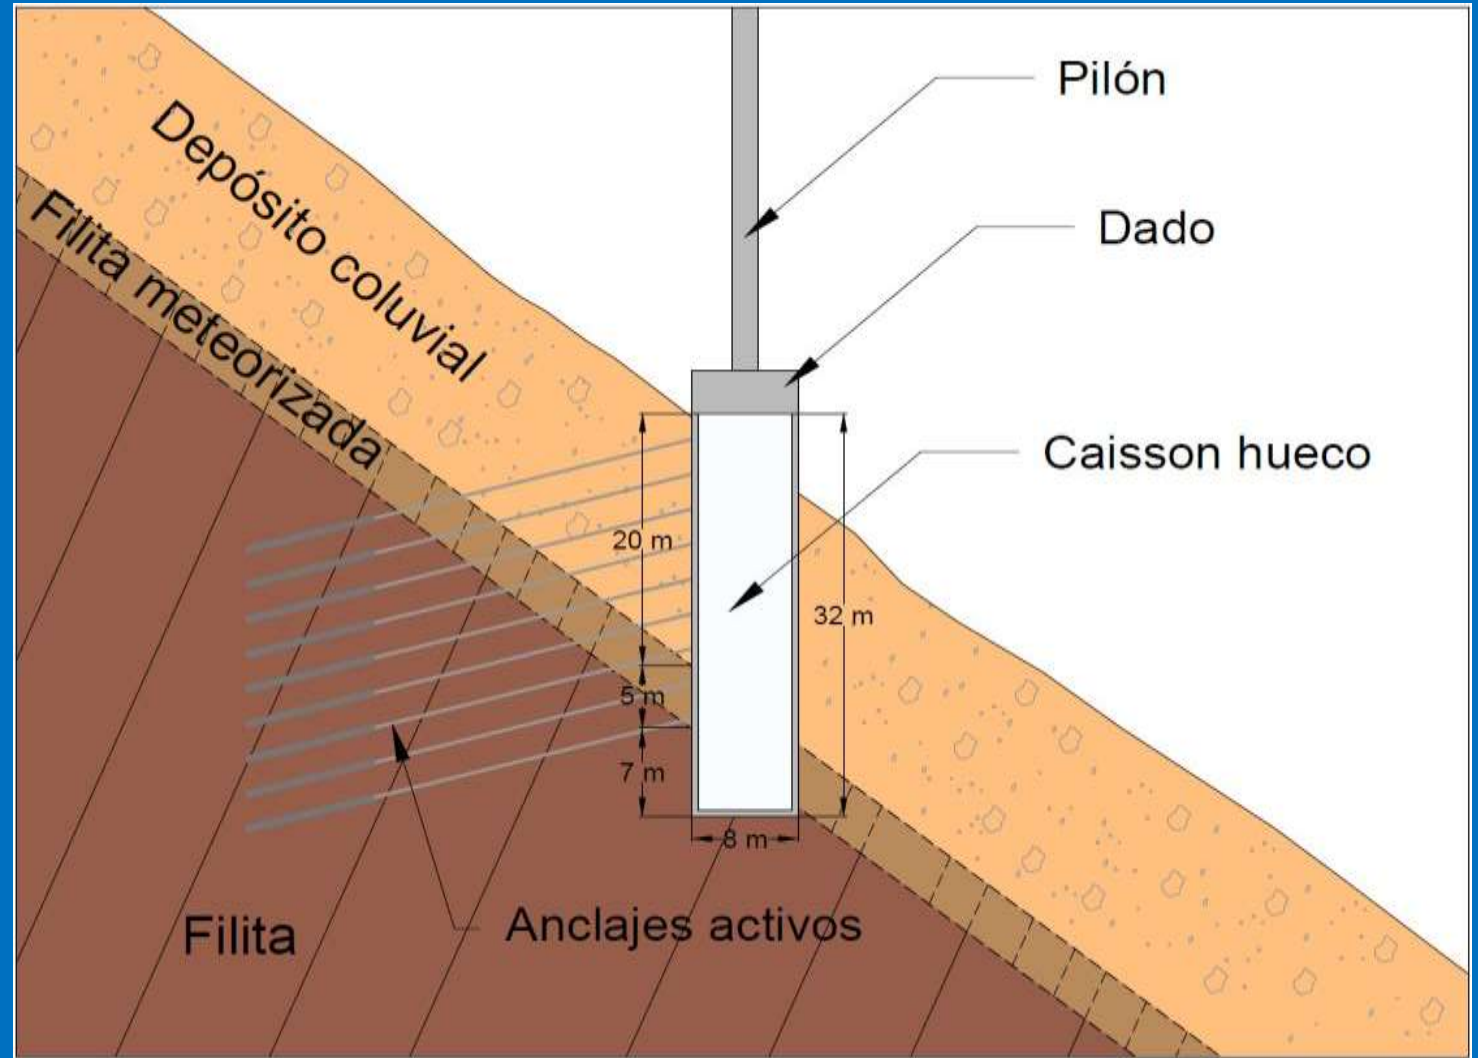
At the site of the right tower (the one that collapsed) exists a Colluvium deposit 20 meters thick.

Each pylon was supported on "individual" caissons of approximately 8 meters diameter.

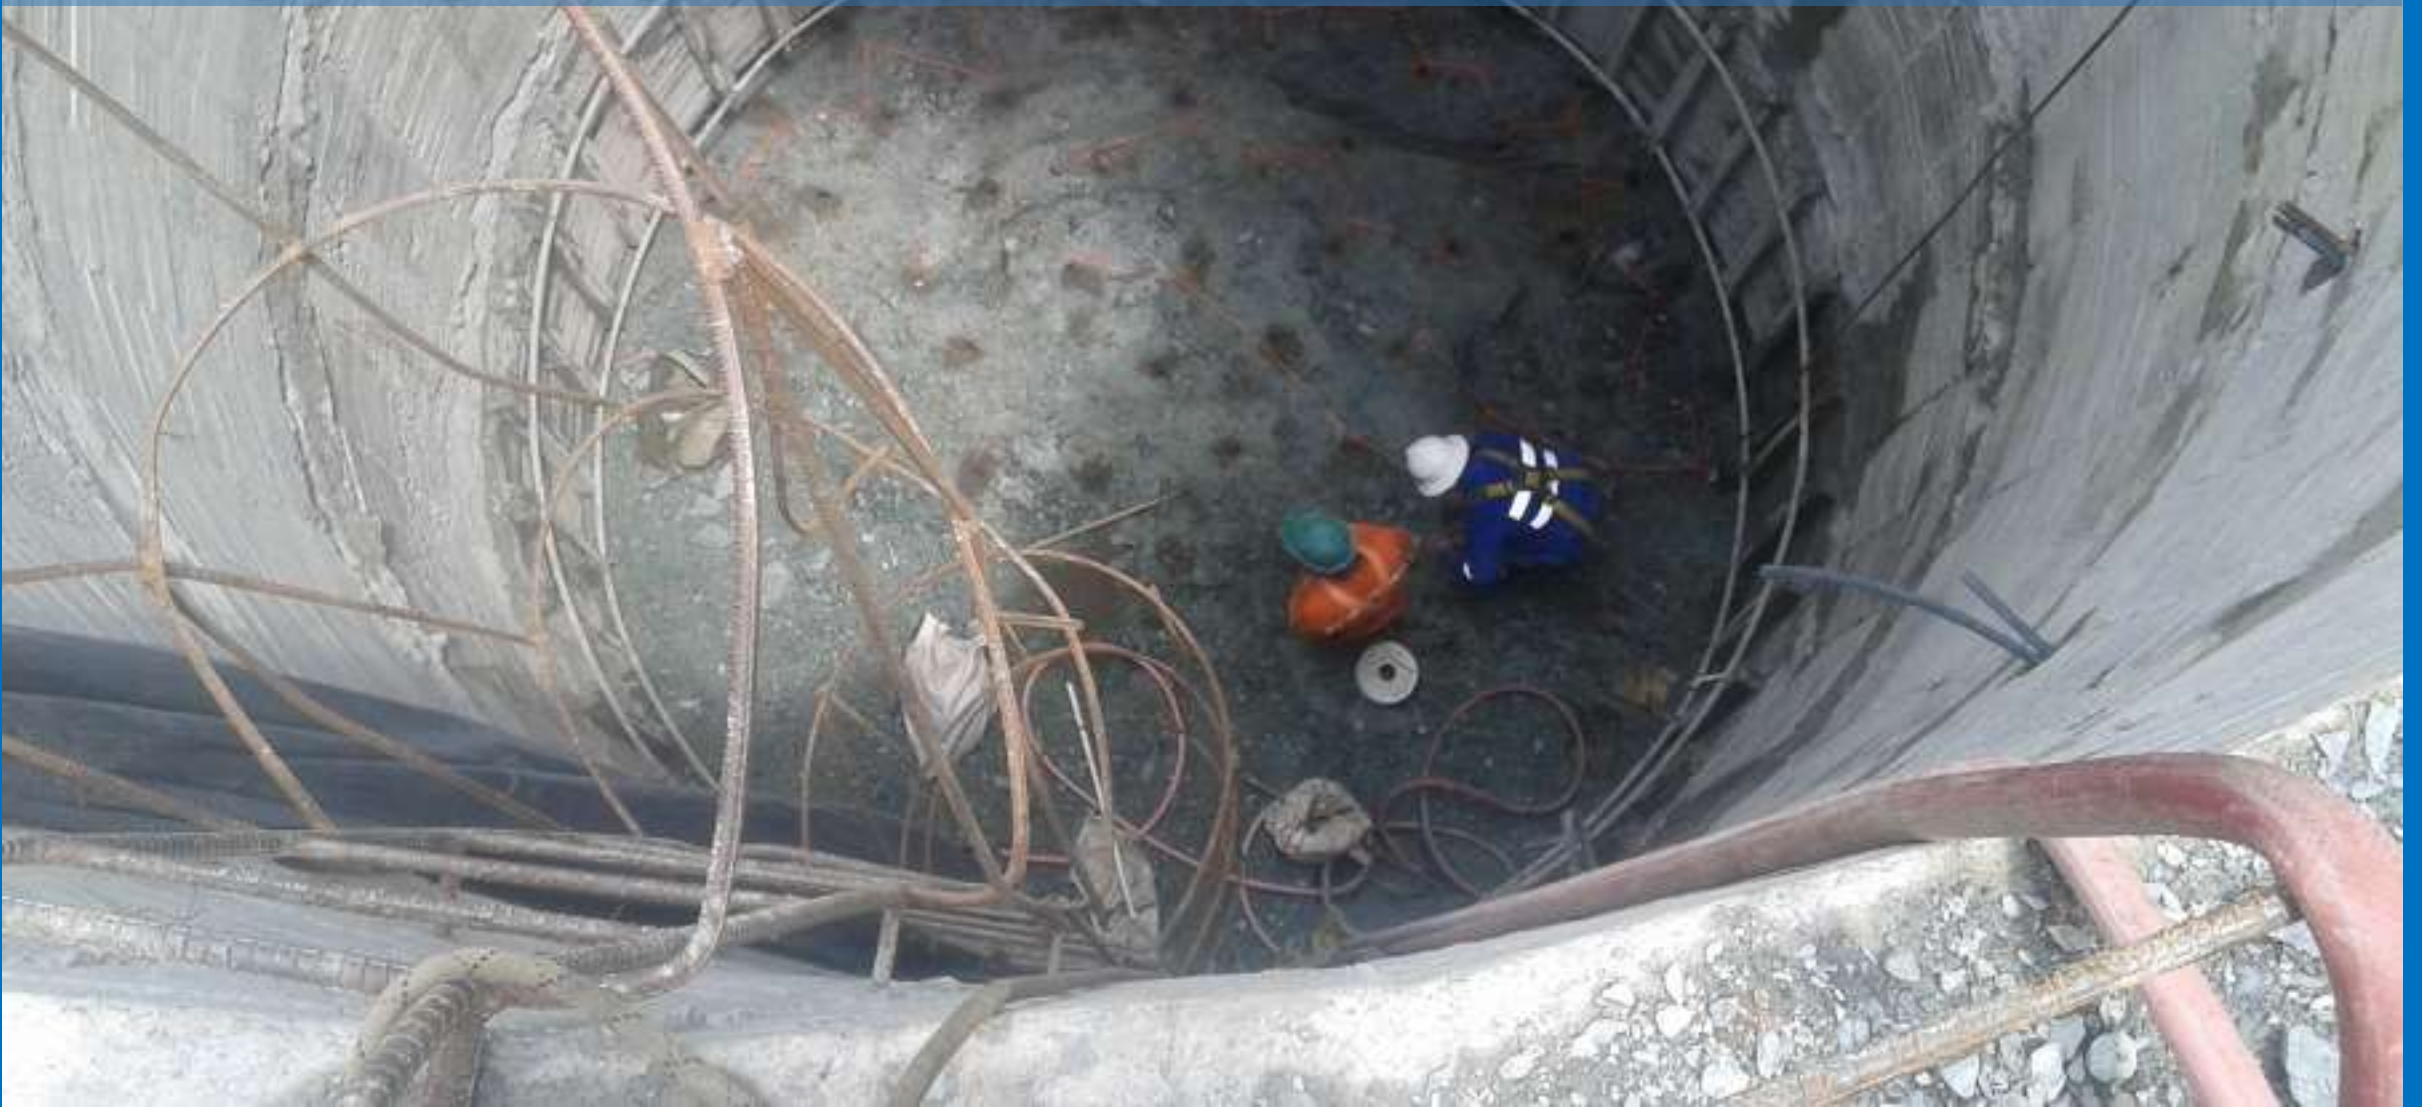
Explosives were used to advance the excavation of the caisson.

¿Could the use of explosives have affected the integrity of the phyllites and quartzites or the colluvium in the foundation?

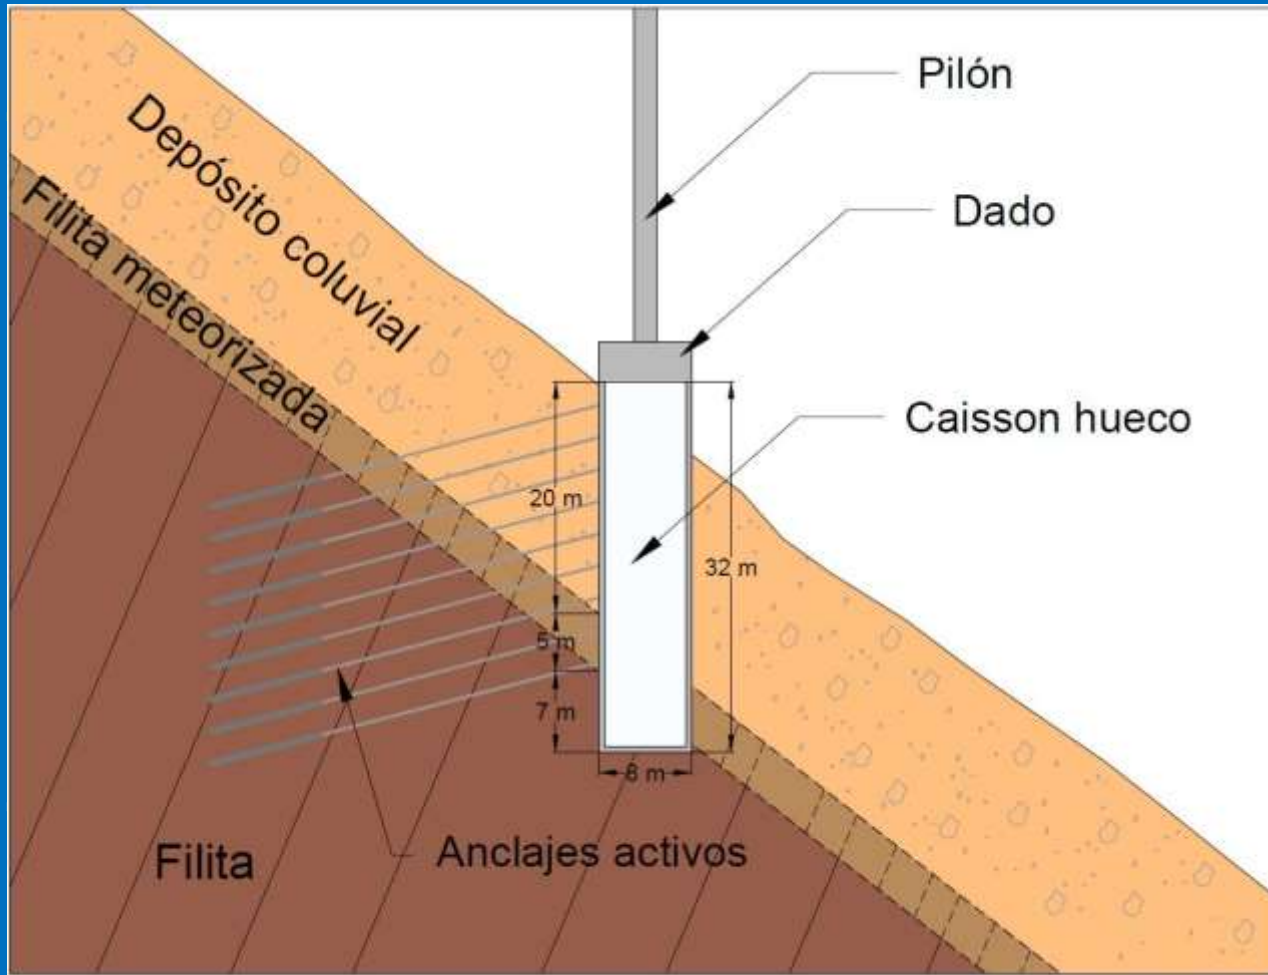
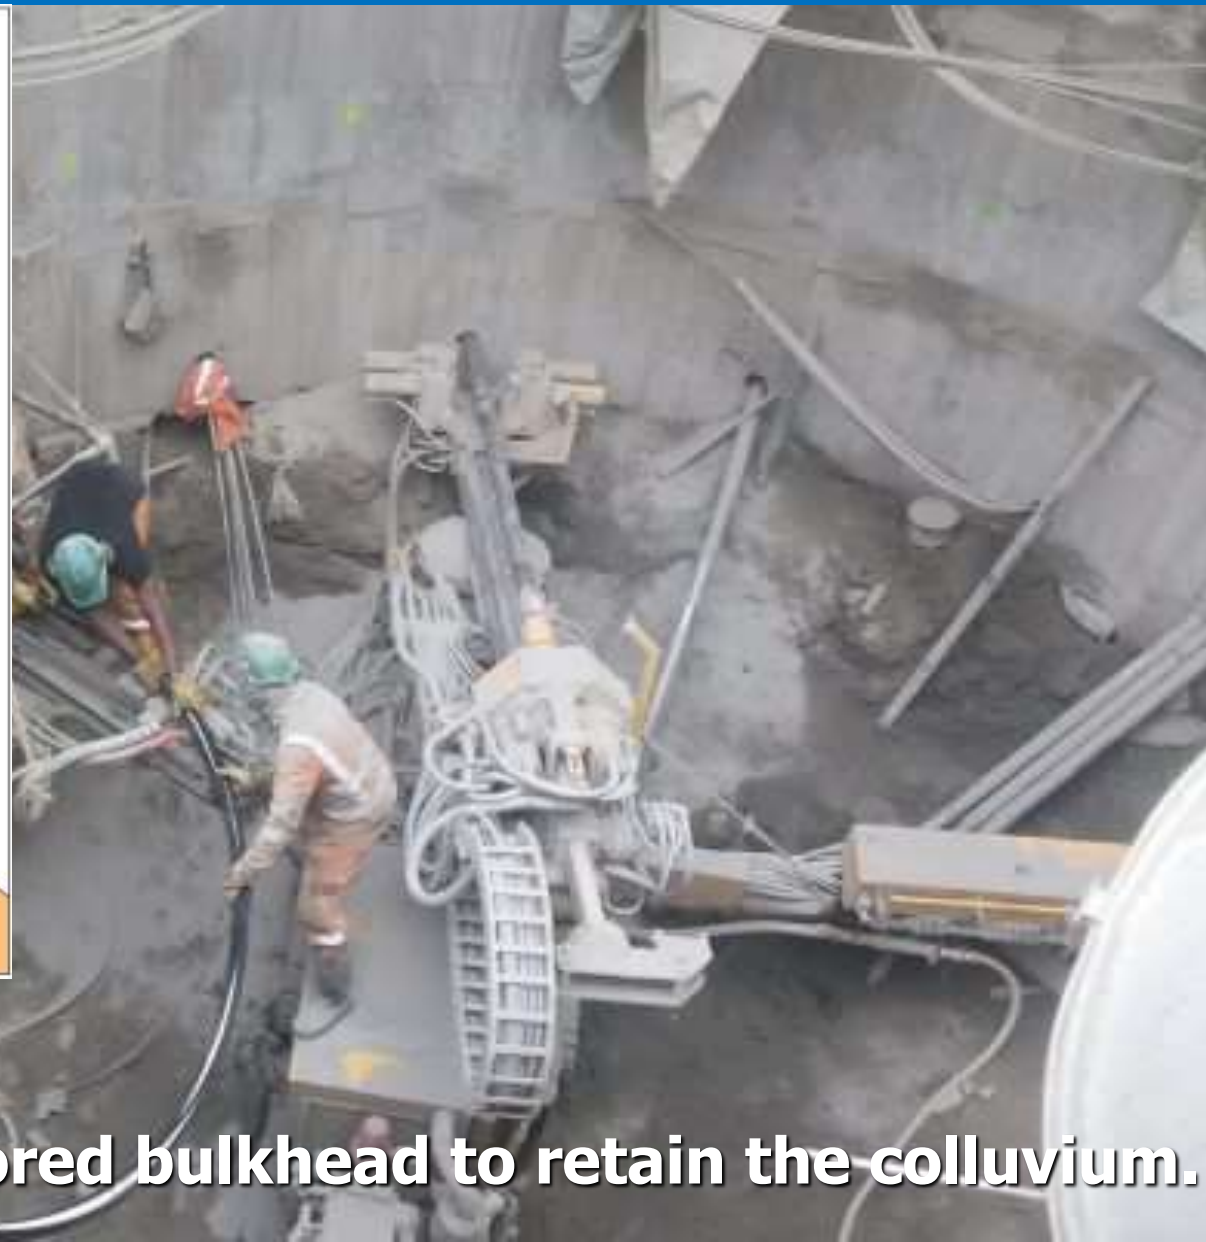
To counteract the effect of the colluvium against the caisson 9 tiers of 50 tons nominal load/anchor, tie-backs were installed over the top 20 meters of the 32 meters deep hollow caisson.

The caisson works as a tie-back anchored bulkhead to retain the colluvium.

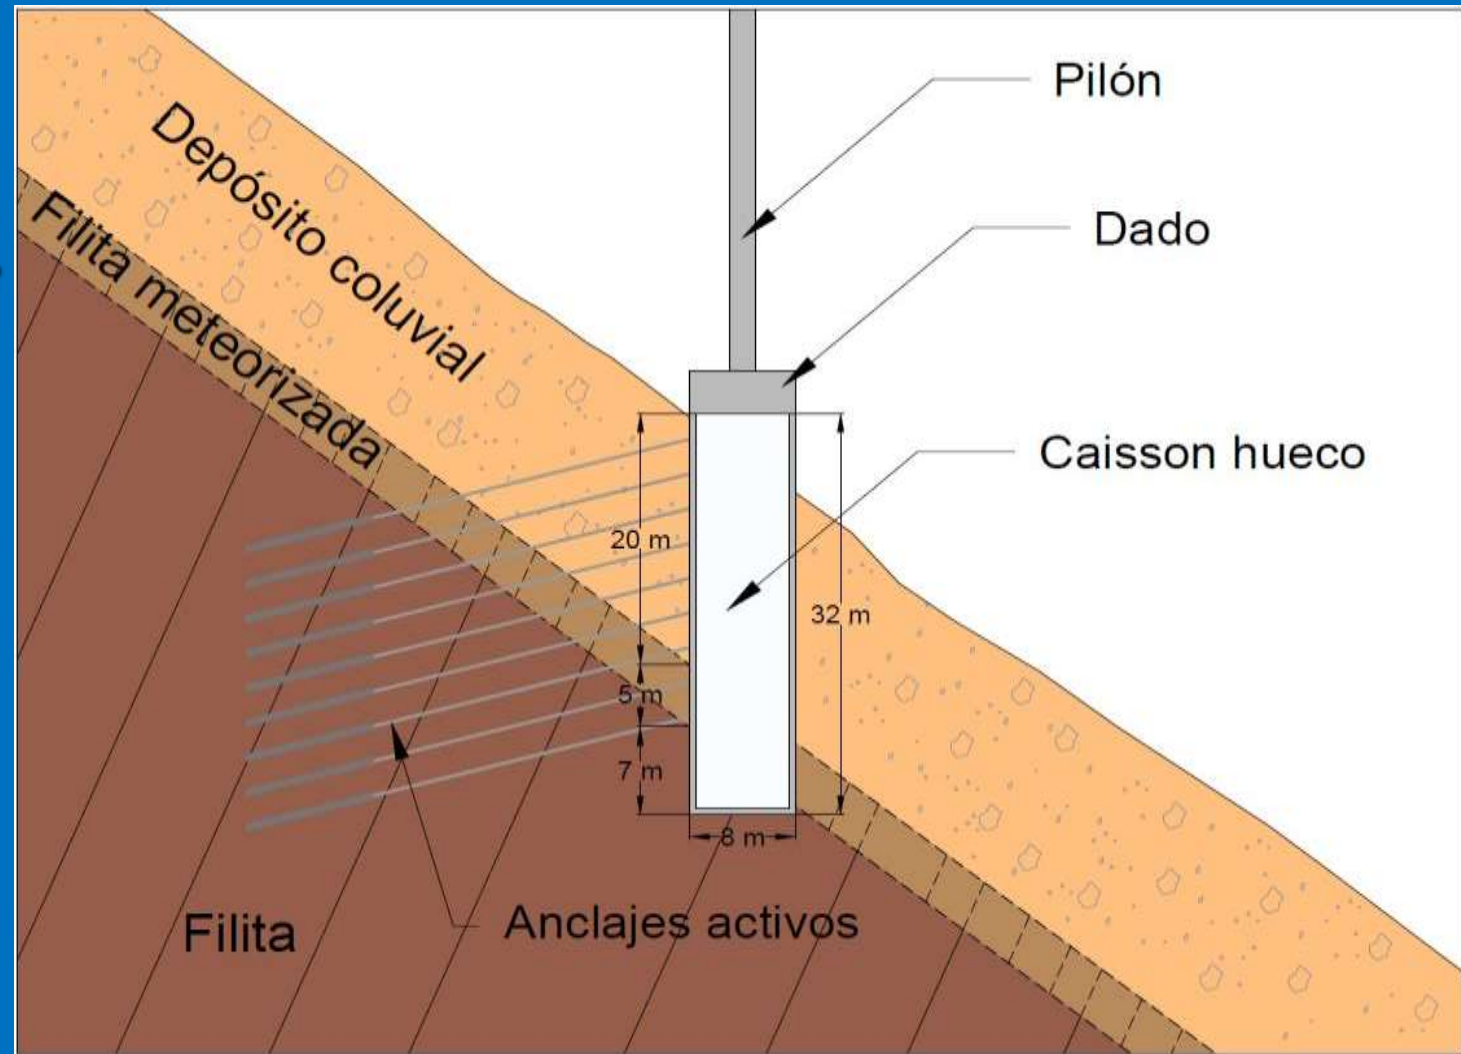
In the conditions of the colluvium middle of hillside, is it possible that some horizontal displacement of the foundation may have occurred ?

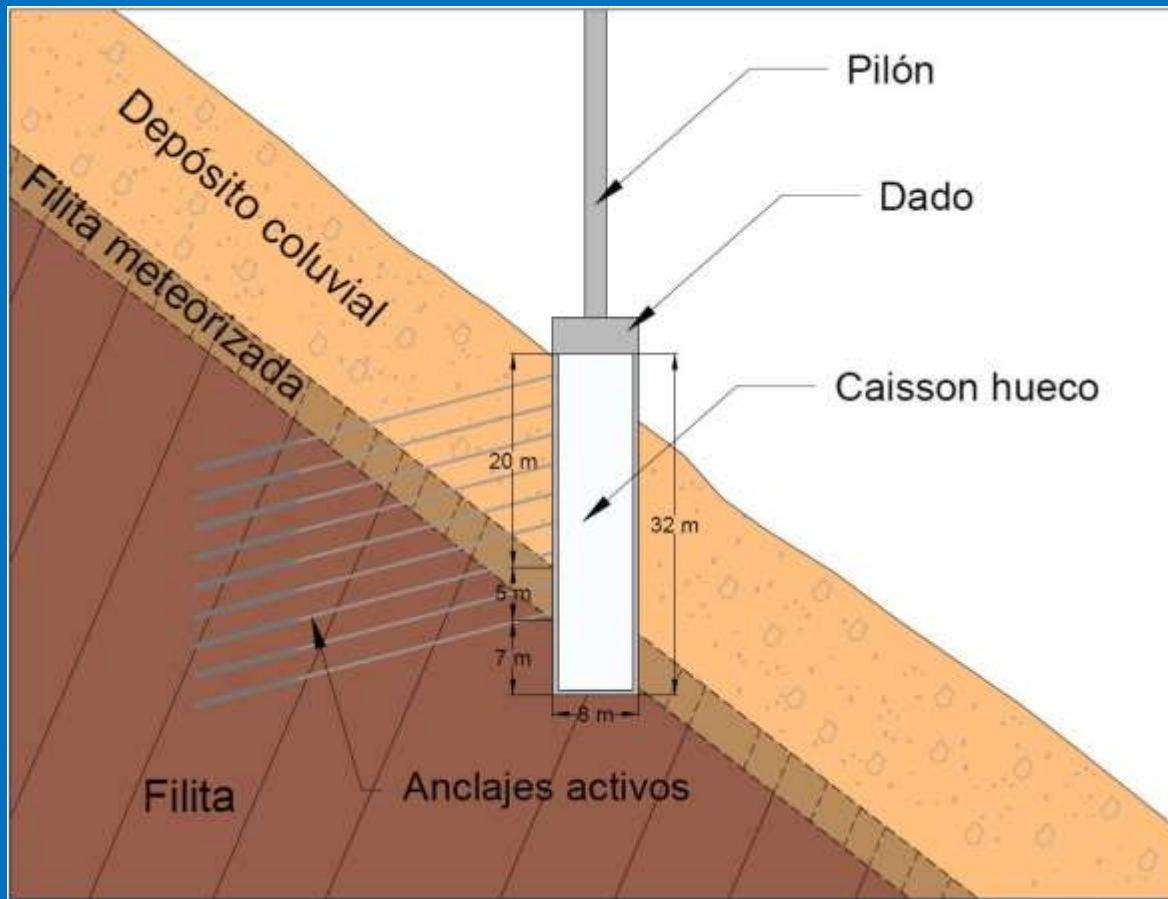
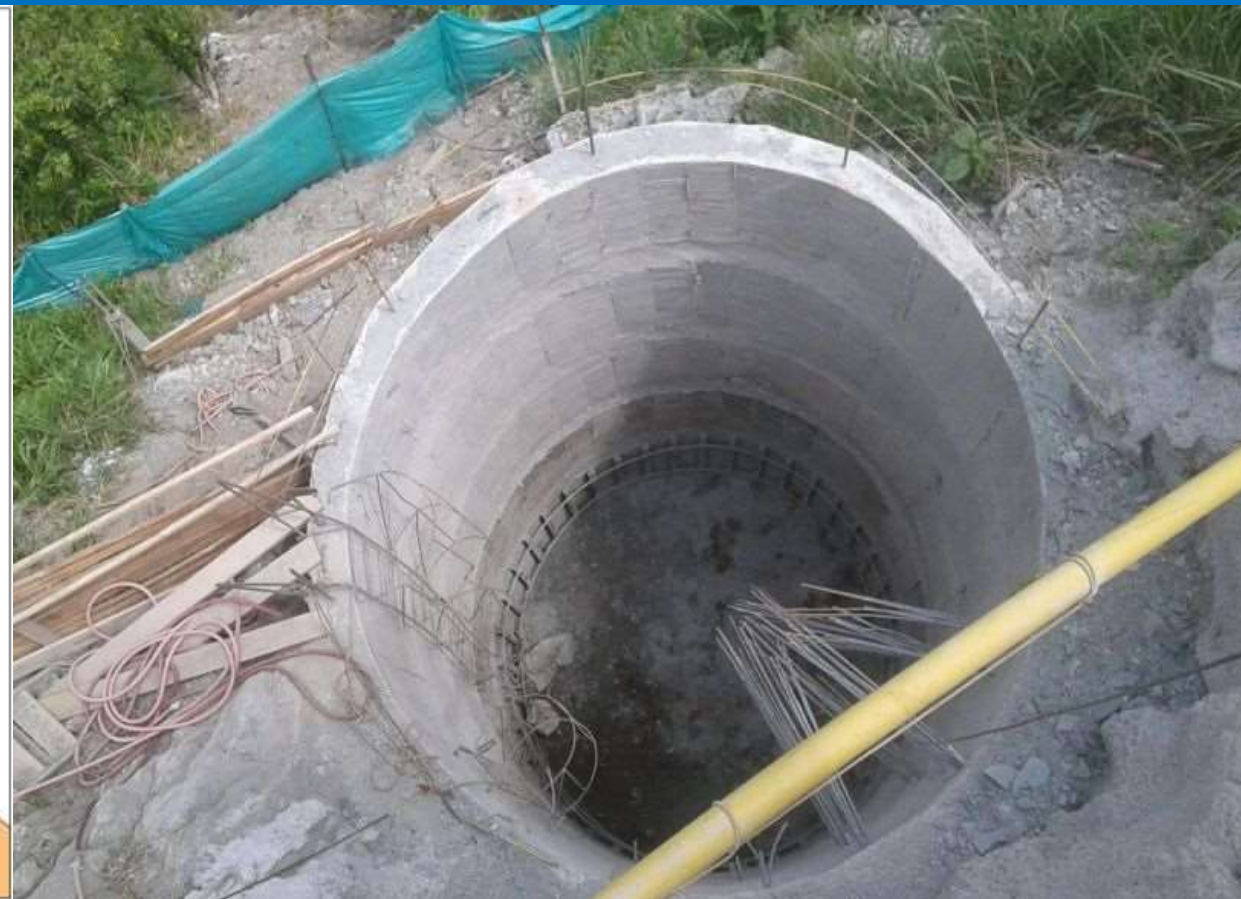
The caisson emerges above the ground surface on the exposed hillslope.

Is the caisson sufficiently confined in the ground?

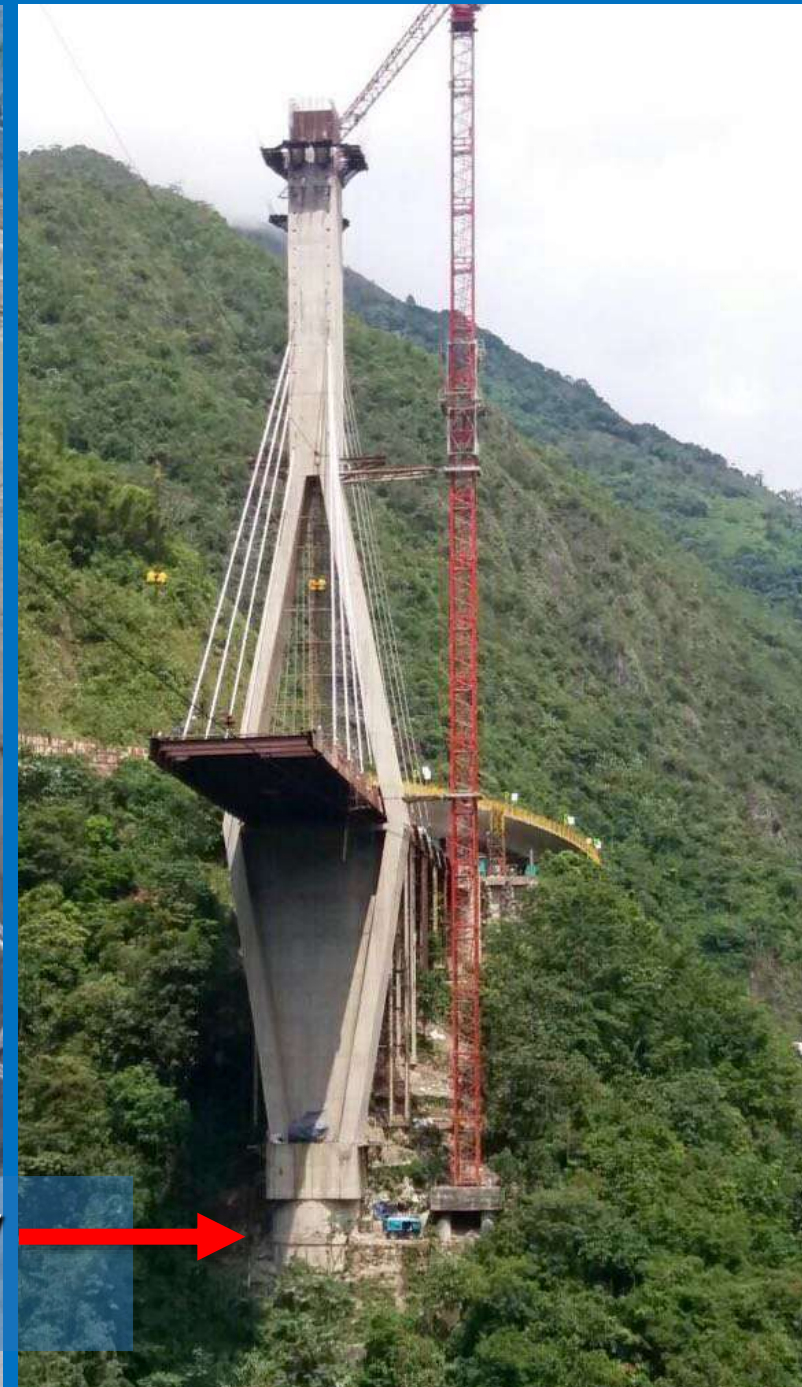
The individual caisson was capped with a cube block and a diamond and pencil tip shaped pylon.

The cube cap of the single caisson was built unconfined above the ground surface.

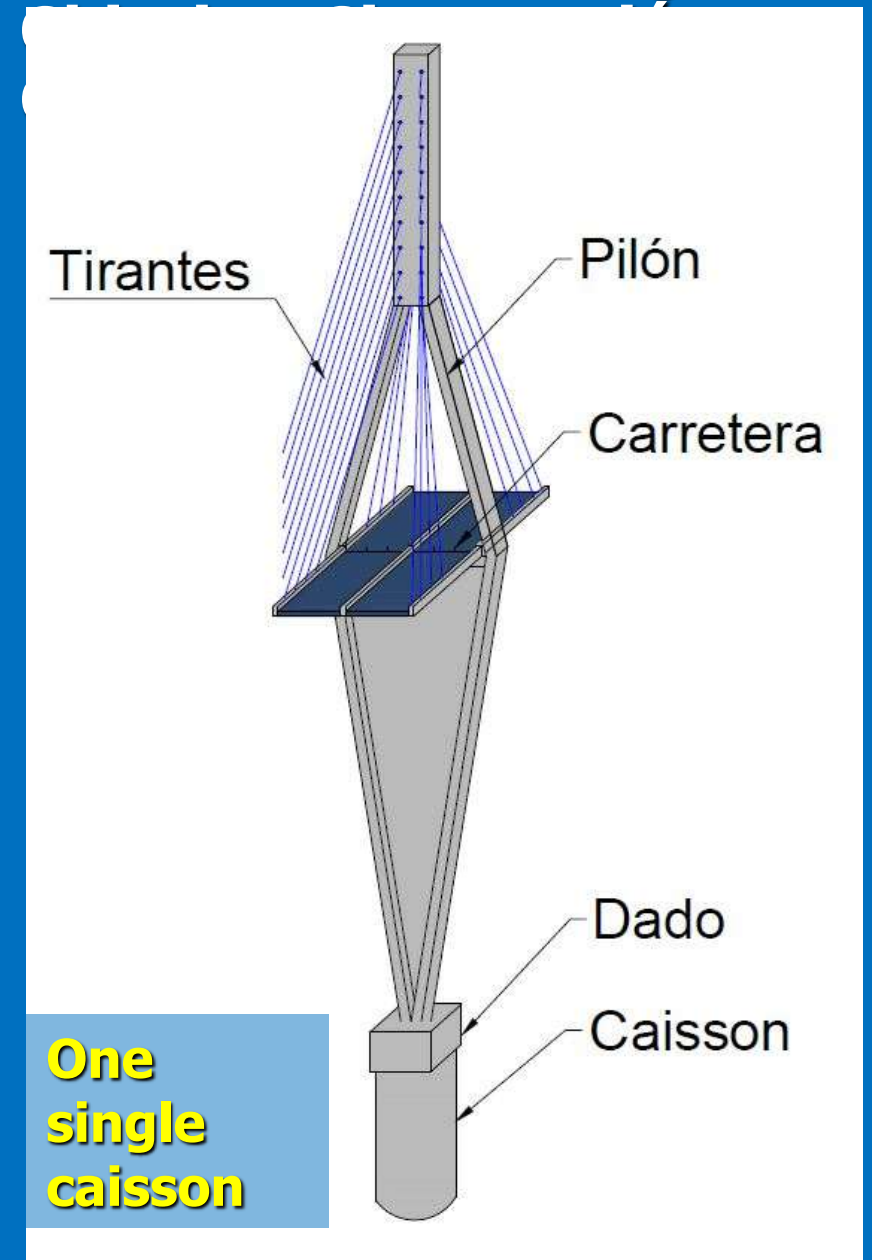
Foundation at Chirajara

The foundation must work as a fix point to minimize the buckling effect.

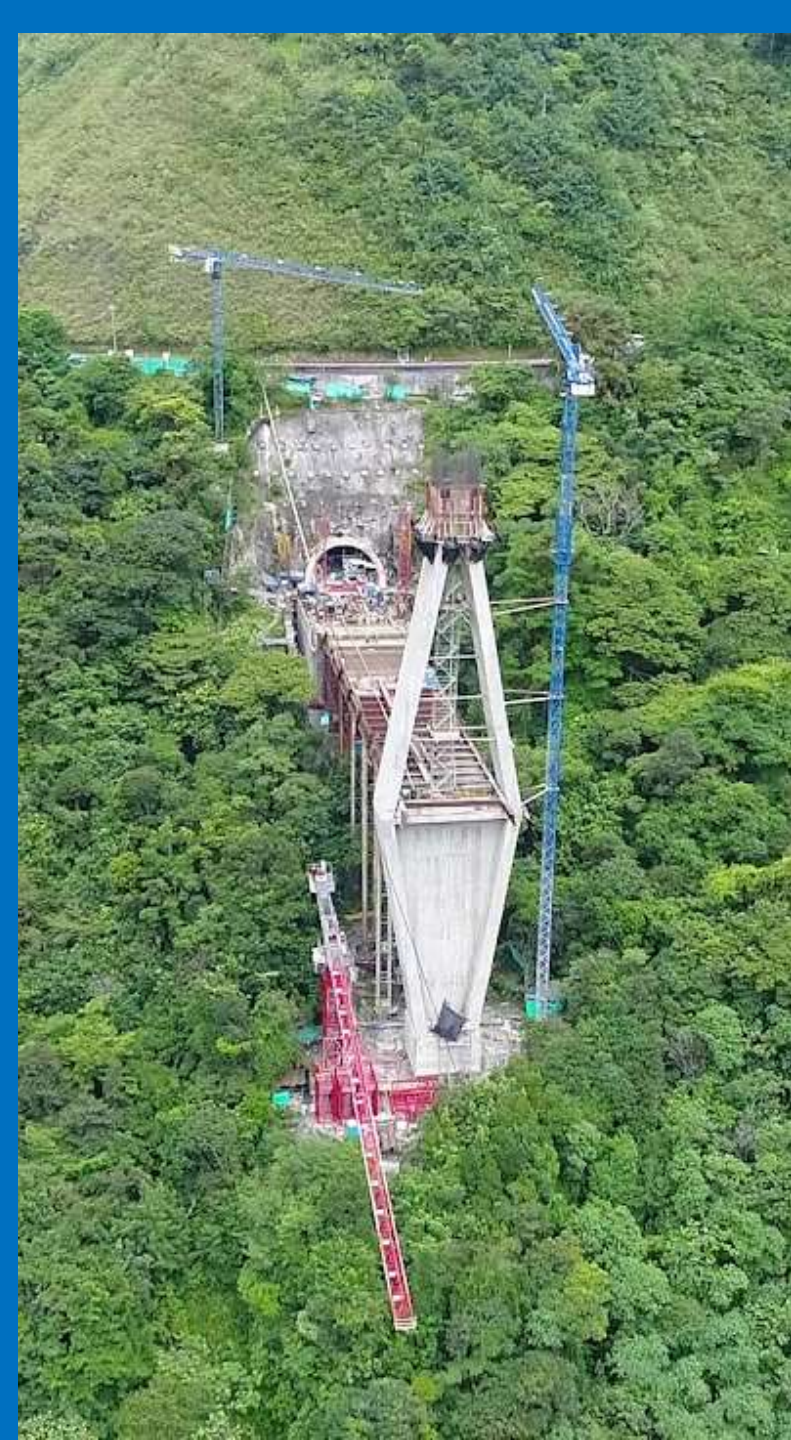
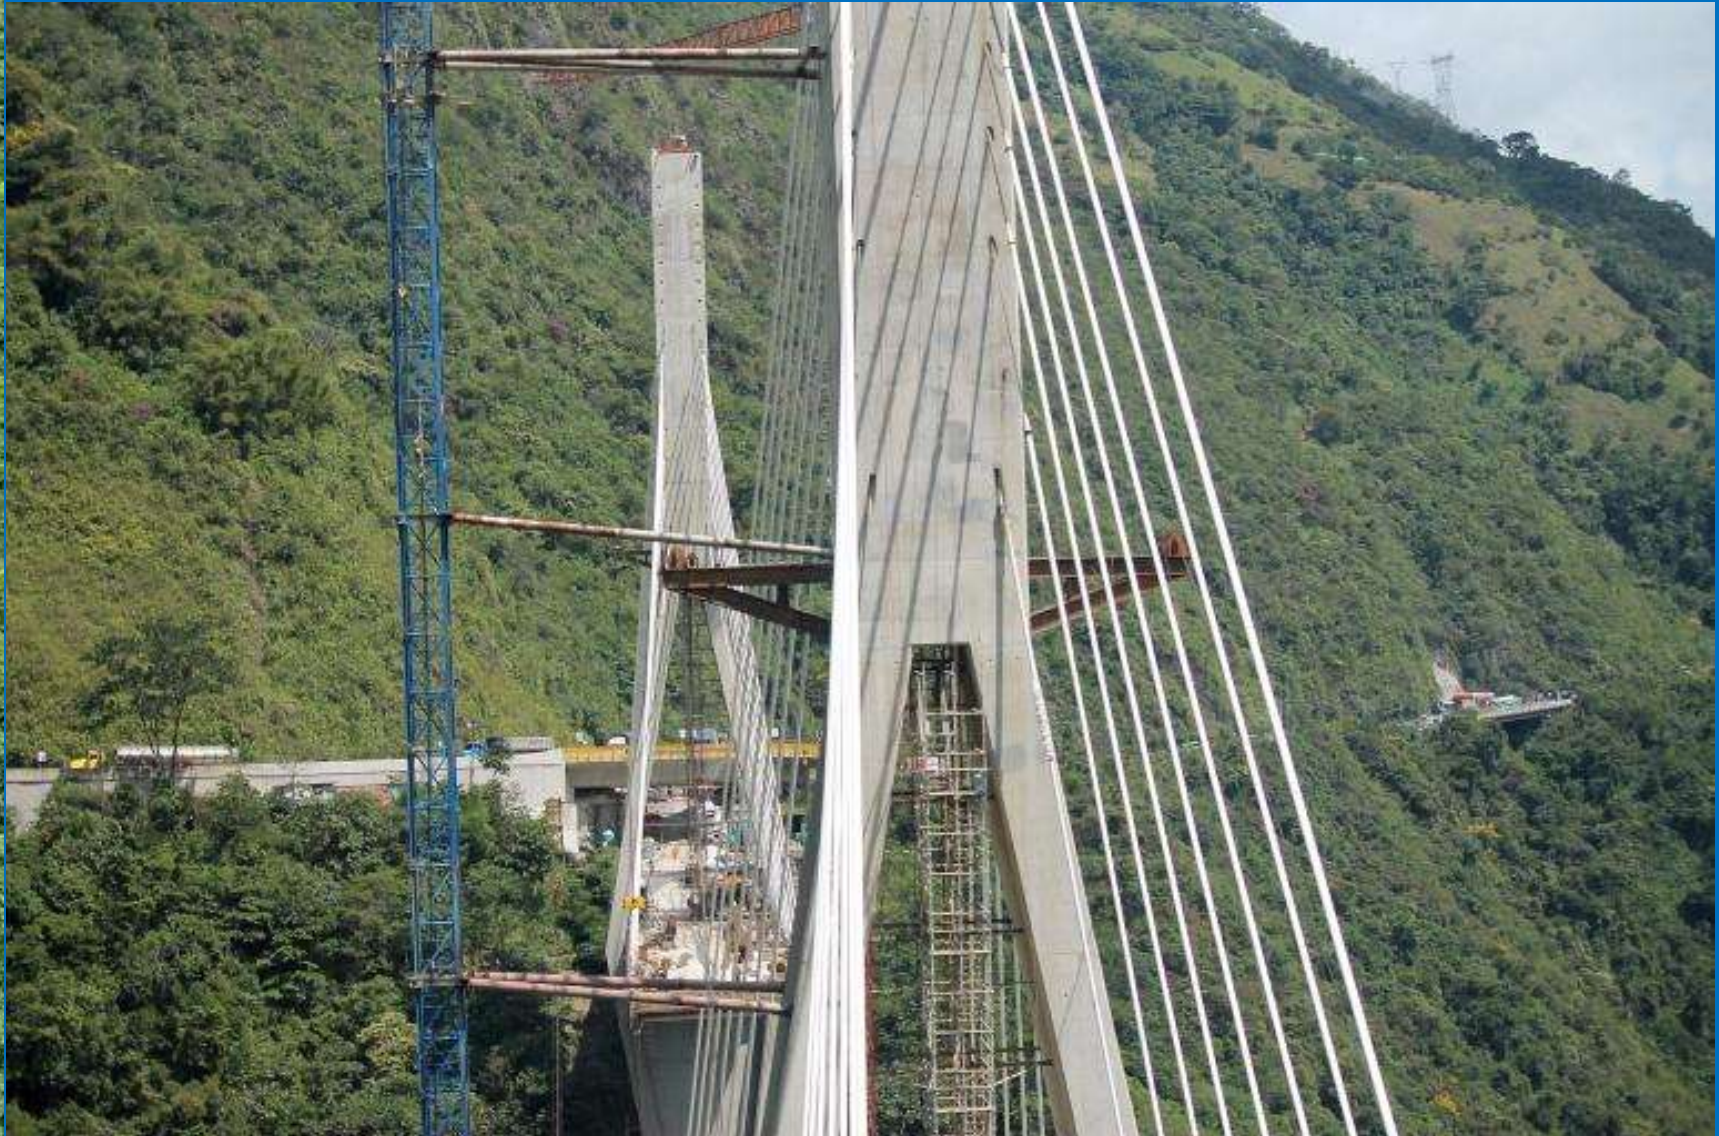
The shape and litness of the pylon at Chirajara prompted it to fail by buckling?

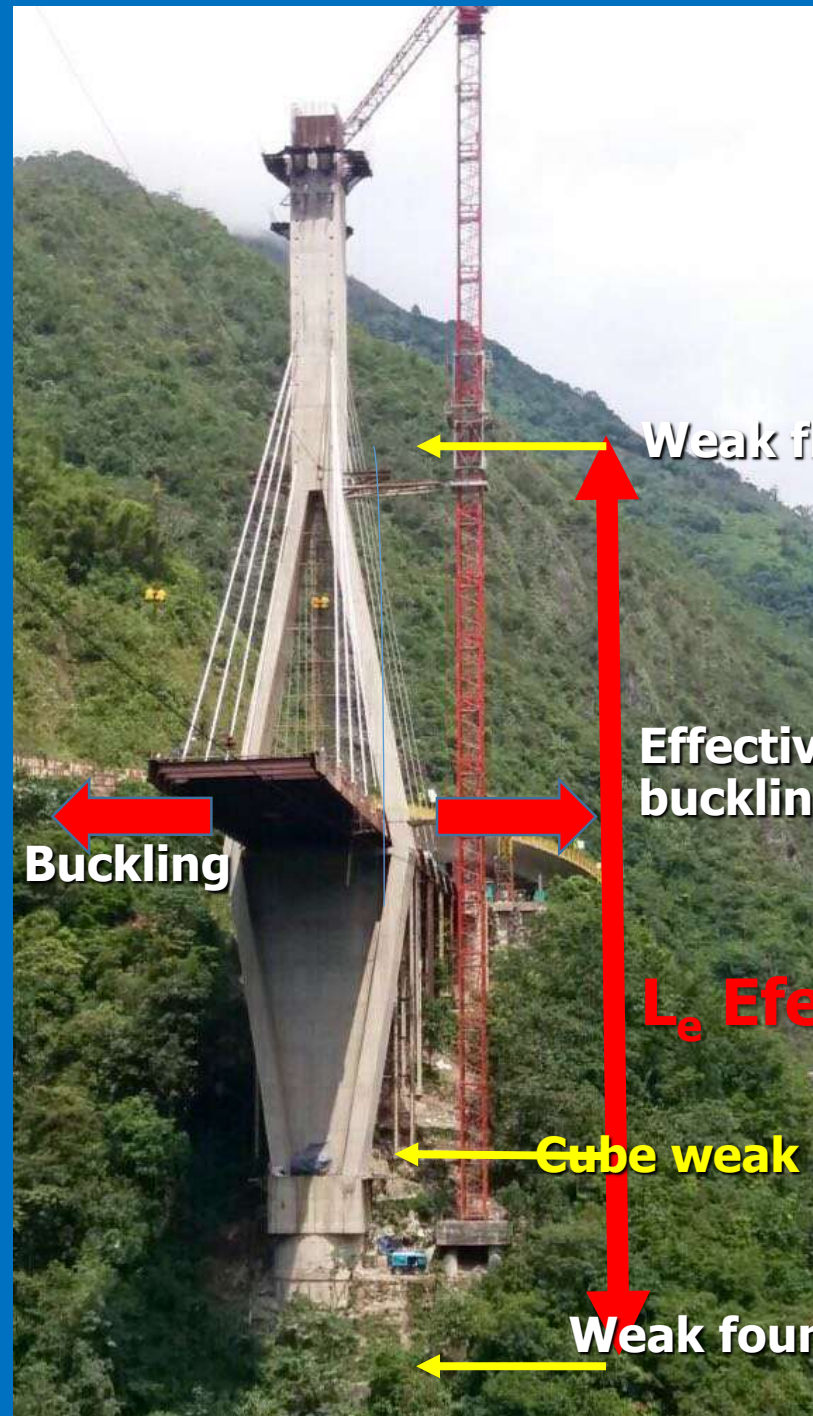
Increased compression overcomes the pylon's critical capacity, the weak upper and lower points break and the buckling failure is launched.

The leaning of the pylon may intuitively suggest that the first to break was the weak foundation point.
