What prompted the collapse of the Chirajara Bridge ?

Ing. JAIME SUAREZ DIAZ

**Why the pylon (tower)
failed at Chirajara?**

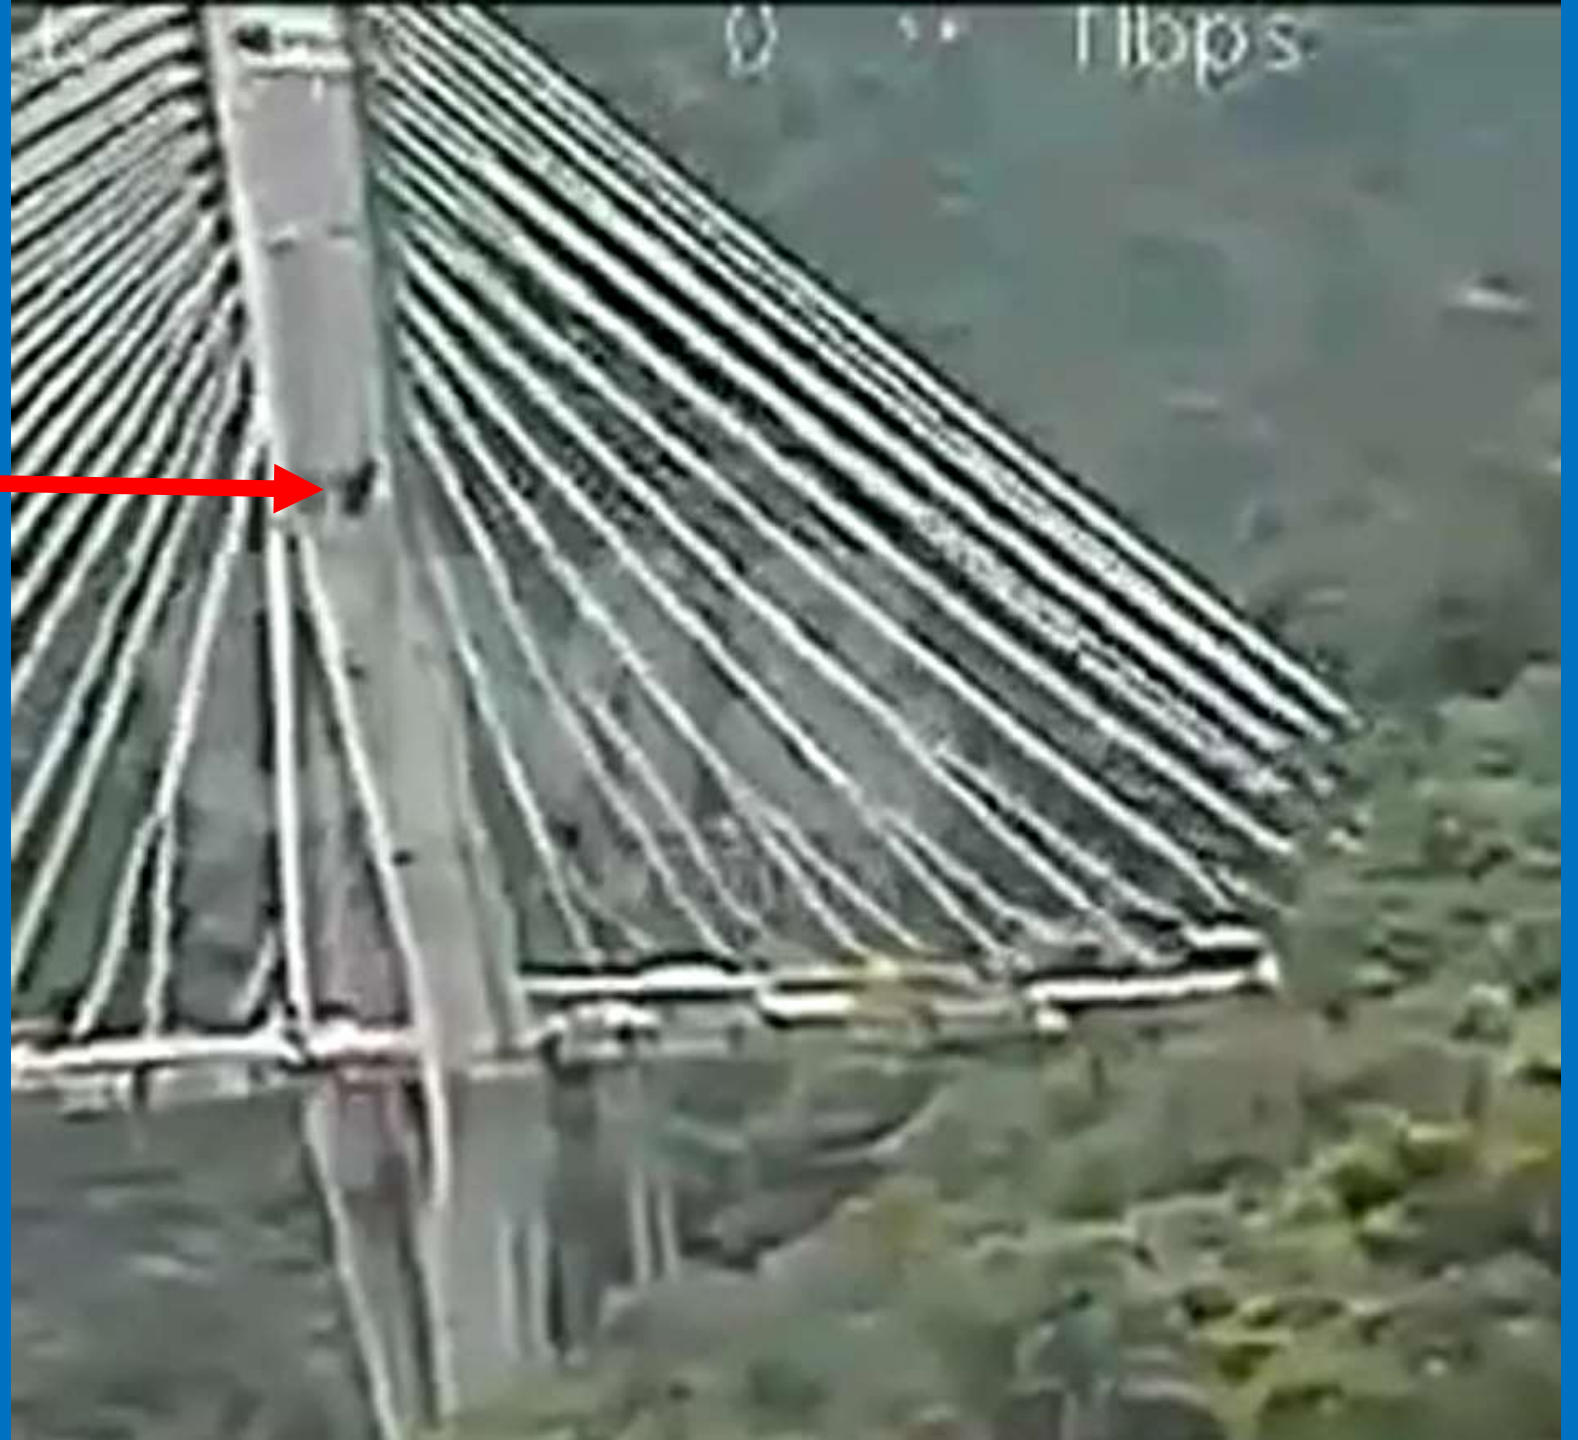
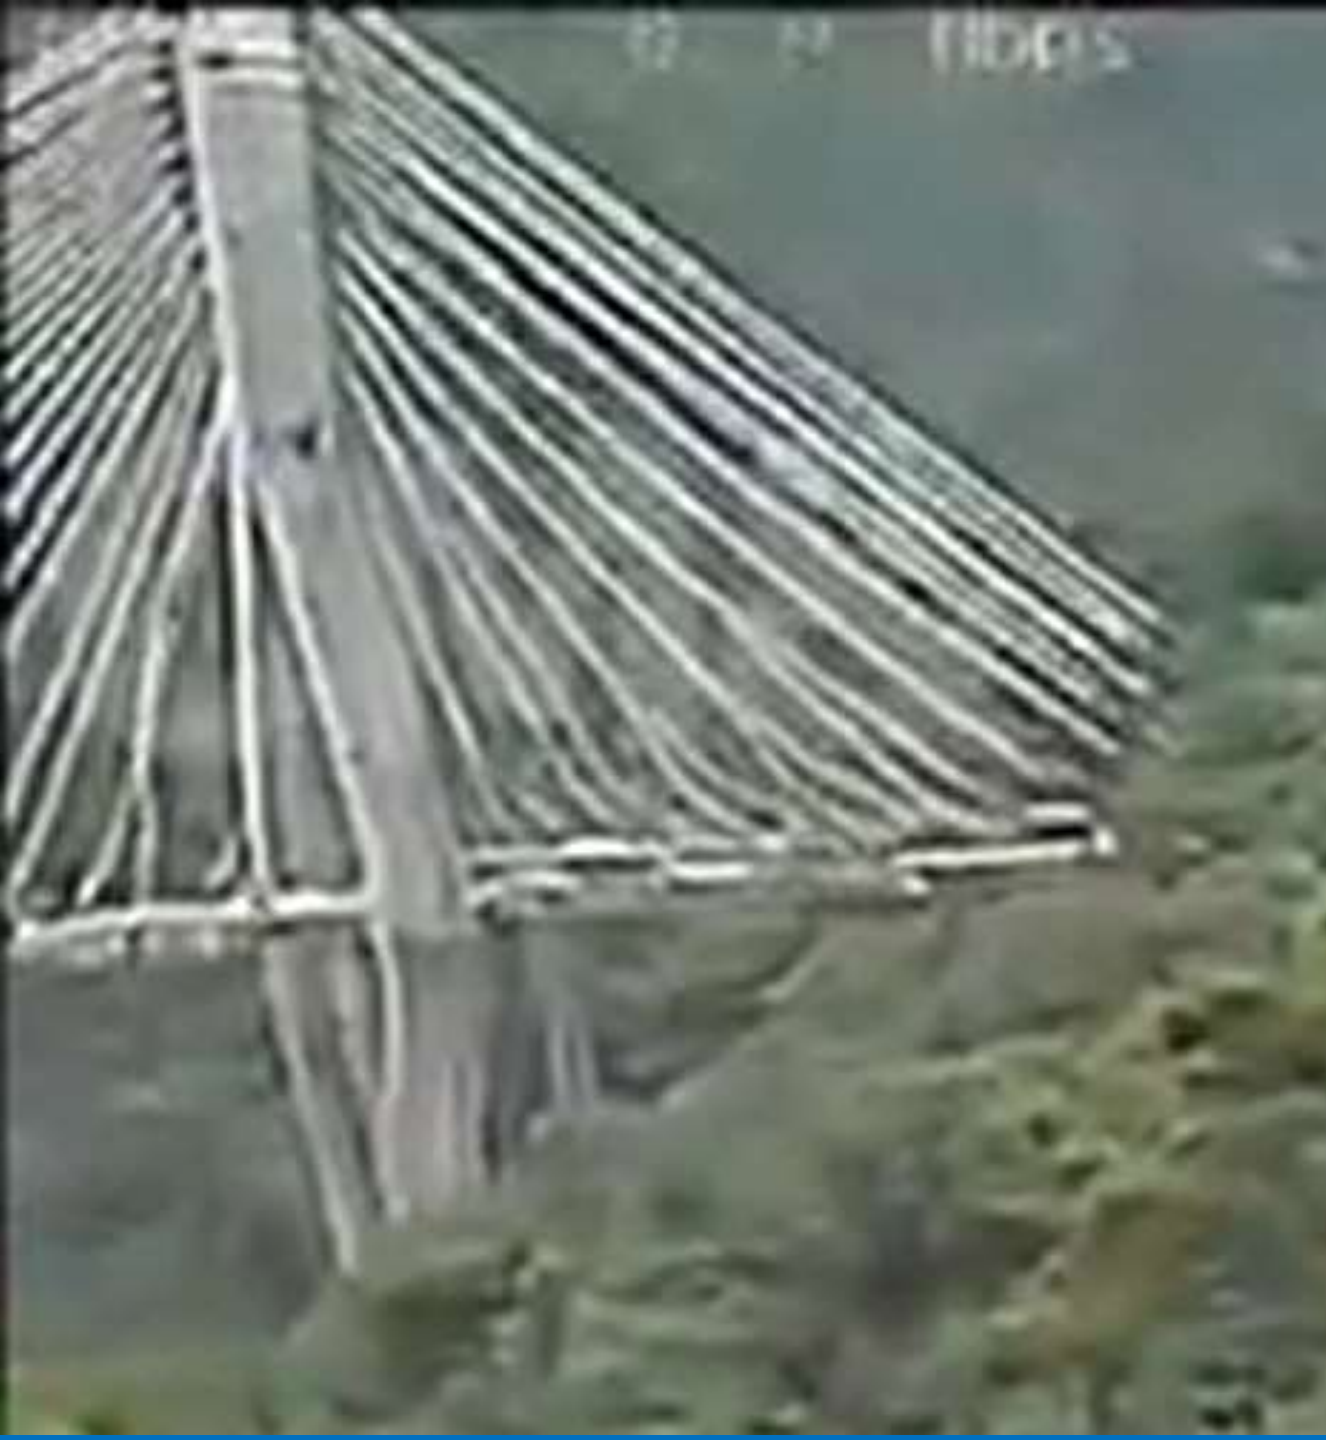
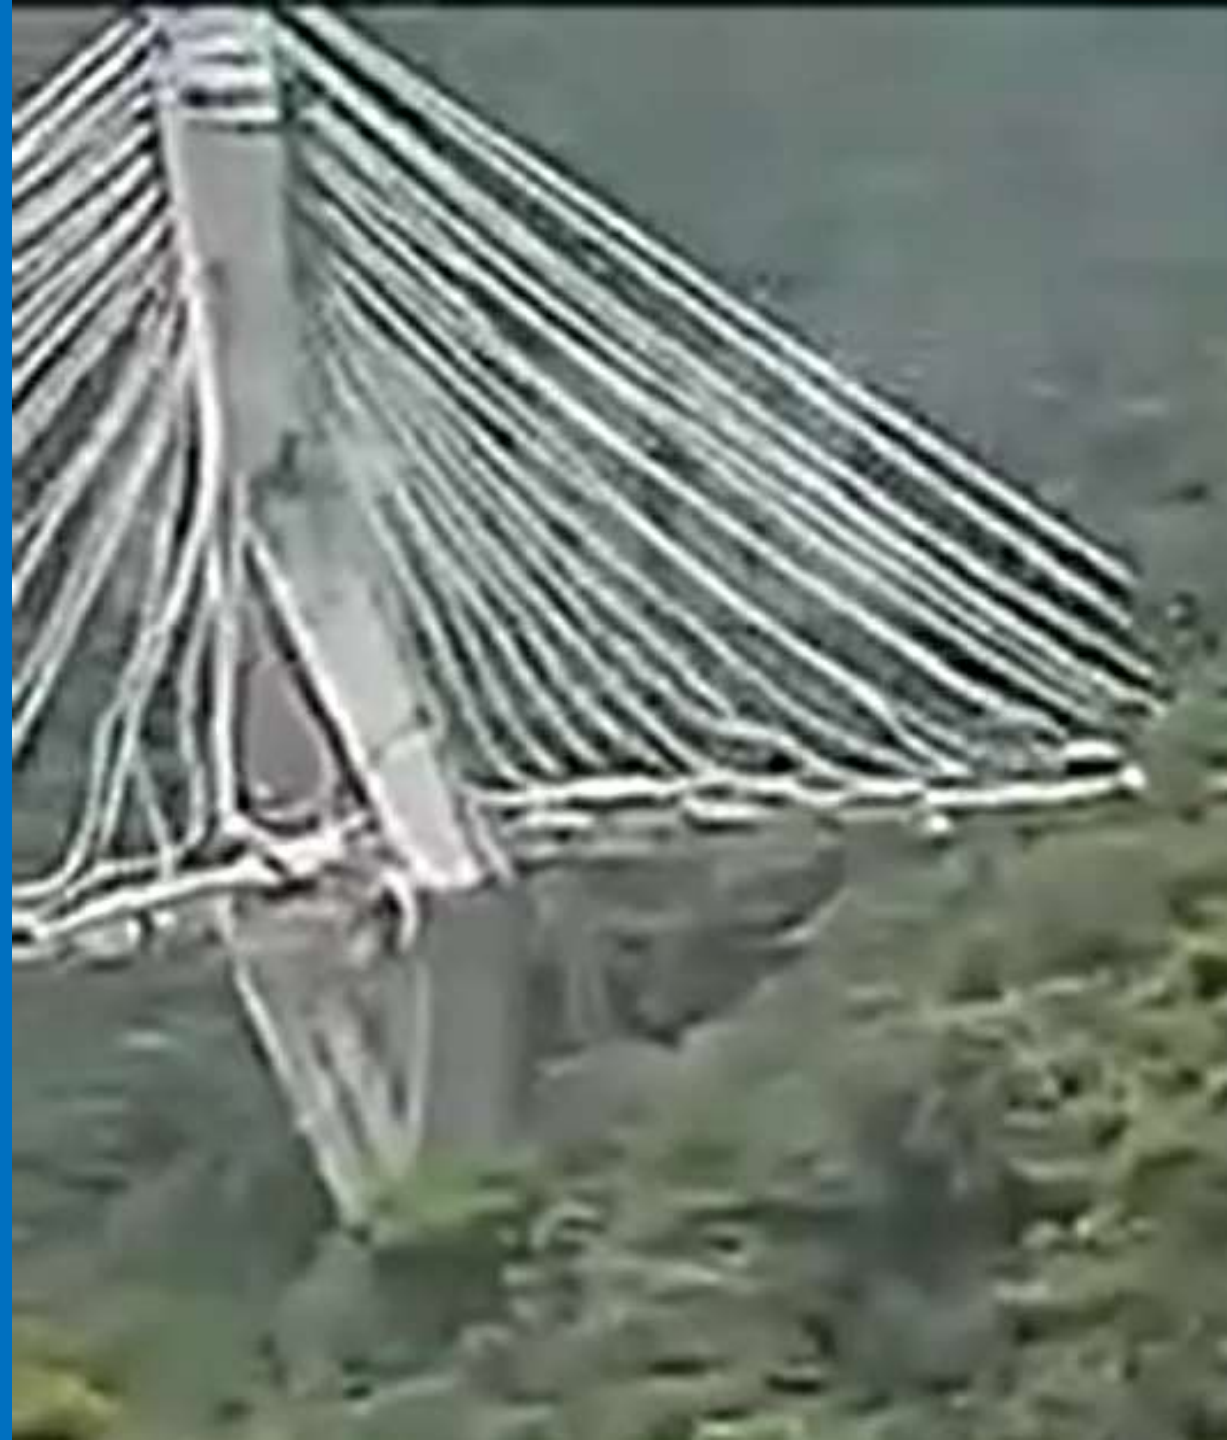
Bending moment failure at the joint between the column and the cube caisson cap.

Failure point at the toe of the pylon.

**There is no visual
evidence of any
movement of the
foundation. However,
it is not known if any
displacement of a few
centimeters may have
occurred.**

The bending moment generates a horizontal force at the semi-rigid point of the joint between the pylon and the foundation

The horizontal force could cause displacement of the mono-caisson

The assumption of a possible movement of the foundation could be challenged or confirmed if an investigation of the top tiers of tie-backs indicates loss of tension.

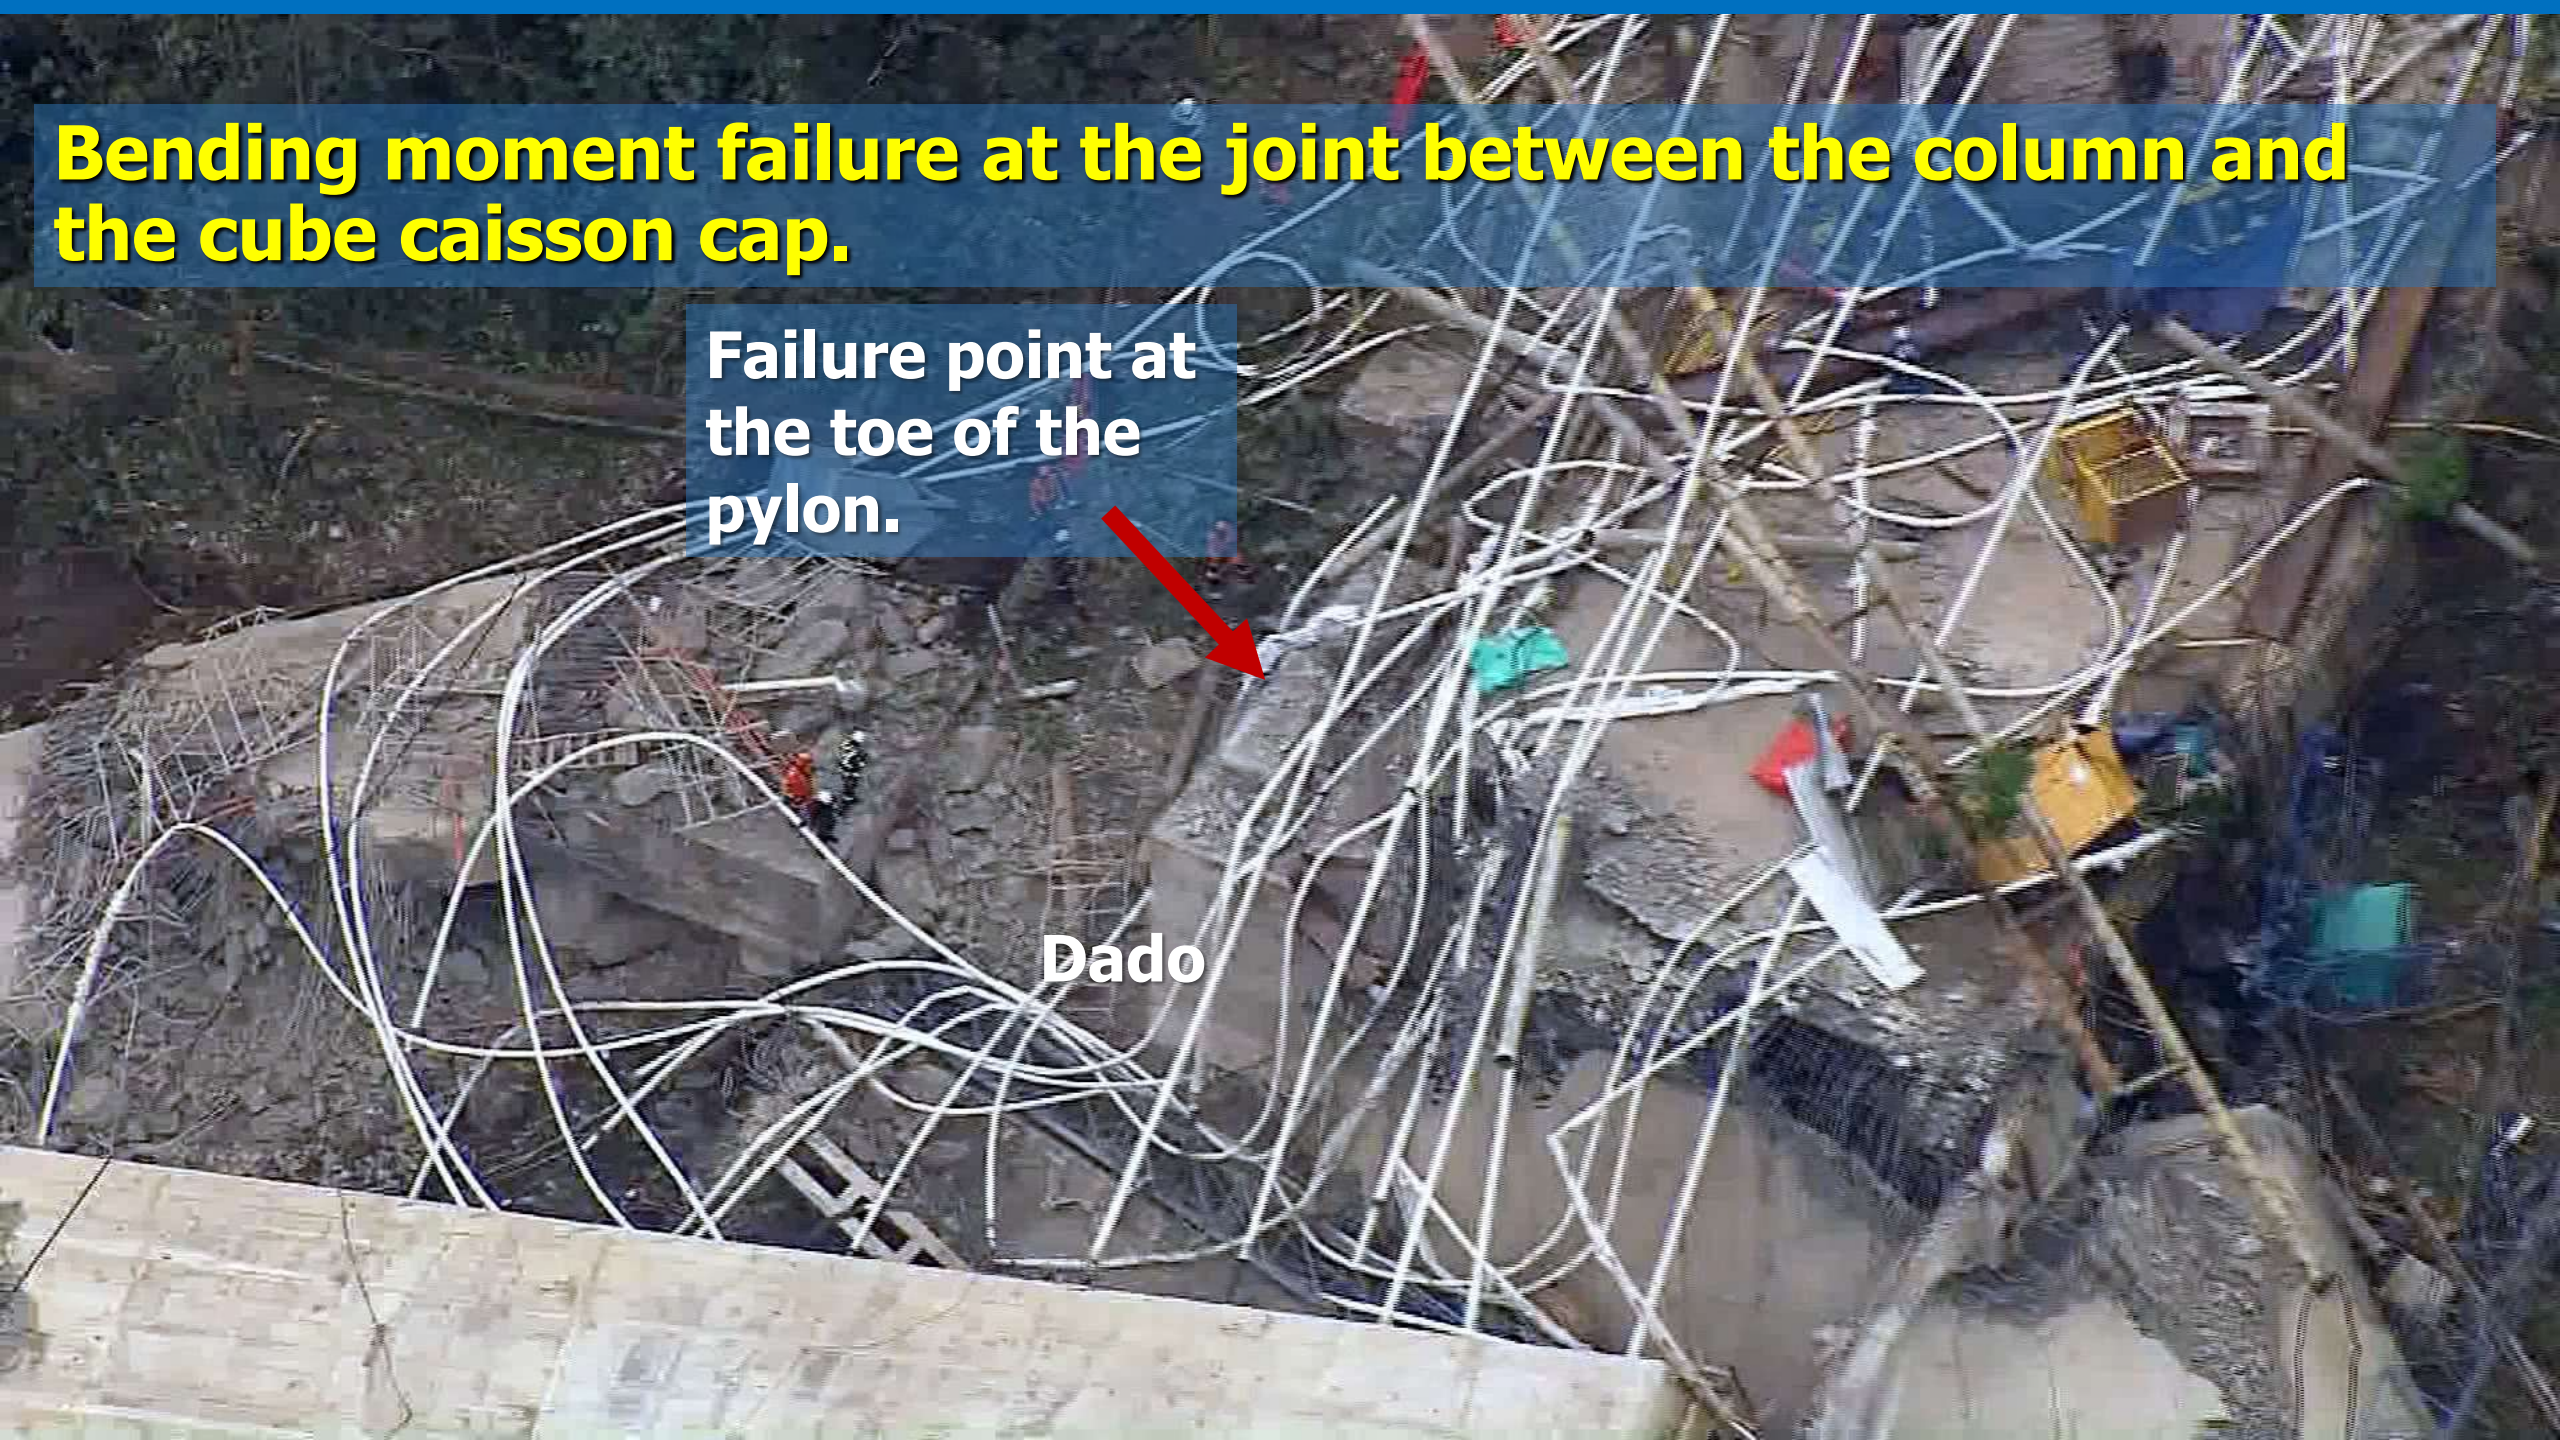
Dado

**Failure point at
the toe of the
pylon.**

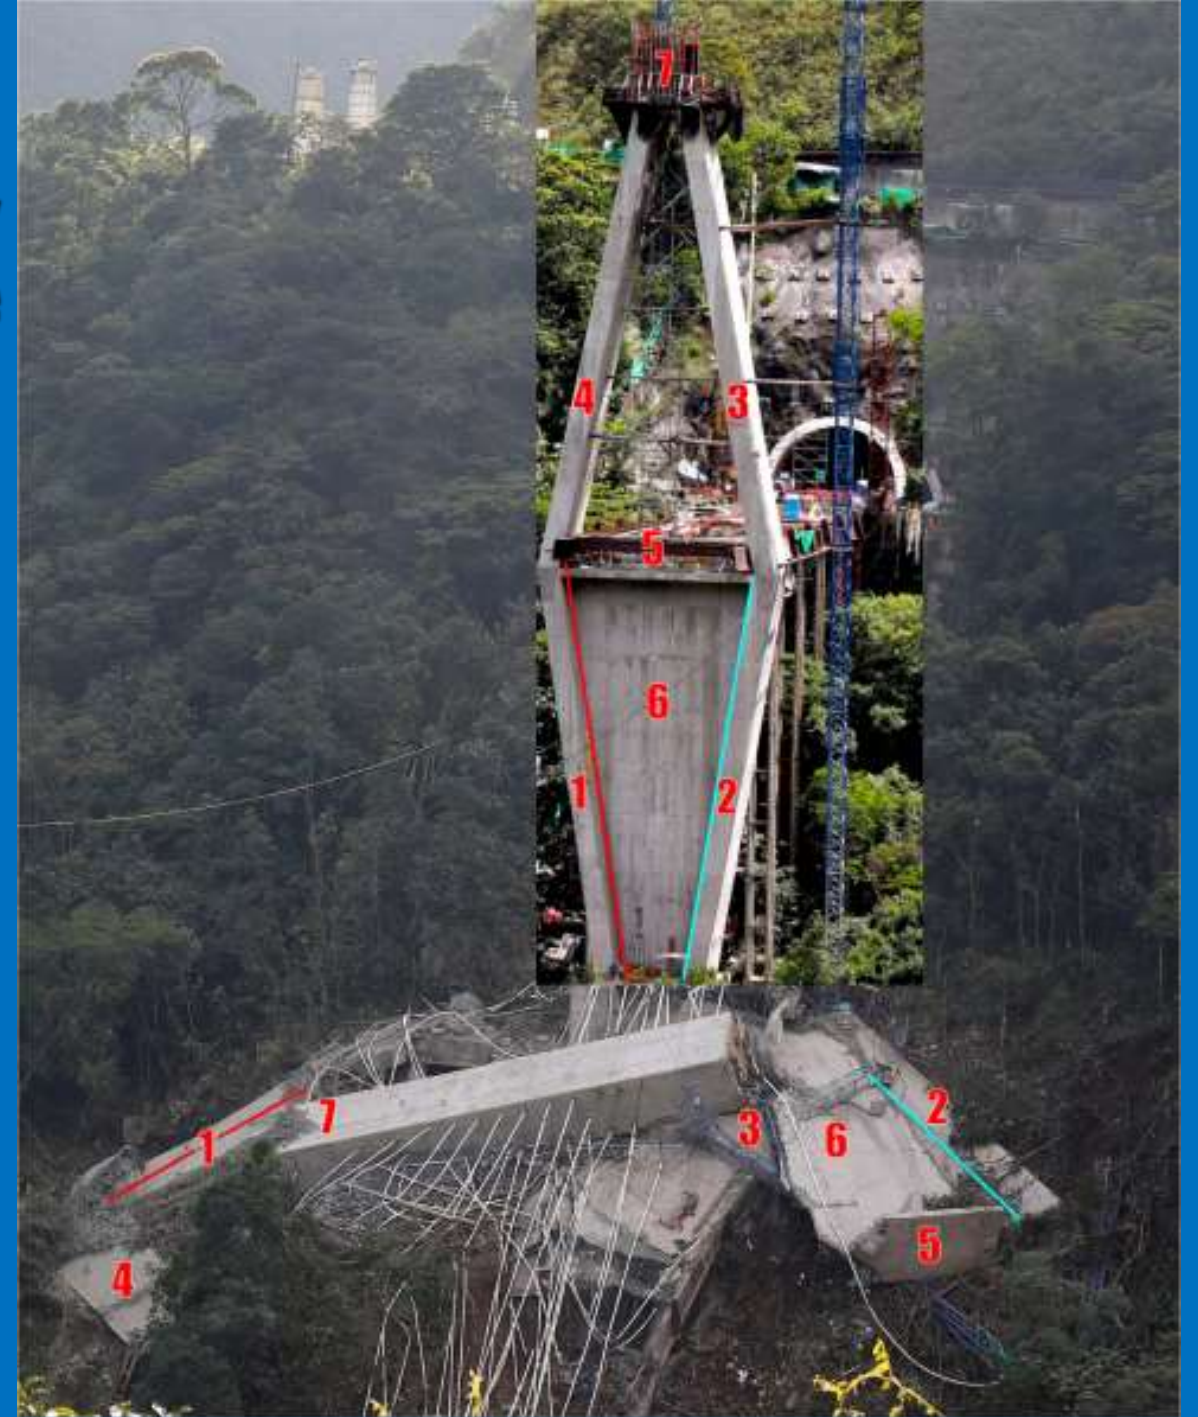
Graphic composition of how the pylon components came to rest after the collapse.

“ Columns 1 to 4 conformed the diamond, 5 was a horizontal cross brace beam, 6 was a concrete diaphragm wall that filled the lower part of the diamond, and supported 5. 7 is the lower end of the tower. The colored lines highlight the unions between the wall and the lower columns of the diamond. The base (with cube shape} that supported the tower was left in place virtually intact. ”

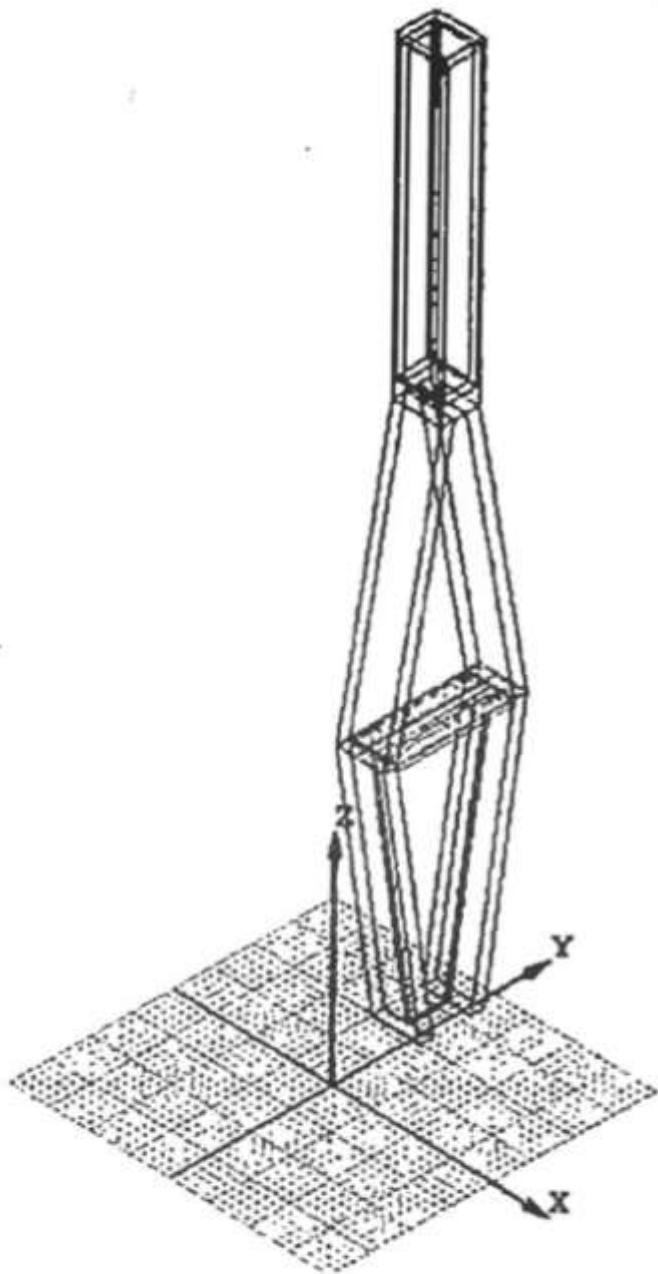
1. Failure by lack of Tension capacity in the cross “bracing” beam and diaphragm wall due to the change in direction of the load that descend on the tower columns because of its “diamond” shaped geometry.

This is the main hypothesis in the CHIRAJARA case since very little prestress was observed in the cross “bracing” beam and scarce tension reinforcement in the diaphragm wall in the direction parallel to the cross bracing beam.

It can be observed in the videos that the lower columns break apart from the connection with the bracing slab followed by the breakage of the connection with the diaphragm wall thus causing the collapse of the tower and its cantilevered roadway deck.

There is not evidence of this condition in the CHIRAJARA case since it is noted that the foundation remained intact even after the collapse.

There is no evidence of this condition in the CHIRAJARA case since no tearing of the cables was observed prior to the failure of the tower. In fact, it is observed that at the start of the tower failure the cables loose tension and fall altogether with the road deck.

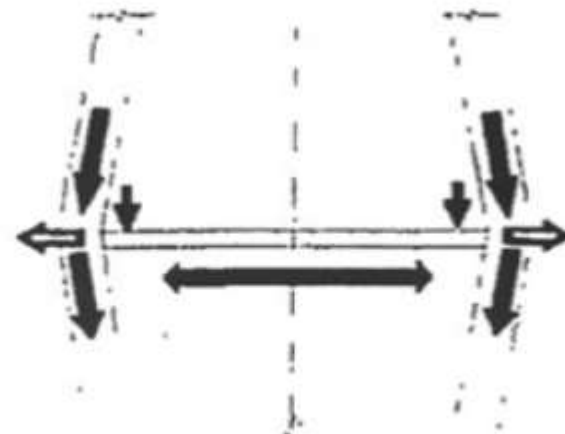
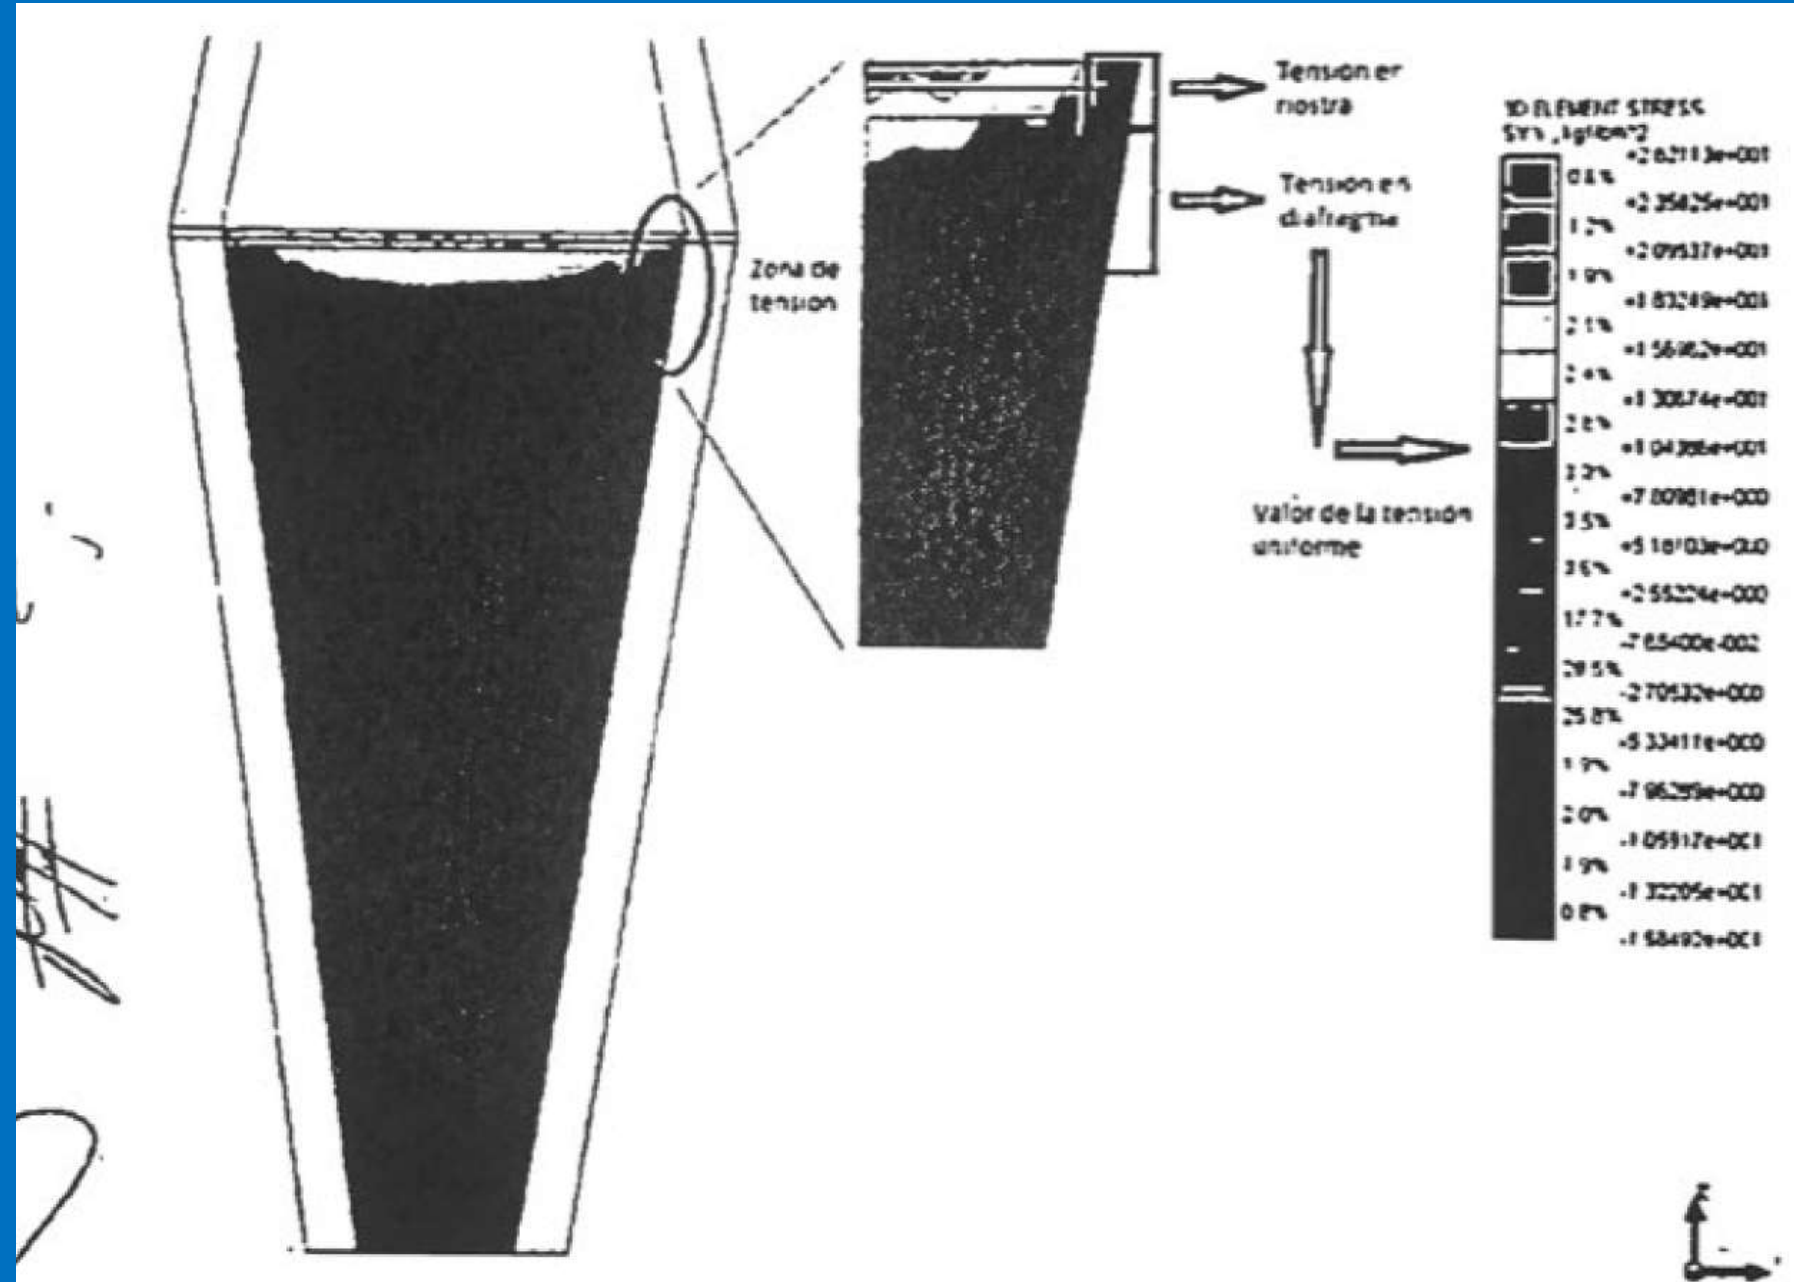
Distribución de esfuerzos en muro diafragma y riostra (losa travesaño)

Para mejor comprensión de los esfuerzos obtenidos en la zona de interés se muestran los esfuerzos en la dirección YY que corresponde al eje transversal al puente o al eje longitudinal de la losa travesaño

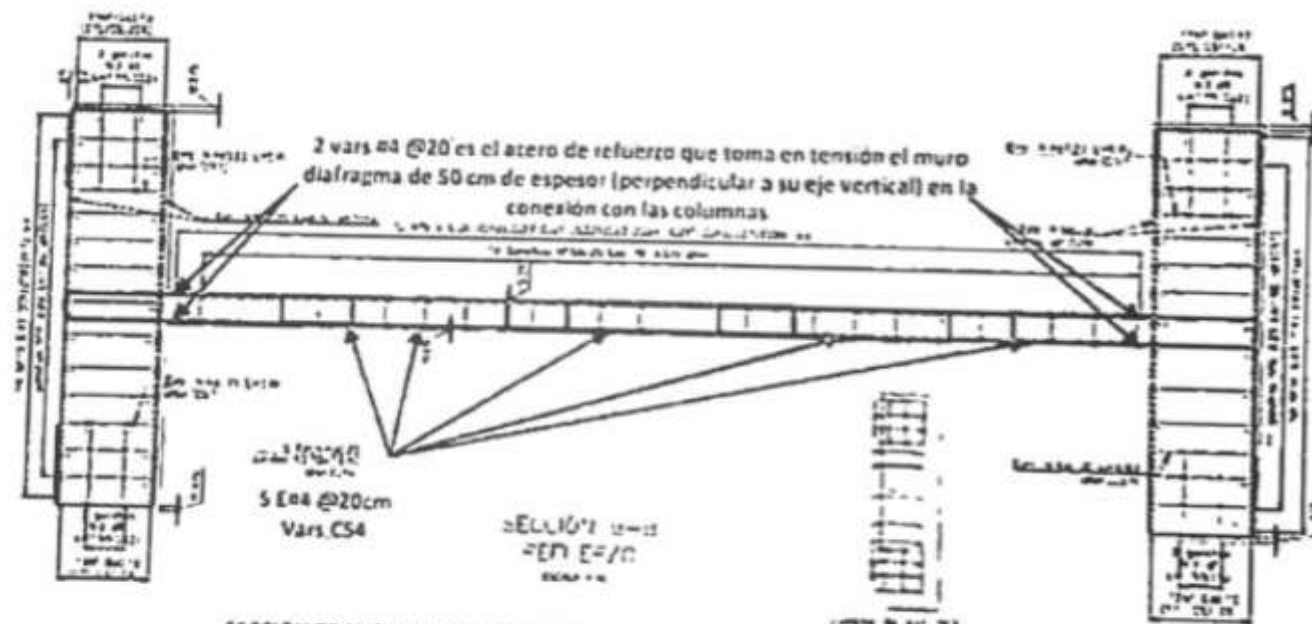
SECCION TRANSVERSAL DE COLUMNAS Y MURO DIAFRAGMA
BAJO LA LOSA TRAVESAJO

Acero de Presfuerzo en dirección transversal al eje del puente
12 torones 0.6"

No hay continuidad del acero de refuerzo de la losa transversal
en la columna

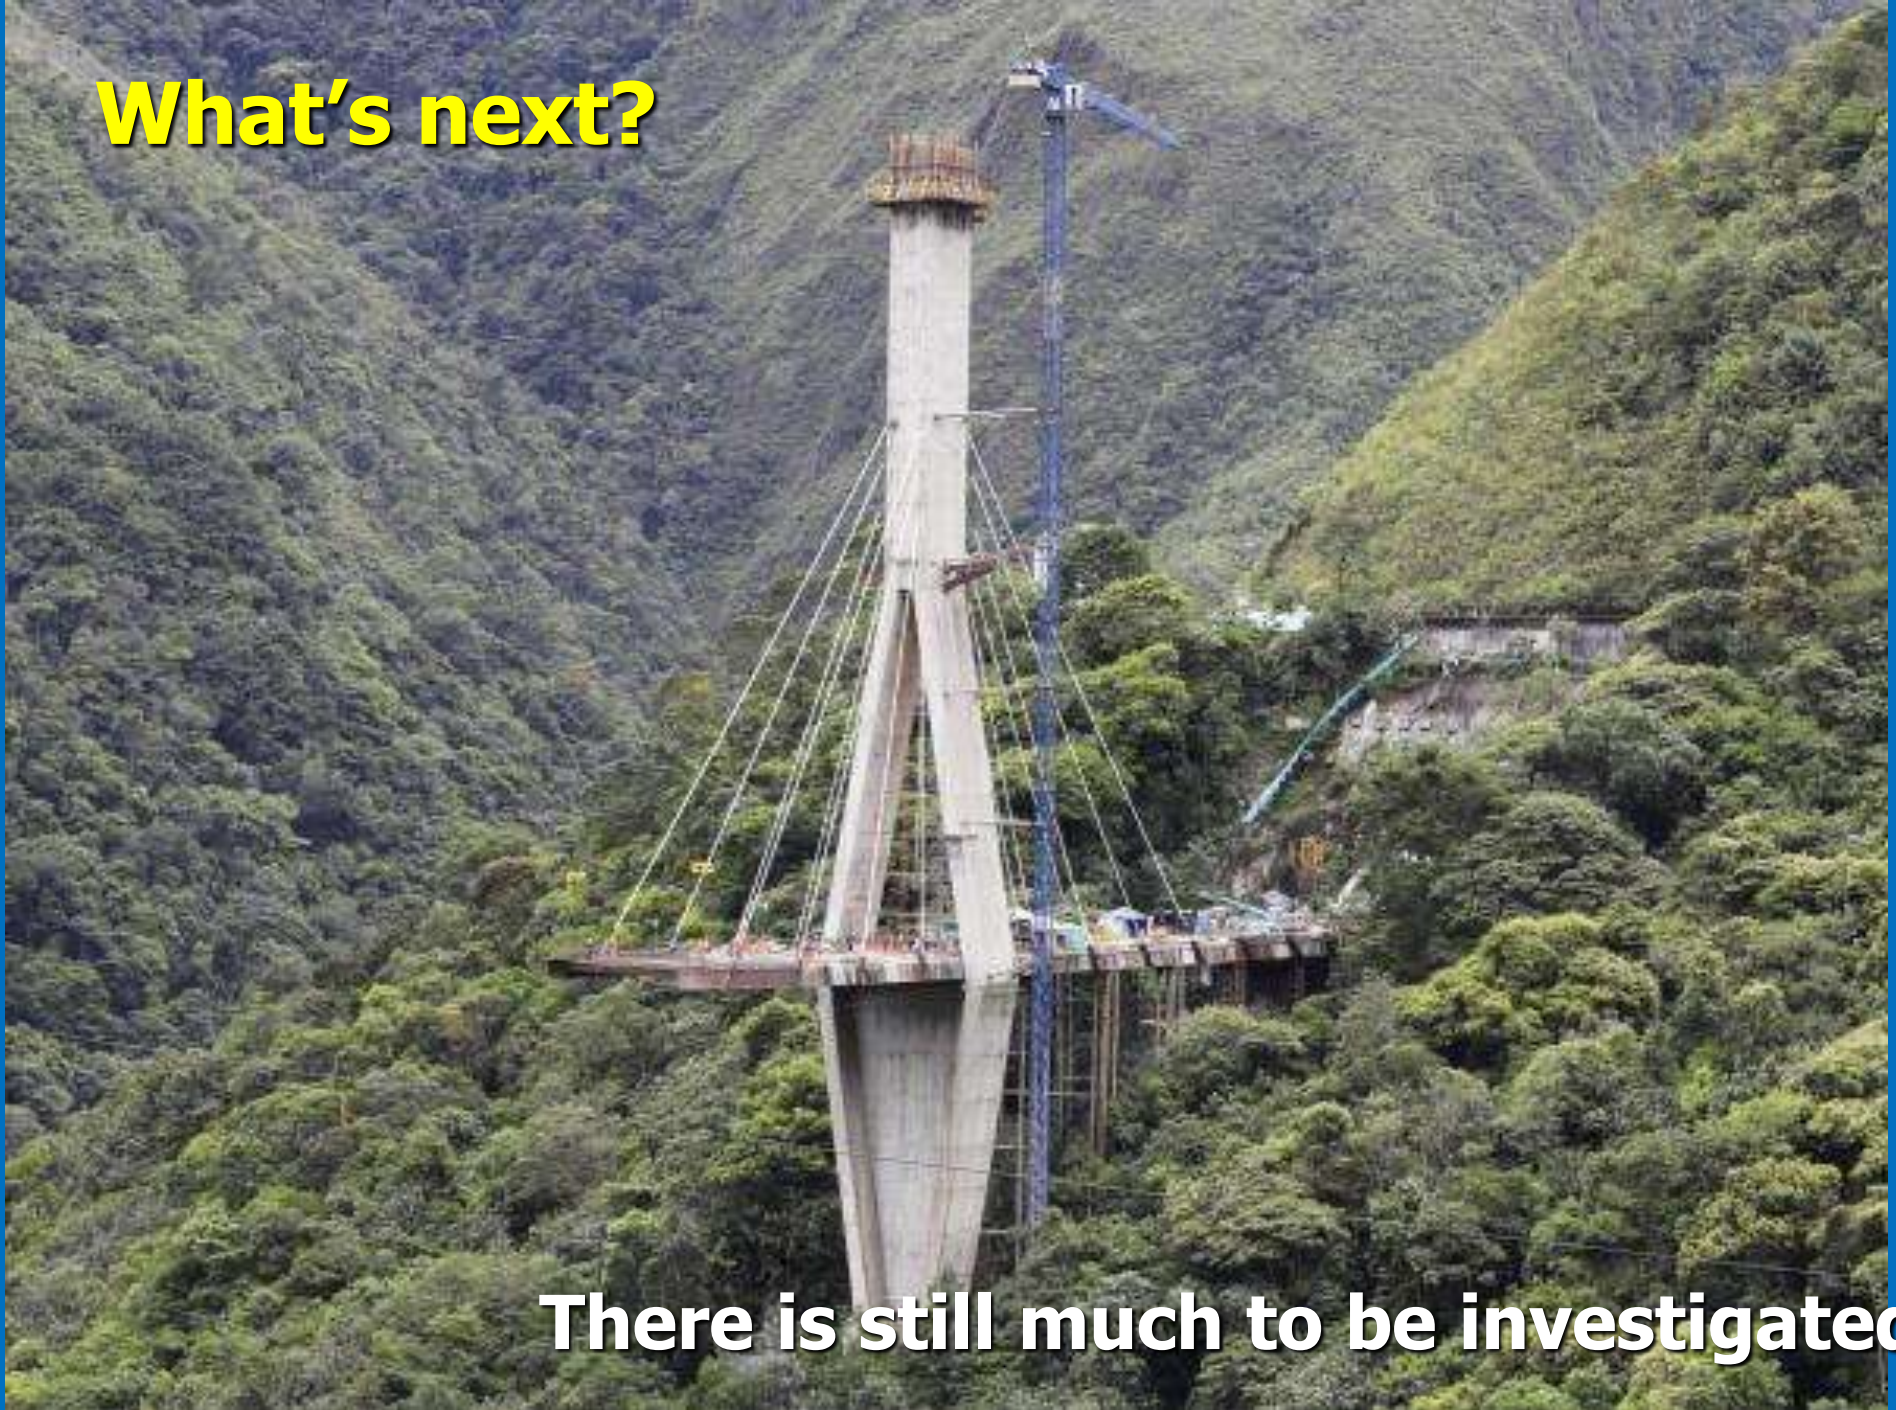
FISURA EN LA PANTALLA

Fracture in the vertical diaphragm wall of the existing pylon
