## TUBE FAILURE STATUS

Since Heat Exchanger operation in 2001 year, for 15 years Tube failure occurred at 3, 4 pass area particularly as much as 8~10 tube leakage yearly.

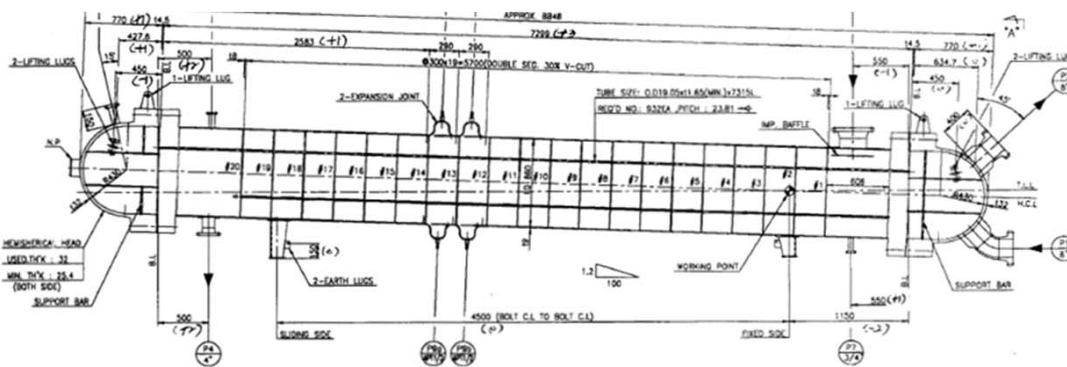
1) Shell Side Flash Vapor : 0.3% of Terephthalic Acid contained Water, Condensate water  
pH 3.8

Shell Side	Tube Side		Shell Side	Tube Side
Fluid	Process Steam	Reactor Feed	Design Press' (K/G)	14.5	120
재질	SUS304L	SUS316L	Operating Press' (K/G)	9.0	100
No. of Pass	1	4	Design Temp' (°C)	199	200
No. of Tube	-	932	Operating Temp' (°C) (In/Out)	178	128 / 162
Surface Area (m <sup>2</sup> )	408		Heat Duty (MMkcal)	13.79
