Bridge # 070001

12/08/ 2023

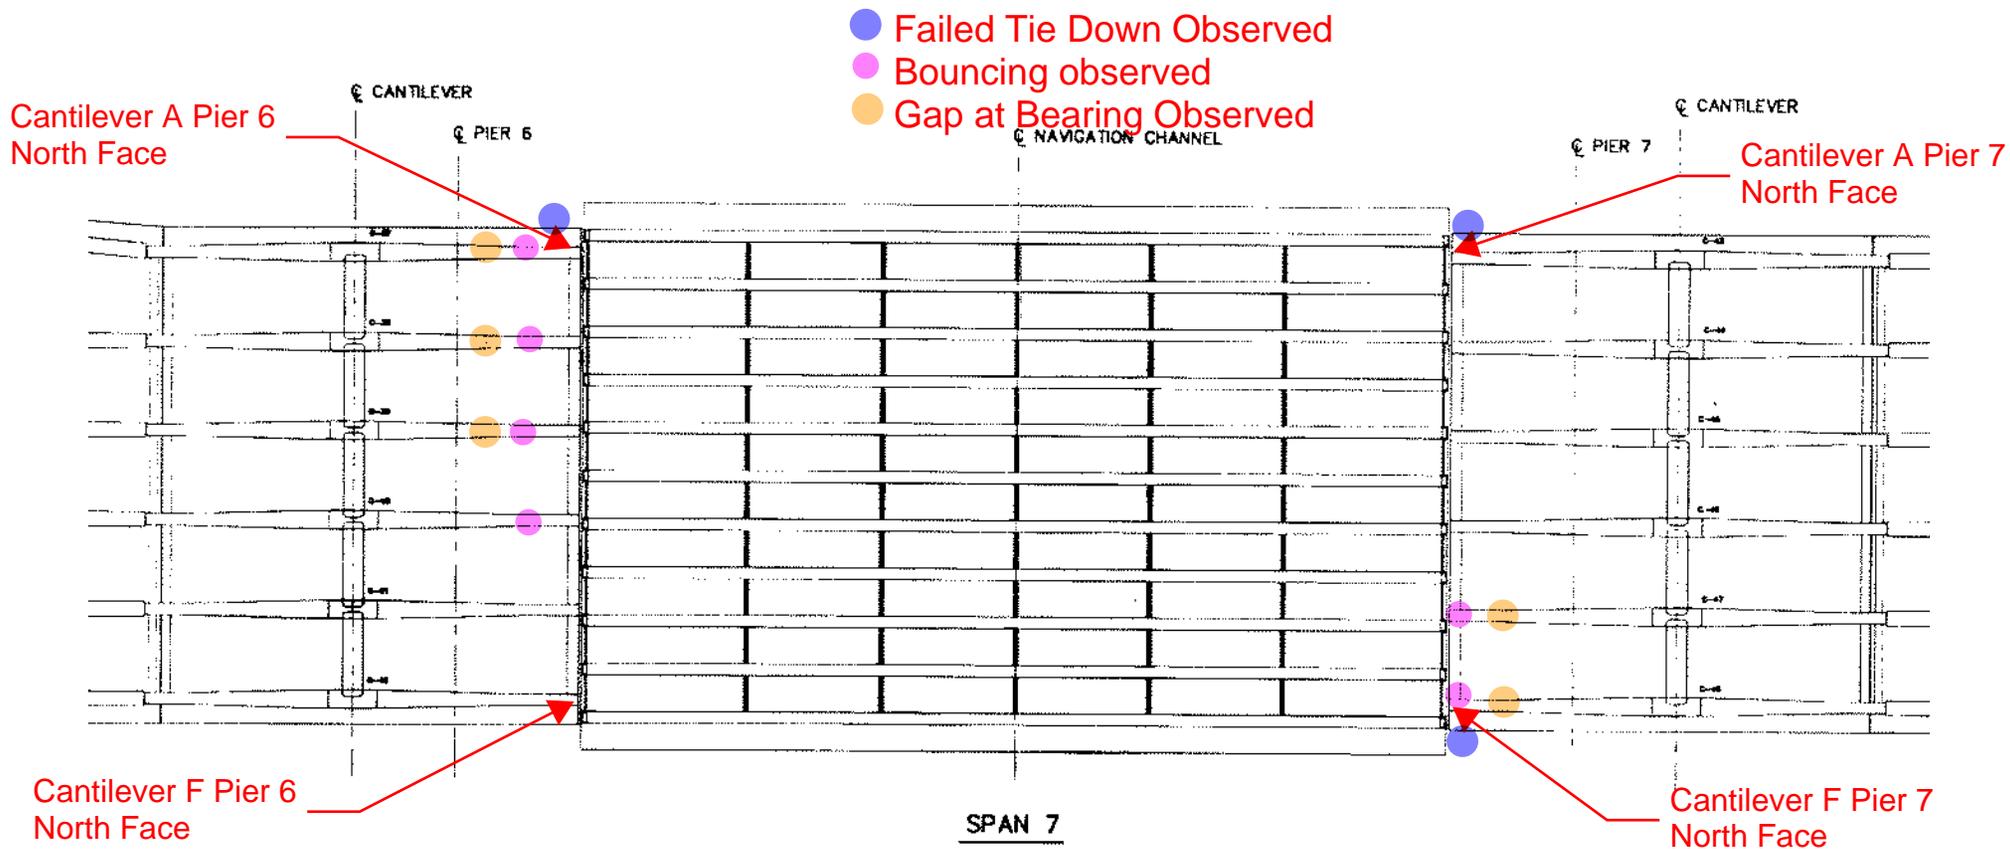
Cantilever A Pier 6 North Face

- See photos 1 and 2.
- 1" diameter remaining at base of steel rod (original 1 3/8" diameter based on 1967 record plans) (See Photo 1).
- Defect to cause failure of tiedown not found, however, it was observed a gap between cantilever end and beam seat (fit 11" long section of clipboard in gap), bouncing of cantilever end and tiedown under live load. It is assumed based on the observations that the tiedown has failed with the failure location not visible. (See Photos 1 and 2)

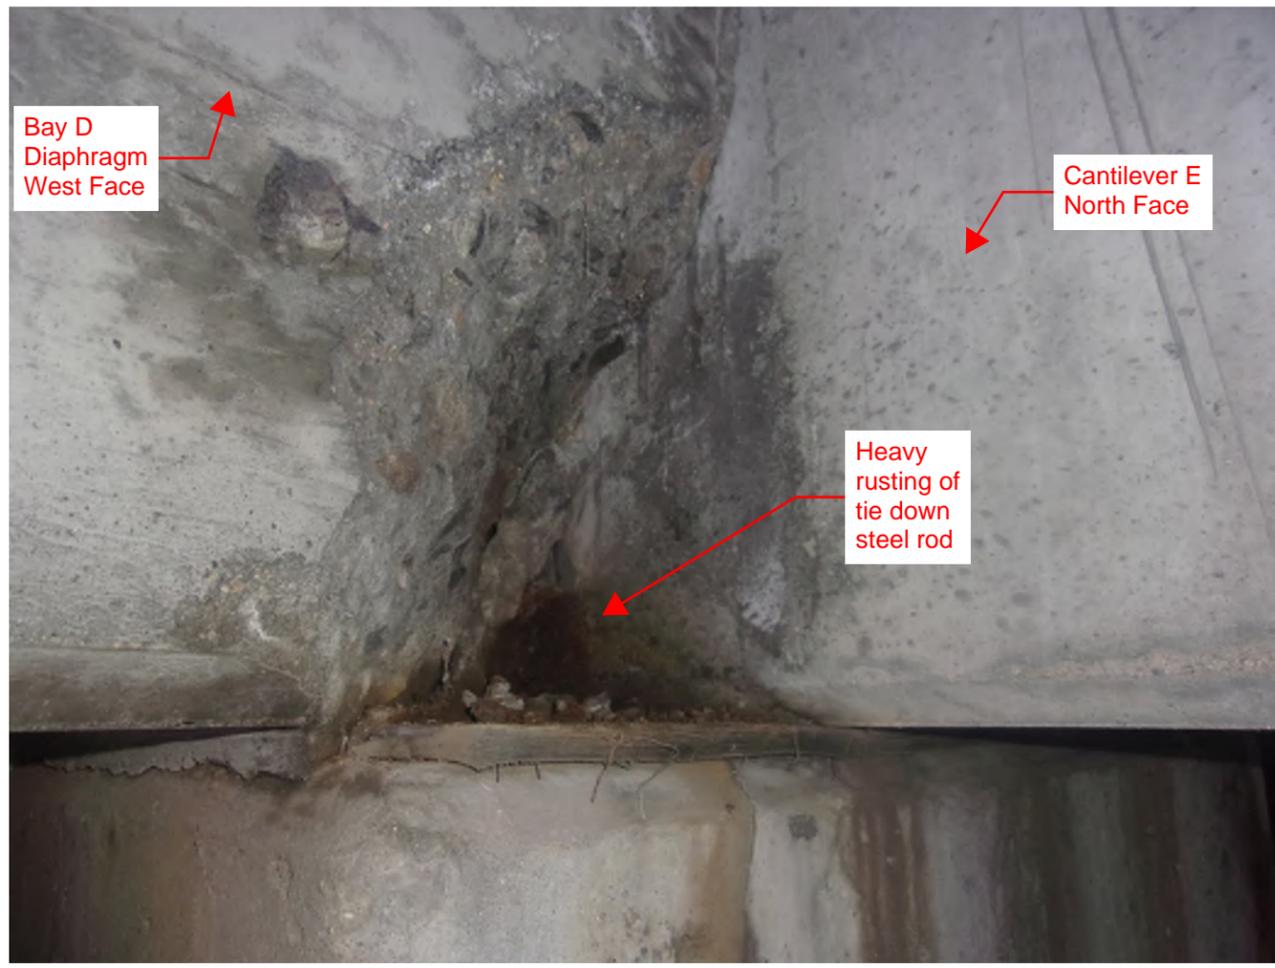
Cantilever E North Face

Note:
 - Spalls on diaphragm at Cantilever E north and south face. Tie down steel rod exposed with heavy rusting.
