Rough sketch of bearing arrangement in shaft based on strip down of failed unit (anti-rotation device may be shown reversed)

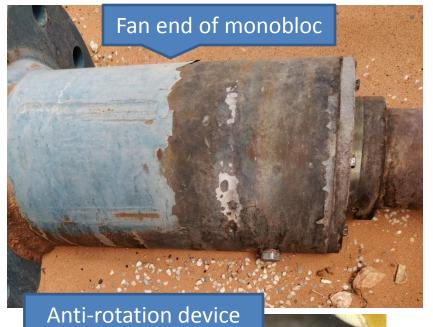
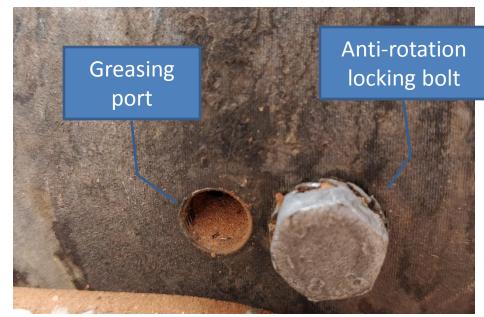
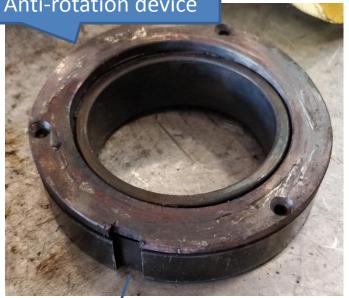
Concern is that the grease cannot get to ball bearing due to presence of anti-rotation device and the locking bolt for the anti-rotation device, which largely fills the slot where it locks the outer part of the anti-rotation device.

Grease path to roller bearing restricted by locking bolt
