2a - Responses, Photo reference - #1

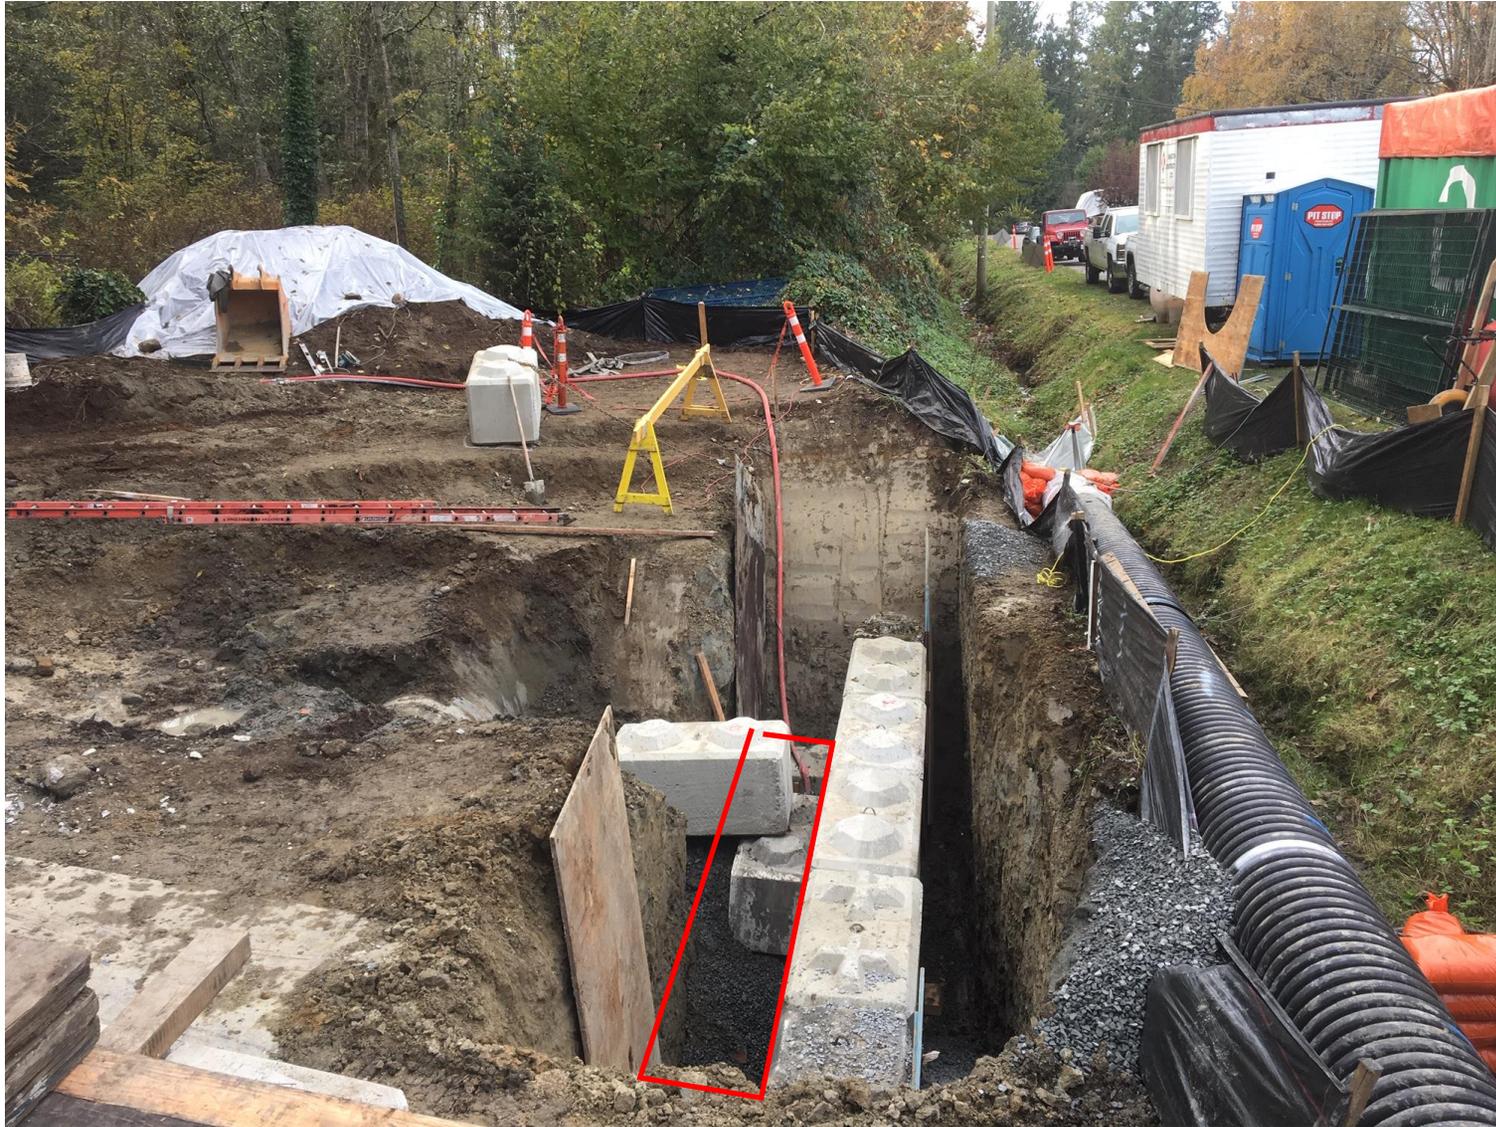
Section 5.4 in WSP's geotech report for site specific, F-014a indicates no groundwater and that the soil was wet about 2.1m.

Section 6.1 in WSP's geotech report generalizes all the sites in the report and states that "significant groundwater seepage may also be encountered from adjacent utility trench backfill / pipe bedding where excavation for construction of the proposed chambers exposes these materials".

Given the photos above, the "significant groundwater seepage..." seems to be quite significant and from KCL's point of view should've been detailed or shown in the drawings had this been known. KCL believes that is was not included because notes were taken in Section 5.4 rather than note taken from Section 6.1.
