: Repairs & Coating of Jacketed Vessels

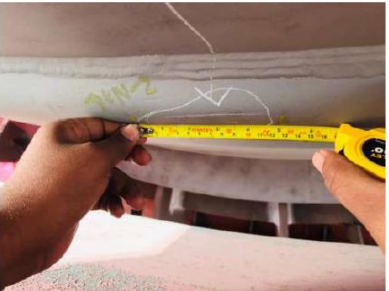
<p>PT dent surfaces and perform pneumatic test to check the mechanical integrity which is approved by client dated 13-April- 2021. Test pressure : 721 psig.</p> <p>Areas to be tested are</p> <p>A) 1st and 2nd half tube from dish head Mechanical Damages (Dent) observed location at orientation 45° and 105.</p>	QICL	30-Mar-2021	Closed		<p>QICL provided dent length:</p> <p>DENT LENGTH OF 128 MM OBSERVED</p>

<p>QICL Performed the PT on the above identified locations and test results confirmed the no surface defects and found satisfactory. Reports# QICL /J915 /PT/ 3304A/ 03 & QICL /J915 /VIR/ 3304A/ 04 reviewed and Endorsed.</p> <p>Pneumatic test has been performed and found satisfactory.</p>

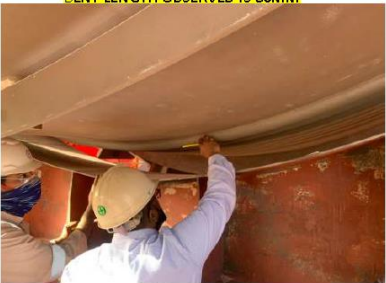
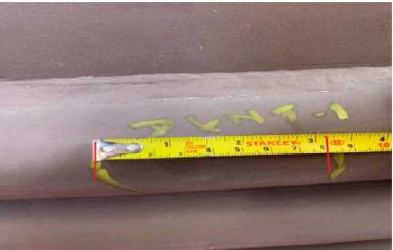
<p>DENT LENGTH OBSERVED IS 80MM</p>

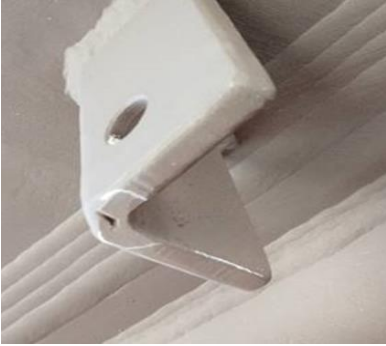
8.	WELD	18-April-2021	FR# 58 (QICL/ J915/VIR /3304-B / 01, item 15)	<p>@ V3304B: Head</p> <p>Weld under fill was observed on one Insulation support clip corner weld surface @ 270° Orientation.</p>

MDR: Grind to remove porosity	QICL	26-Apr-21	10.05.2021	FR#78	<p>QICL Action:</p> <p>Weld defects removed and NDT Performed.</p> <p>NDT Report# QICL/J915/PT/3304B/03 reviewed, Endorsed and found satisfactory</p>

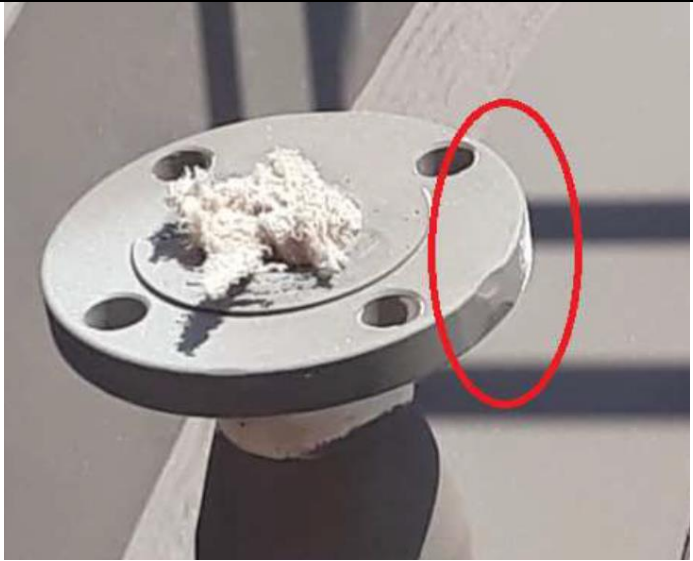
14.	MATL	18-April-2021	FR# 58 (QICL/ J915/VIR /3304-B / 01, item 18)	One mechanical damage was also found on the Nozzle N8C Flange surface. The observed mechanical damage physically shows uneven surface level (Protrusion). The height (+) of the uneven surface was less than the Flange RF height.	MDR: Buff flange edge smoothly. Remove rug from nozzle hole. Using plastic or metal plate to cover the hole and to prevent fibers or foreign objects fall in.	QICL	26-Apr-21	09.05.2021	FR#77	<p>QICL Action:</p> <p>Mechanical Damage was removed on the Identified surface and NDT performed. Test results was found satisfactory.</p> <p>NDT Report# QICL/J915/PT/3304B/04 was reviewed and Endorsed.</p>

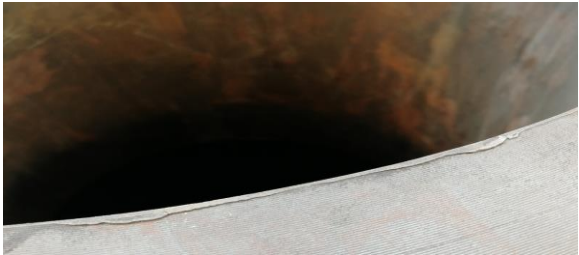
16.	MATL	14-06-2021	FR#105	<p>Mechanical damages were found on the Nozzle M1 Flange serration surfaces at 2 locations.</p> <p>1 Location 1: (Inner edge)- Mechanical damage found up to 4 mm in radial projection with protrusions. As per ASME B16.5 Protrusions above the serrations are not permitted. Hence it is not acceptable.</p>

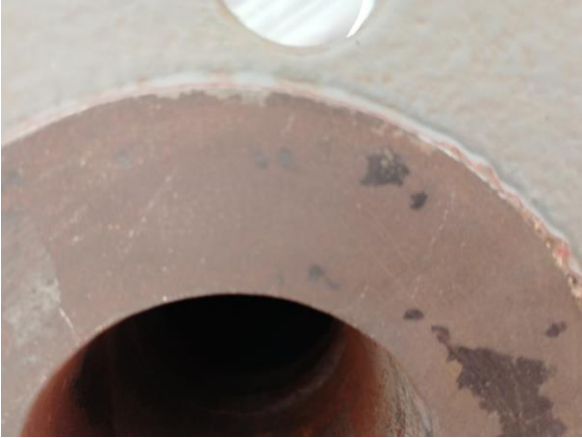
20.	MATL	29.06.2021	FR#118	Flange Serrations on the RF surface at the Nozzle N9C was not visible and looks rusted. QICL needs to take the necessary action to ensure the Flange serration on the RF surface.

QICL REPLY: Flange was cleaned with liquid cleaner rust was removed but serration is not visible. It is coil nozzle and we have very short duration we cannot do anything for this. MCD is confirm us for the blanking and N2 Filling. Field to repair.	Field		Open		Serrations will be repaired at site Ref Email from MCD TEAM Dated on 02.07.2021

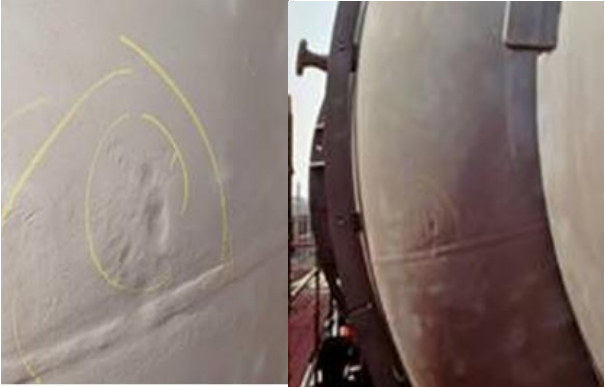
Action Item No.	Category	OPENED		Description	Action	Action By	Date Due (2 weeks)	CLOSED		Comments
		Date	SQS Report No.					Date	SQS Report No.	
1.	(MATL)	13-Feb-2021	31010- 2	<p><u>@ V3306 Head External Surface</u> Deep grinding marks were found on the Head surface at the locations 0°-90° & 180°- 90°</p>

Recheck thickness	QICL	25-Feb-2021	Closed	31010- 3	Thickness report reviewed and confirmed the actual thickness was more than the required thickness.

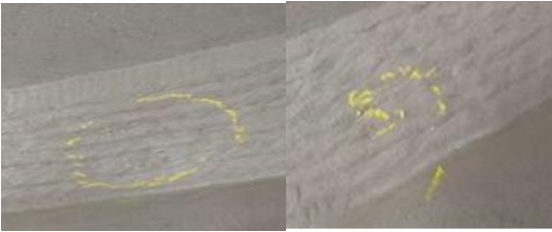
2.	(WELD)	13-Feb-2021	31010- 2	<p><u>@ V3306 Head External Surface</u> Weld spatters found (Random locations) on / around welds.</p>

<p>MHI Response: it is the sand adhesion during remove the scaffold after finishing temporary coating, it can be removed when the sandblasting for external surface.</p>	QICL	25-Feb-2021	Closed

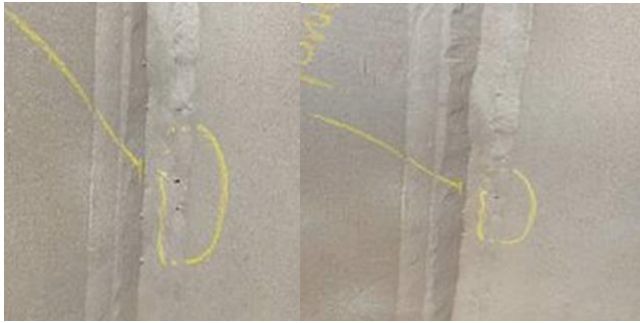
4.	(WELD)	13-Feb-2021	31010- 2	<p>@ V3306 Shell External Surface Weld defect (Porosity) found on the Half pipe weld to Shell @ 13th Half Pipe from Head end; @ 0°-90°</p>

Relevant rounded indications found less than 3/16 in and it is accepted as per code, no action required.			Closed		Action not required

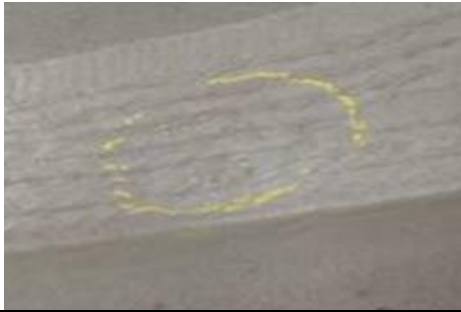
5.	(WELD)	13-Feb-2021	31010- 2	<p>@ V3306 Shell External Surface Weld spatters found (Random locations) on / around the Half pipe weld to Shell.</p>

MHI Response: it is the sand adhesion during remove the scaffold after finish temporary coating, it can be removed when the sandblasting for external surface.	QICL	25-Feb-2021	Closed

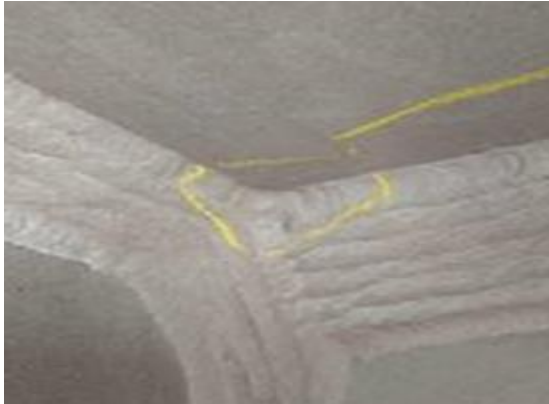
8.	(WELD)	13-Feb-2021	31010- 2	<p>@ V3306 Shell External Surface Weld defect (Arc crater) found at the shell stiffener top ring weld surface. @ 180°-90° location.</p>

Polish and PT	QICL	25-Feb-2021	06-Mar-2021	FR#21	NDT report reviewed and satisfied after completion of the corrective action

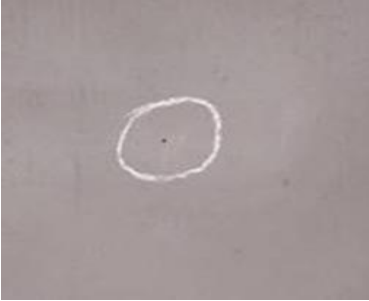
10.	(MATL)	13-Feb-2021	31010- 2	<p>@ V3306 Shell External Surface Pin hole found on the base material in-between location of 9th Half pipe to 10th Half pipe from the Head @ (180°-90°).</p>

<p>The observed pin hole looks less than 1mm depth. Grind the surface and should perform the NDT (PT/MPI) on the surface.</p> <p>Recheck thickness</p>	QICL	25-Feb-2021	Closed	FR# 19	Thickness report reviewed and confirmed the actual thickness was more than the required thickness.

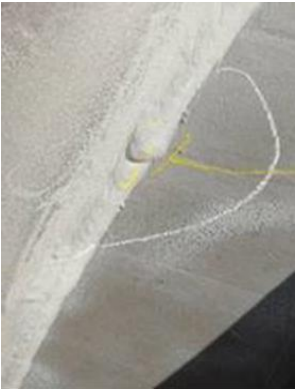
14.	(WELD)	13-Feb-2021	31010- 2	<p>@ V3306 Cone External Surface Weld overlap found on the Half pipe weld to Cone in one location. @ 90°-0°)</p>

Remove the weld overlap by grinding and Perform the NDT (PT/MPI) on the applicable area.	QICL	25-Feb-2021	06-Mar-2021	FR#21	NDT report reviewed and satisfied after completion of the corrective action

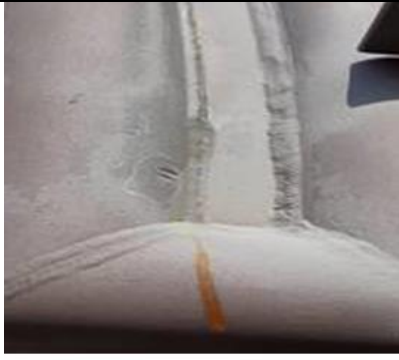
16.	(MATL)	13-Feb-2021	31010- 2	<p>@ V3306 Cone External Surface Mechanical damage found at one location on one Half pipe surface. @ 180°-90°.</p>	MHI Response: the design minimum thickness of half-pipe is 6mm, please measure the depth of hole, if the depth is less than 1.6mm, please grind it smoothly and perform PT.	QICL	25-Feb-2021	06-Mar-2021	FR#21	NDT report reviewed and satisfied after completion of the corrective action

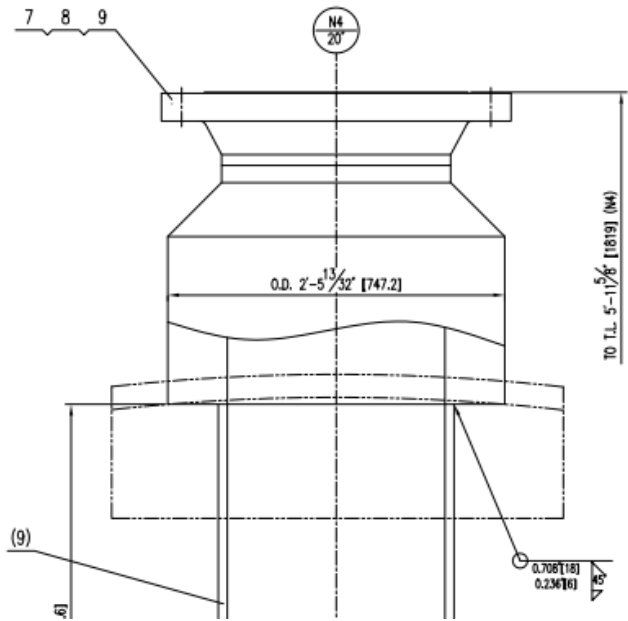
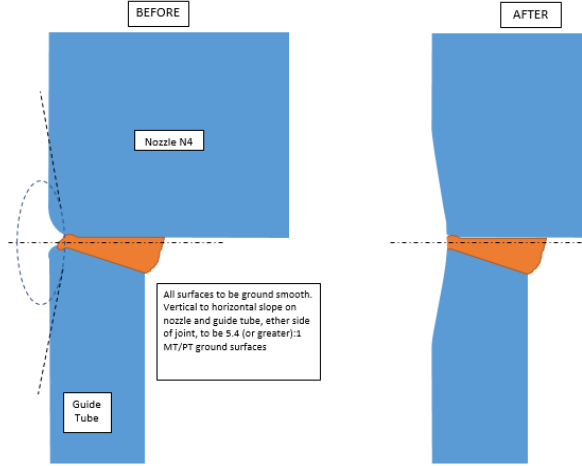
17.	(WELD)	14-Feb-2021	FR# 04	<p>While checking Nozzle N4 inside, it was found lack of weld penetration at the Butt Joint in Part no#9 with part # 8. The requirement of Weld / Edge preparation was verified in the Dr# '236910-BAY3-MHI-31006-01-00047 and noted the below.</p>

<p>Grind and taper 5.4:1 ratio each side. MT/PT ground surfaces</p>

QICL	26-Feb-2021	Closed		<p>Refer to email sent to QICL, Feb 20, 2021</p> <p>Corrective action was completed. NDT reports reviewed and satisfied.</p>

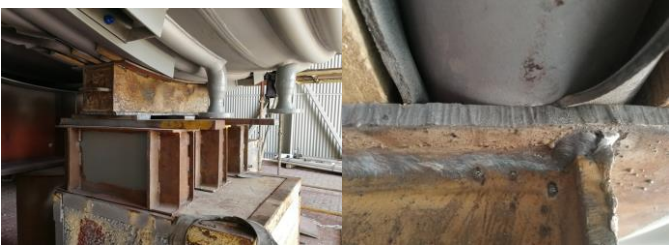
preparation/cleanliness on the above said flanges including flange holes prior to primer activity.						
33.	CTG/MATL	26-04-2021	FR#65	V3306- Final Topcoat External Visual Inspection During the above witnessed Inspection, it was found that QICL has been fixed one Temporary packing at the vessel cone surface. The installed Temporary support is having direct contact with the vessel Half tube surface and due that the Half tube surfaces might have been damaged. Hence Close visual inspection is required to ensure the absence of any coating, material defects. QICL needs to take the necessary action for the above observation.

QICL to action on remedial works	QICL	05.05.2021	FR#70	01-05-2021	QICL Action: QICL removed the Installed Temporary packing. Close visual Inspection has been performed on the Half Tube material surface. No coating / material damages were observed, and the Inspection result was found satisfactory. Inspection report# QICL/J915/VIR/3306/14 was reviewed and endorsed. Hence the above punch point# 33 was closed.

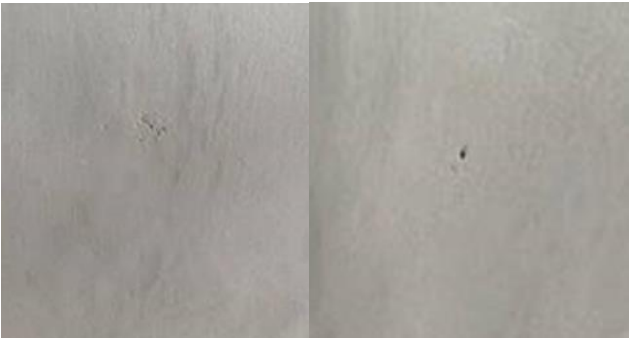
34.	MATL	19-04-2021	FR#59	Cluster Porosity, and pin hole found the Nozzle N7 Blasted surface. This is not acceptable.

QICL needs to remove the observed defects and do the NDT on the repair area.	QICL	03-05-2021	FR#66	27-04-2021	Corrective Action by QICL: QICL repaired the identified weld, material defects on the N7 nozzle at V3306 as specified in the Flash report# 59 and performed the NDT on all the repaired areas. The submitted Inspection reports # QICL/J915/VIR/3306/11 & QICL /J915/VIR/3306/11 were reviewed and was found satisfactory. Hence the identified observations were closed.

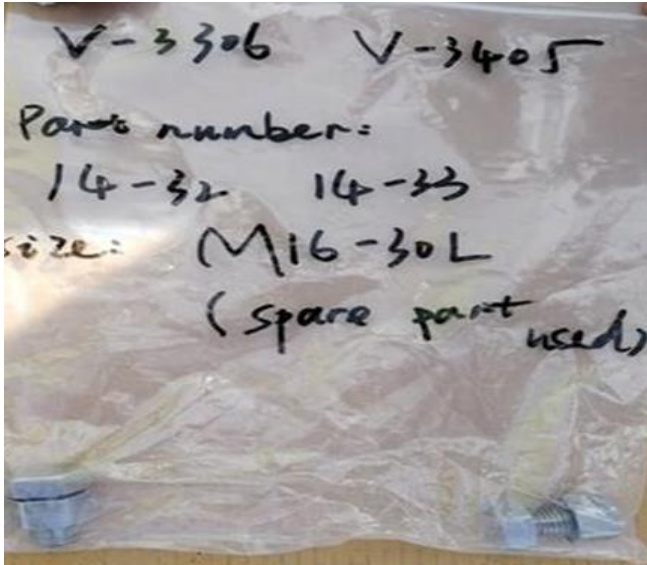
3.	DOC	06-03-2021	FR#21	<p>@ Packing Lists # SO22; Si no# JMH20-580059; (V-3305) MHI Packing List has been showing the Part no# 14-32 (M16 Bolt) and Part no# 14-33 (Hex Nut) for Vessel V 3305, whereas in the received packing shows the different Vessel number V 3405.</p>

<p>Discard these (2) sets of stainless steel bolting for platform.</p> <p>MHI will mail (2) sets of galvanized bolting to replace them, 5/8" dia- 1.181" (30 mm long) .One set for V-3306, new part # 15-45 for bolt and 15-34 for nut, The other set for vessel V-3305, the new part # 14-45 for bolt and 14-33 for nut.</p> <p>QICL to trial fit to make sure no fouling to safety gate in fully open and close positions.</p>	MHI/QICL	20-03-2021	06.07.2021	FR# 125

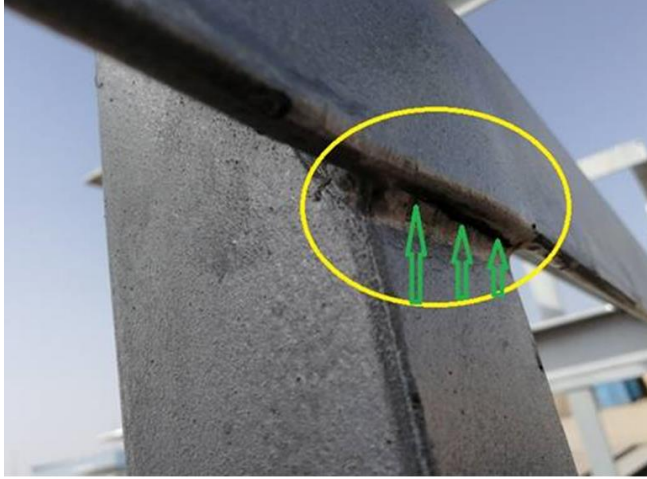
4.	WELD	06-03-2021	FR#21	<p>@ Packing Lists # SO22; Si no# JMH20-580059; (V-3305) Weld crack was found at one location in the received Platform Handrail.</p>

<p>Repair the weld crack and redo galvanizing based on approved Galvanizing Repair Procedure</p>	QICL	20-03-2021	06.07.2021	FR# 121 FR# 125	<ol style="list-style-type: none"> <u>QICL Action:</u> Weld crack removed and rewelded. NDT performed on the repaired area. 2.3. Visual inspection was carried out on the repaired area and found satisfactory. Inspection reports# QICL-J915-VIR-3305-04; QICL-J915-PT-3305-05, 06 were reviewed and Endorsed. The damaged/removed galvanized coating was restored as per the approved galvanizing procedure Coating Inspection report# QICL-J915-PNT-45 reviewed and endorsed.

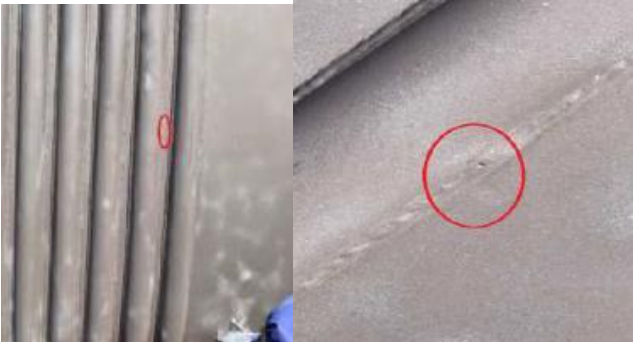
5.	WELD	07-04-2021	QICL report # J915/VIR/3305/02	<p>Mechanical damage observed on welding of 2nd half pipe to shell joint from dish head near nozzle N17 at orientation 270° to 0°.</p>	<p>Grind, PT and re-check weld size (6 mm min.)</p>	MHI/ QICL	25-Apr-2021	Closed		<p><u>QICL Action:</u> Mechanical Damage was removed on the Identified surface and NDT performed. Test results was found satisfactory.</p> <p>NDT Report# QICL/J915/PT/3305/01 was reviewed and Endorsed.</p>

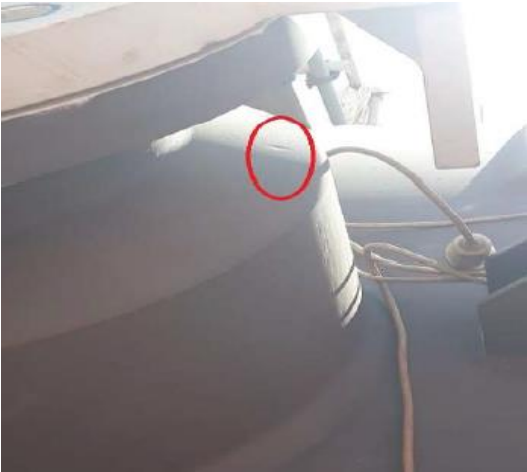
7.	WELD	07-04-2021	QICL report # J915/VIR/3305/02	<p>Deep grinding marks observed manway hub M2A at orientation 270°.</p>

Grind and PT	MHI/QICL	25-Apr-2021	Closed		<p>QICL Action: The identified weld defect was removed on the Identified surface and NDT performed. Test results was found satisfactory.</p> <p>NDT Report# QICL/J915/PT/3305/02 was reviewed and Endorsed.</p>

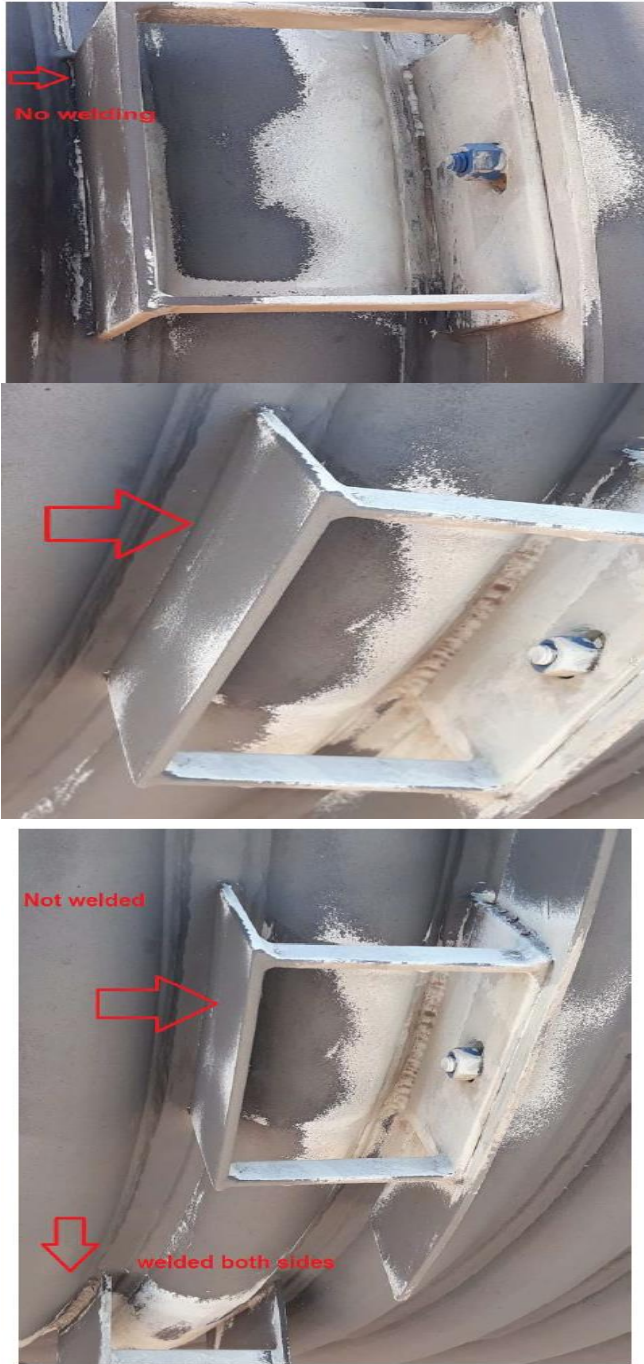
8.	WELD	07-04-2021	QICL report # J915/VIR/3305/02	<p>3 No's of insulation support clip to cone are observed without welding & poor weld profile and cluster porosity observed on support clips welding.</p>	<p>(1) Cut off and grind smoothly(TYP) all unwelded clips. (2) Grind to remove cluster porosity and correct the weld pro-file for painting purpose.</p>	MHI/QICL	25-Apr-2021	Closed		<p>QICL Action: Trimmed off the incomplete weld clips and ground smooth on the cutting edges. NDT-PT performed on the cutting edges. Test results found satisfactory.</p>

<p>(3) Make sure top plates have continuous fillet welds both sides,</p>

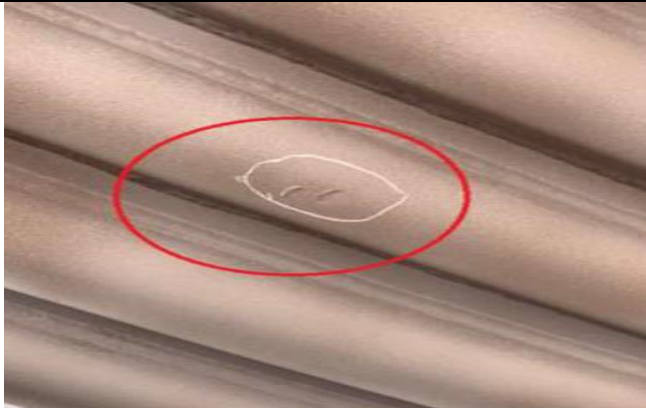
<p>NDT Report# QICL/J915/PT/3305/01 was reviewed and Endorsed.</p>
9.	WELD	29.04.2021	FR# 68	Weld spatters found (Random locations) on / around the Half pipe weld to Cone.	QICL to remove the spatters			Closed		<p>QICL Action Spatters removed.</p>
10.	MATL	29.04.2021	FR# 68	One minor mechanical damage was observed on the Half tube surface- 4th Half tube towards shell side from support ring# 2 @ 60° orientation.	Grind, PT, and check pipe thickness (6 mm min.)			Closed		<p>QICL Action: The identified mechanical damage was removed on the Identified surface and NDT performed. Test results was found satisfactory.</p> <p>NDT Report# QICL/J915/PT/3305/02 was reviewed and Endorsed.</p> <p>UTG has been carried out on the smooth grinded surface</p>

and found the actual Thickness more than the required thickness. UTG Report# QICL-J915-V3305-UTG-01 was reviewed and Endorsed.
11.	WELD	29.04.2021	FR# 68	<p>Poor weld profile was found on the Half tube weld surface towards cone side - 7th Half tube from the Insulation support cleat#4 @ 60°-140° Orientation.</p>

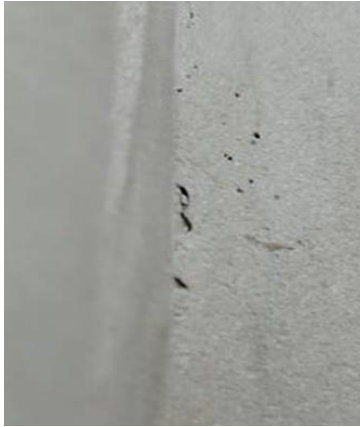
12.	WELD	29.04.2021	FR# 68	<p>Cluster porosity was found at the 1st Half tube weld surface from Radioactive Cleat# 10 @ 133° Orientation</p>

<p>Grind/buff smoothly to remove porosity and PT, and check the weld size (6 mm min.)</p>			Closed		<p>QICL Action: The identified weld defect was removed on the Identified surface and NDT performed. Test results was found satisfactory.</p> <p>NDT Report# QICL/J915/PT/3305/02 was reviewed and Endorsed.</p>

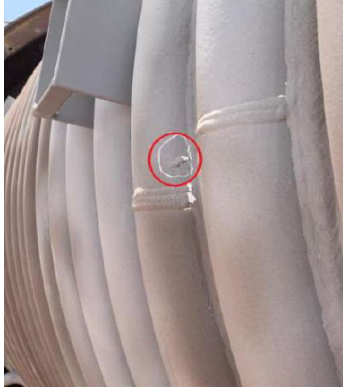
15.	WELD	29.04.2021	FR# 68	<p>Weld metal Deposit found on the Half Tube surface- 1st Half tube towards cone End from Insulation support ring # 5</p>

Grind, PT , and check pipe thickness (6 mm min.)			Closed		<p>QICL Action: The identified weld defect was removed on the Identified surface and NDT performed. Test results was found satisfactory.</p> <p>NDT Report# QICL/J915/PT/3305/03 was reviewed and Endorsed.</p> <p>UTG has been carried out on the smooth grinded surface and found the actual Thickness more than the required thickness.</p> <p>UTG Report# QICL-J915-V3305-UTG-01 was reviewed and Endorsed.</p>

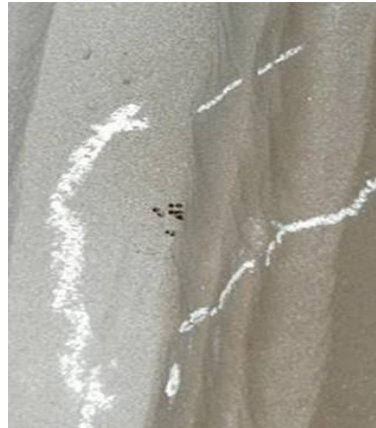
16.	WELD	29.04.2021	FR# 68	Cluster porosity found at the Half tube weld surface- 4th Half tube from the Insulation support ring #5 @ 340° Orientation.	Grind, PT, and check weld size (6 mm min.)			Closed		<p>QICL Action: The identified weld defect was removed on the Identified surface and NDT performed. Test results was found satisfactory.</p> <p>NDT Report# QICL/J915/PT/3305/03 was reviewed and Endorsed.</p>

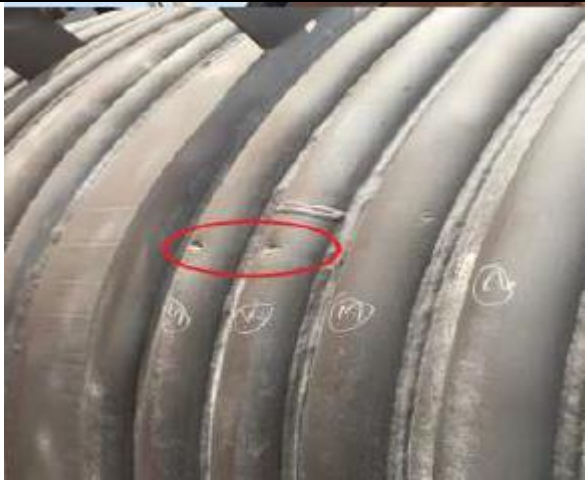
18.	MATL	29.04.2021	QICL/J915/VIR/3305/02-Rev 01	Mechanical Damage observed on 4 th and 5 th Half tube from insulation support# 5 towards shell at 180°	QICL to re-evaluate the degree of damage and depth of dent. If it is lightly dent, smooth and no sharp edges or buckle, then grind, PT, check the thickness (6 mm min.) and pneumatic test at 728 psig. If it is severe, then cut and patch, PT and pneumatic test (similar to repair procedure for V-3304B)			Closed	<p>QICL Action: The identified mechanical damage was removed on the Identified surface and NDT performed. Test results was found satisfactory.</p> <p>NDT Report# QICL/J915/PT/3305/02 was reviewed and Endorsed.</p>

<p>UTG has been carried out on the smooth grinded surface and found the actual Thickness more than the required thickness.</p> <p>UTG Report# QICL-J915-V3305-UTG-01 was reviewed and Endorsed.</p>

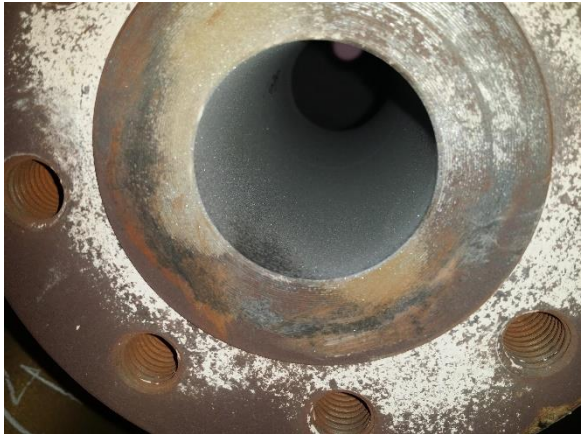
19.	CTG	07.06.2021	FR#99	<p>The Serrations on these Flanges of Nozzles N11A, N11B have been blasted as they were not properly covered during Blasting Process.</p>

Resurfacing to meet ASME B16.5	AMI / QICL	26.06.2021	FR# 115	<p><u>QICL Action:</u></p> <ol style="list-style-type: none"> Supplier performed the effective cleaning on the serration surface and offered for reinspection Close visual Inspection has been carried out on the Flange Serrations and found no Imperfection on the serration surface. Hence it is acceptable.

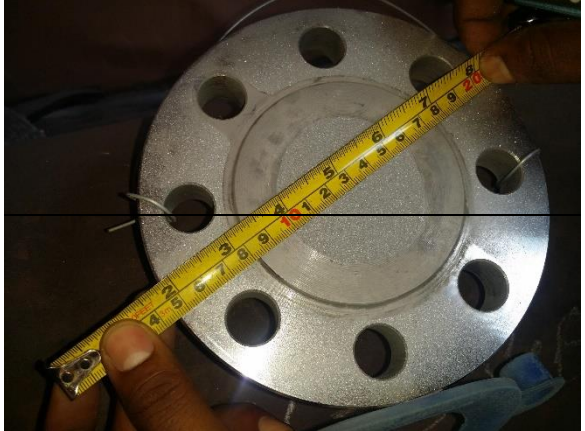
20.	CTG	07.06.2021	FR#99	<p>(2) blind flanges were blasted to 60 mm diameter range.</p>

These two blinds to be used as shipping covers for nozzles # N11A and N18 and painted yellow.	QICL

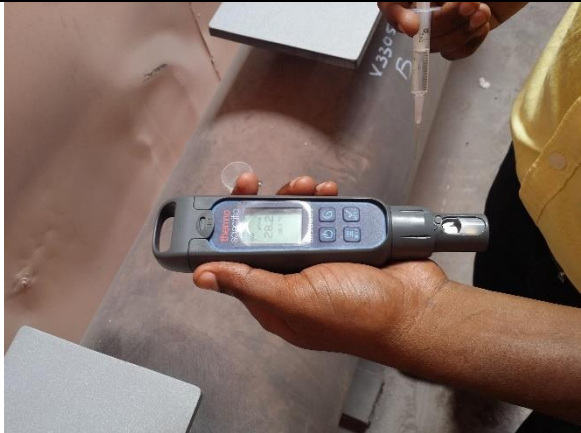
21.	CTG	07.06.2021	FR#99	<p>The salt contamination testing failed as the Bresle method Digital Salt tester could not read the Valves properly.as it was giving 28 --22 mg/m2 for all the test including the dis tilled water</p>		AMI	13-06-2021	FR# 104	<p><u>Action by supplier (AMI)</u></p> <p>a) Additional sample plate prepared. For surface preparation on the sample plate supplier has used the Blasting grit which is taken from the</p>

<p>same lot which was used for the vessel surface preparation.</p> <p>b) Chloride level checked by using Bresle method. Chloride level found less than 20 mg/m2.</p> <p>c) This test was witnessed by MCD and the test result was found satisfactory. Hence the recorded punch point as specified in the Flash report# 99 was closed.</p>

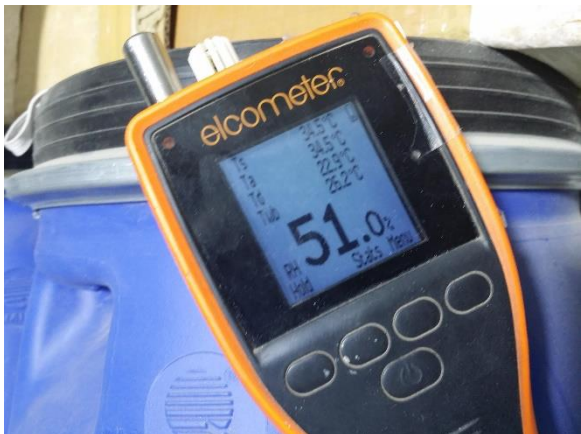
22.	CTG	09.06.2021	FR#101	<p>During the Painting material storage inspection in line to the email from AMI Polymers related to the shelf life validity extension for the shelf life expired PFA material it was observed that AMI Polymers have stored the PFA paint material in the container and the container is placed in the open area under the sun, the temperature measured inside container during inspection at 34.5 deg C. But as per AMI Email storage condition, maximum temperature of 30 deg.C. It is difficult to achieve during peak day time (container is hot from outside due to high temperature in UAE reaching around 45 degC) even the air condition (window AC) is running 24hrs.</p>

AMI	Closed		<p><u>AMI Action</u></p> <p>1.Letter from Chemours was submitted</p> <p>2.Spray ability test was conducted and found OK.</p> <p>3.Adhesion test was carried out on sample plates of V 3304B which was processed within a week of the expiry test.</p> <p>4.The materials were declared 'good' for further processing for V3305.</p> <p>5.After V 3305 was completed, its sample plates were tested for adhesion and found OK.</p> <p>6.This confirmed that the material was OK to be used.,</p>

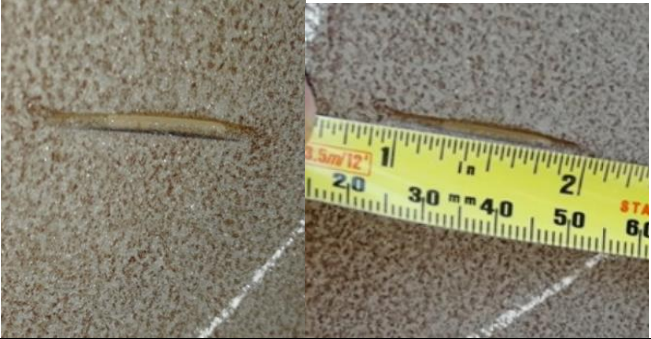
Action Item No.	Category	OPENED		Description	Action	Action By	Date Due (2 weeks)	CLOSED		Comments
		Date	SQS Report No.					Date	SQS Report No.	
1.	(WELD)	17-Feb-2021	31010- 2	<div>@ V3405 Head External Surface</div> <div>Mechanical damage (Length up to 1", depth 1 mm) found on the circumferential weld seam B1 surface near the Head T joint @ 0° level.</div> <div>

</div>	To grind, MT/PT, and re-check thickness	QICL	4-Mar-21	04-Mar-2021	FR#20	<div>Closed</div> <div>Thickness report reviewed and confirmed the actual thickness was more than the required thickness.</div>

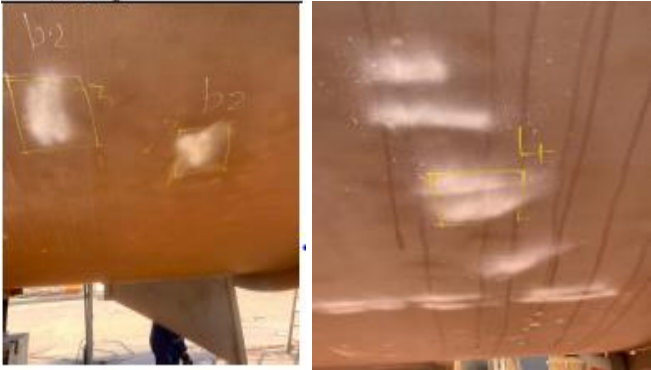
3.	(MATL)	17-Feb-2021 18-Feb-2021	31010- 2	<div>@ V3405 Shell External Surface</div> <div>Deep grinding marks were found on the shell surface at 2 locations in @ 0°-90° Deep grinding marks were found on the shell surface at 3 locations in @ 180°-270°</div> <div>

</div>	To recheck thickness	QICL	4-Mar-21	04-Mar--2021	FR#19	<div>Closed</div> <div>Thickness report reviewed and confirmed the actual thickness was meeting the code requirement thickness.</div>

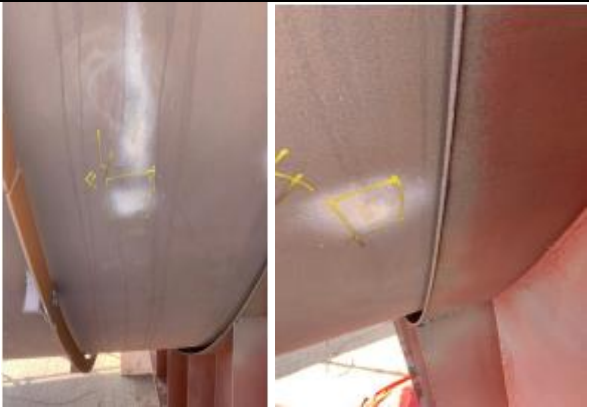
5.	(MATL)	17-Feb-2021 18-Feb-2021	31010- 2	<div>@ V3405 Cone External Surface</div> <div>Deep grinding marks were found on the shell surface at 4 locations @ 0°-90° Deep grinding marks were found on the shell surface at approximately 5 locations @ 270°</div>	To recheck thickness	QICL	04-Mar-2021	25-Feb-21	31010- 3	<div>Closed</div> <div>Thickness report reviewed and confirmed the actual thickness was more than the required thickness.</div>

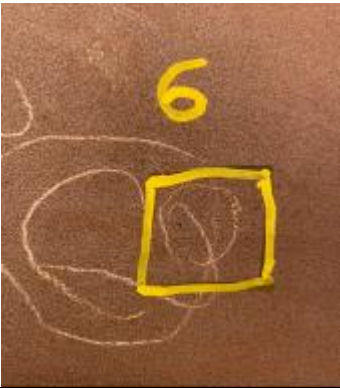
8.	(MATL)	17-Feb-2021	31010- 2	<p>@ V3405 Cone External Surface Pin hole found on the base material in 2 locations @ 180°-90°.</p>

<p>The observed pin hole looks less than 1mm depth. Grind the surface and should perform the NDT (PT/MPI) on the surface.</p> <p>Re-check thickness after grinding</p>	QICL	4-Mar-21	04-Feb-2021	FR#20	Closed Thickness report reviewed and confirmed the actual thickness was more than the required thickness.

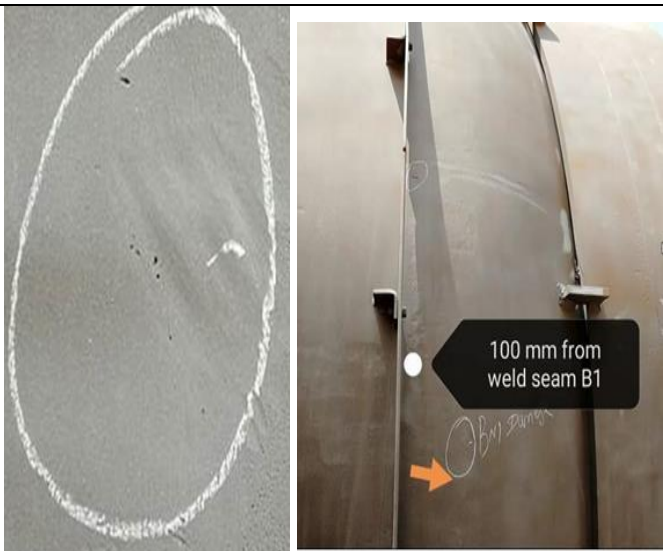
10.	(MATL)	17-Feb-2021		<p>@ V3405 Head External Surface Number of pin holes (Approximately 10) has been observed on the head surface (@ 0°-270°) after removal of temporary external coating. This observed location was found as the Deep grinded surface which was done at the manufacturer facility. The identified location is approximately 100 mm distance from the Cir seam B1 (below the 0° level towards 270°). All the identified pinholes are having approximately 1 mm dia and cumulative length of all holes will may come up to 5 mm.</p> <p>Further investigation is required for this deep pinhole.</p>	To grind, MT/PT and recheck the thickness	QICL	4-Mar-21	04-Feb-2021	FR#20	Closed Thickness report reviewed and confirmed the actual thickness was more than the required thickness.

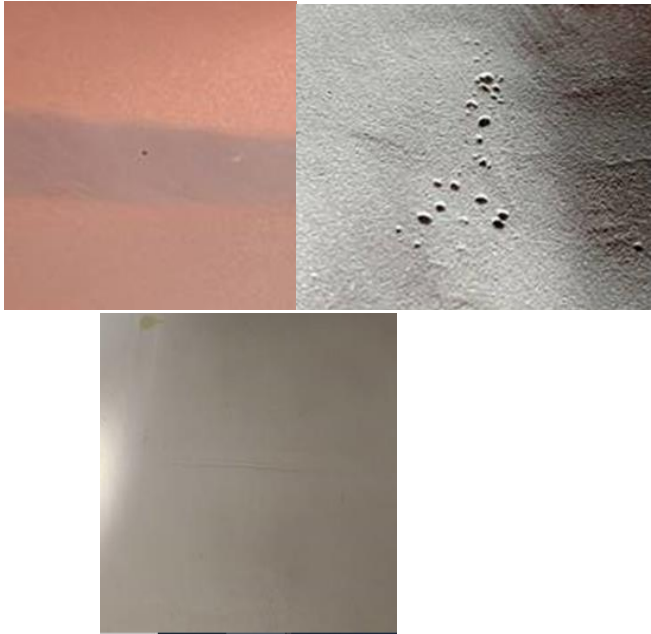
12.	(WELD/MAT L)	22-April-21	FR#63	<p>The below Observations were noted @ V3405 During the Final surface preparation Inspection.</p> <ol style="list-style-type: none"> 1 Weld pin holes found at One Trunnion RF Pad weld surface @ Shell side and cone surface @ near the 1st Insulation cleat 2 Cluster porosity found at one location on the shell surface (Near the cone-Shell Insulation ring @ in line with the Trunnion axis) 3 Sharp edges were found in most of the Brackets 4 Weld drop / spatter observed at one location @ Head surface 5 Mechanical damage found at one location on the Head surface

QICL	06-May-2021	27-April-2021	FR#66	QICL repaired the identified weld, material defects on the vessel V3405 External surface as specified in the Flash report# 63 and performed the NDT on all the repaired areas. The submitted Inspection reports # QICL/J915/VIR/3405/08 & QICL /J915/VIR/3405/04 were reviewed and was found satisfactory. Hence the identified observations were closed.
