301 MISSION STREET SUPPLEMENT III

2-4-2021

Introduction

This report is the 19th in a series of engineering investigative reports on the conduct of the San Francisco Department of Building Inspection (DBI).

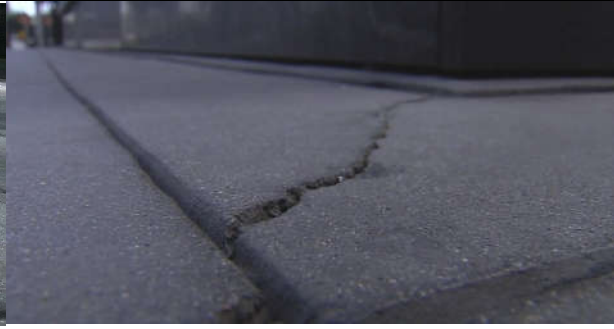
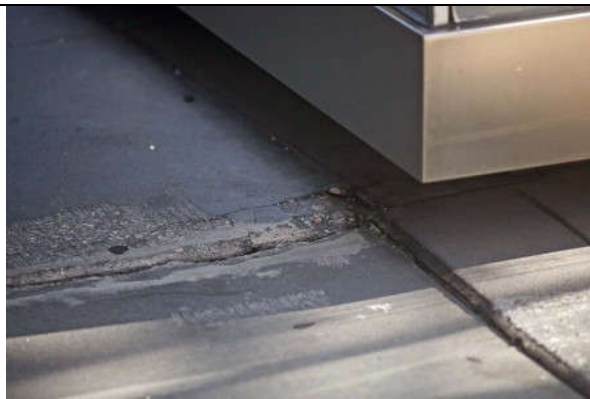
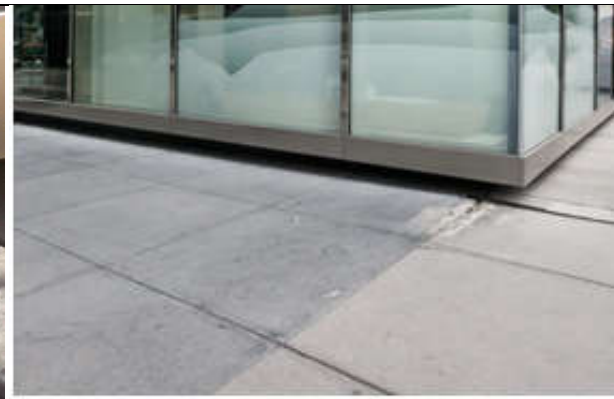
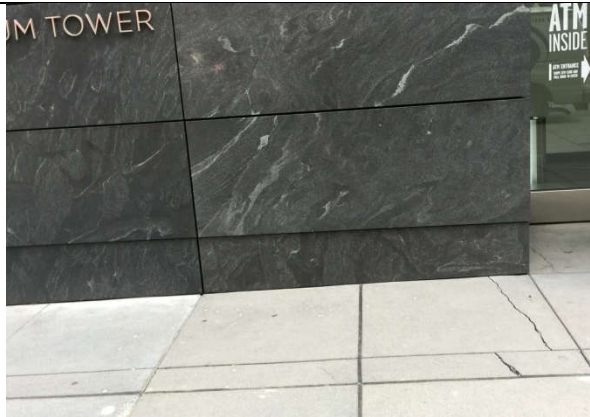
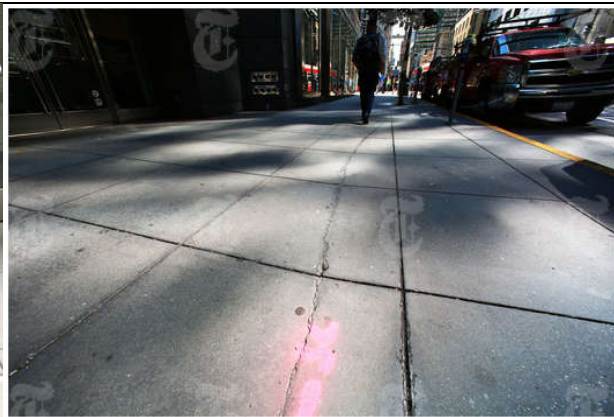
The news media had documented damage to the Millennium Tower's concrete sidewalks as early as August 1, 2016.

Is it conceivable that the Millennium Tower's tilting is exerting pressure on the sidewalk, resulting in the defects that are documented in Figures 2 through 7?

The sidewalk defects documented in Figures 2 through 7 are most likely proof that the existing concrete sidewalk and the underlying soil block provide lateral support to maintain the tilting Millennium Tower's stability. Lateral support is known in geotechnical engineering practice as "passive resistance."

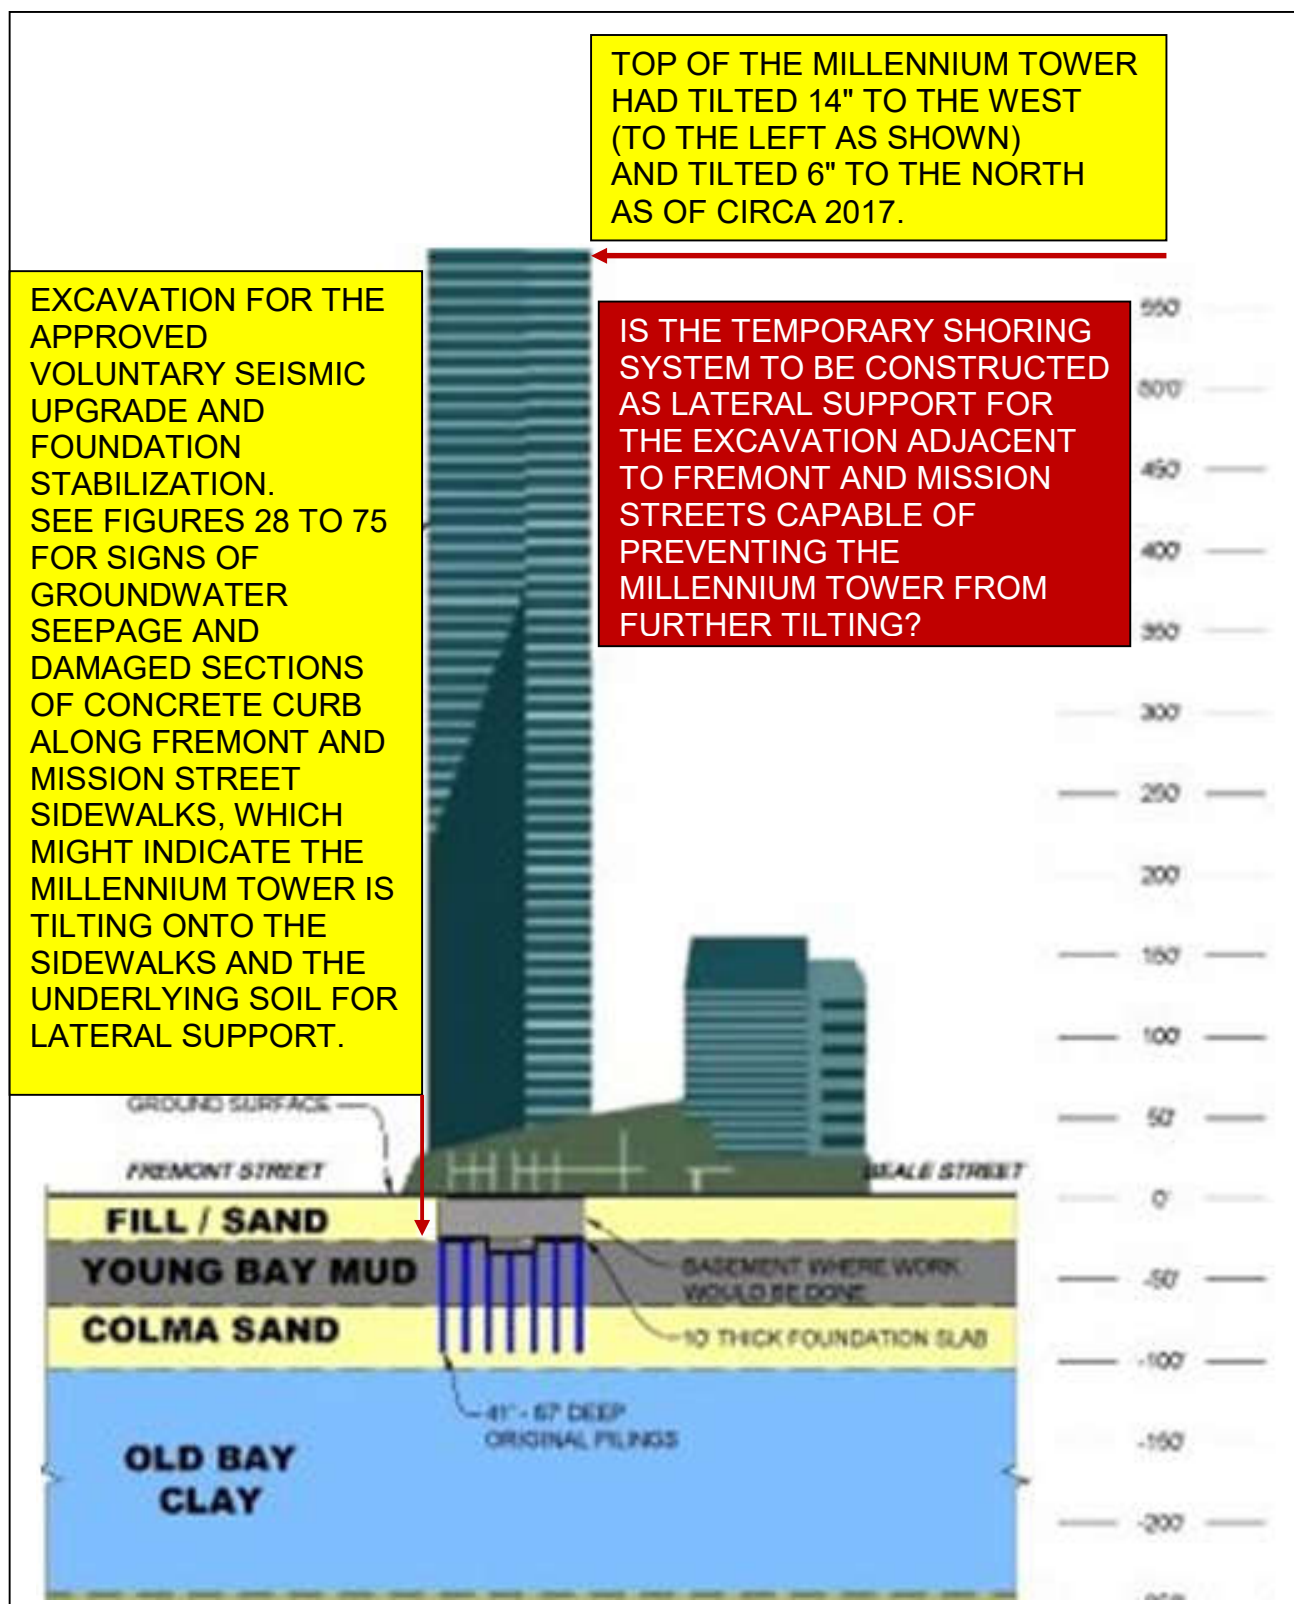
Figure 26: Enlargement of a figure downloaded from an internet search identified as the property of ENGEO, with annotations by Carl C. Chan.

Will the excavation of the soil block underneath the sidewalks result in further tilting of the Millennium Tower?

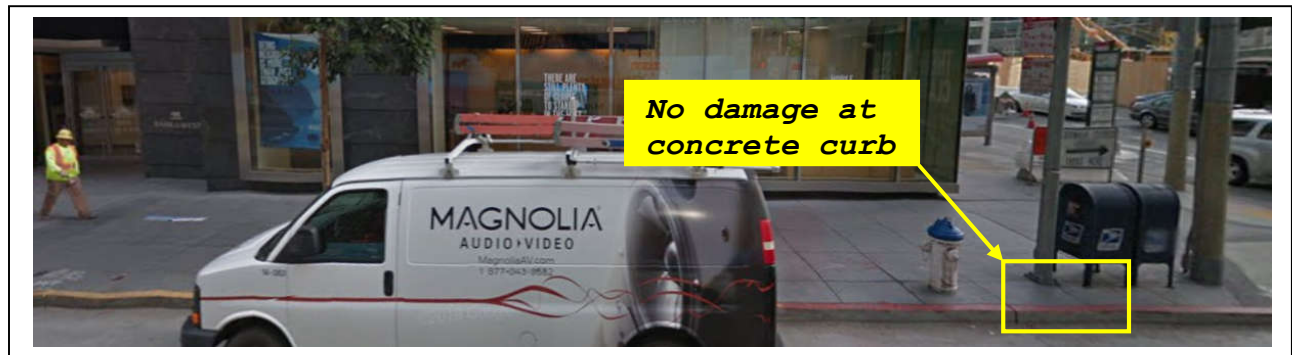
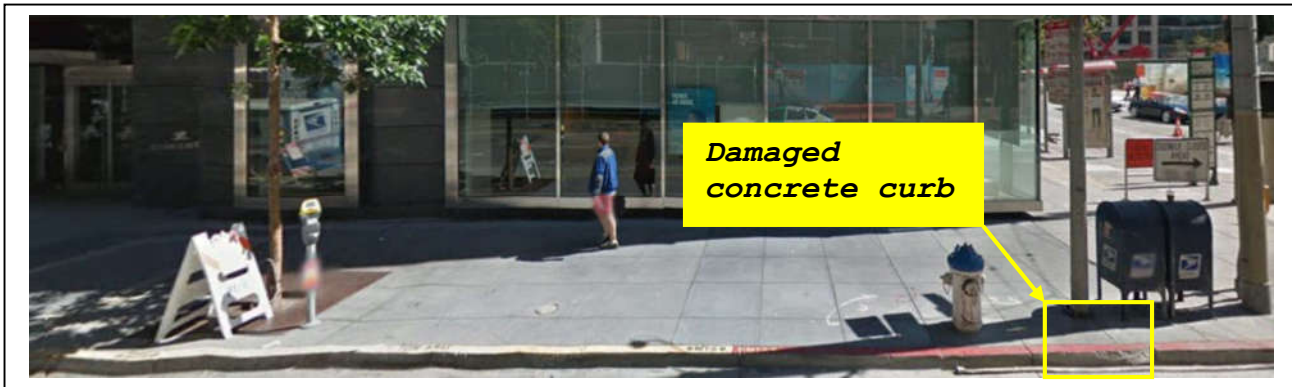
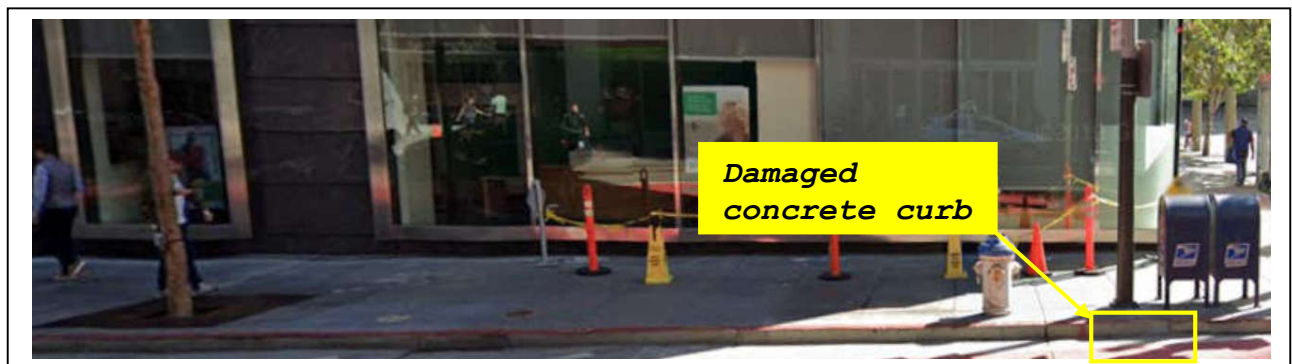
Figure 28: Annotated photograph of Mission Street at the western end of the block, dated November 2013; downloaded from Google Maps.

Figure 29: Annotated photograph of Mission Street at the western end of the block, dated August 2014; downloaded from Google Maps.

Figure 30: Annotated photograph of Mission Street at the western end of the block, dated October 2019; downloaded from Google Maps.

Figure 31: Close-up of concrete curb at Figures 28 to 30.

In Figures 28 to 31, the lack of groundwater seepage onto the sidewalk was likely because the Millennium Tower was tilting to a lesser magnitude toward Mission Street, which corresponds to lower pressure imposed on the soil block adjacent to the foundation of the tilting Millennium Tower.

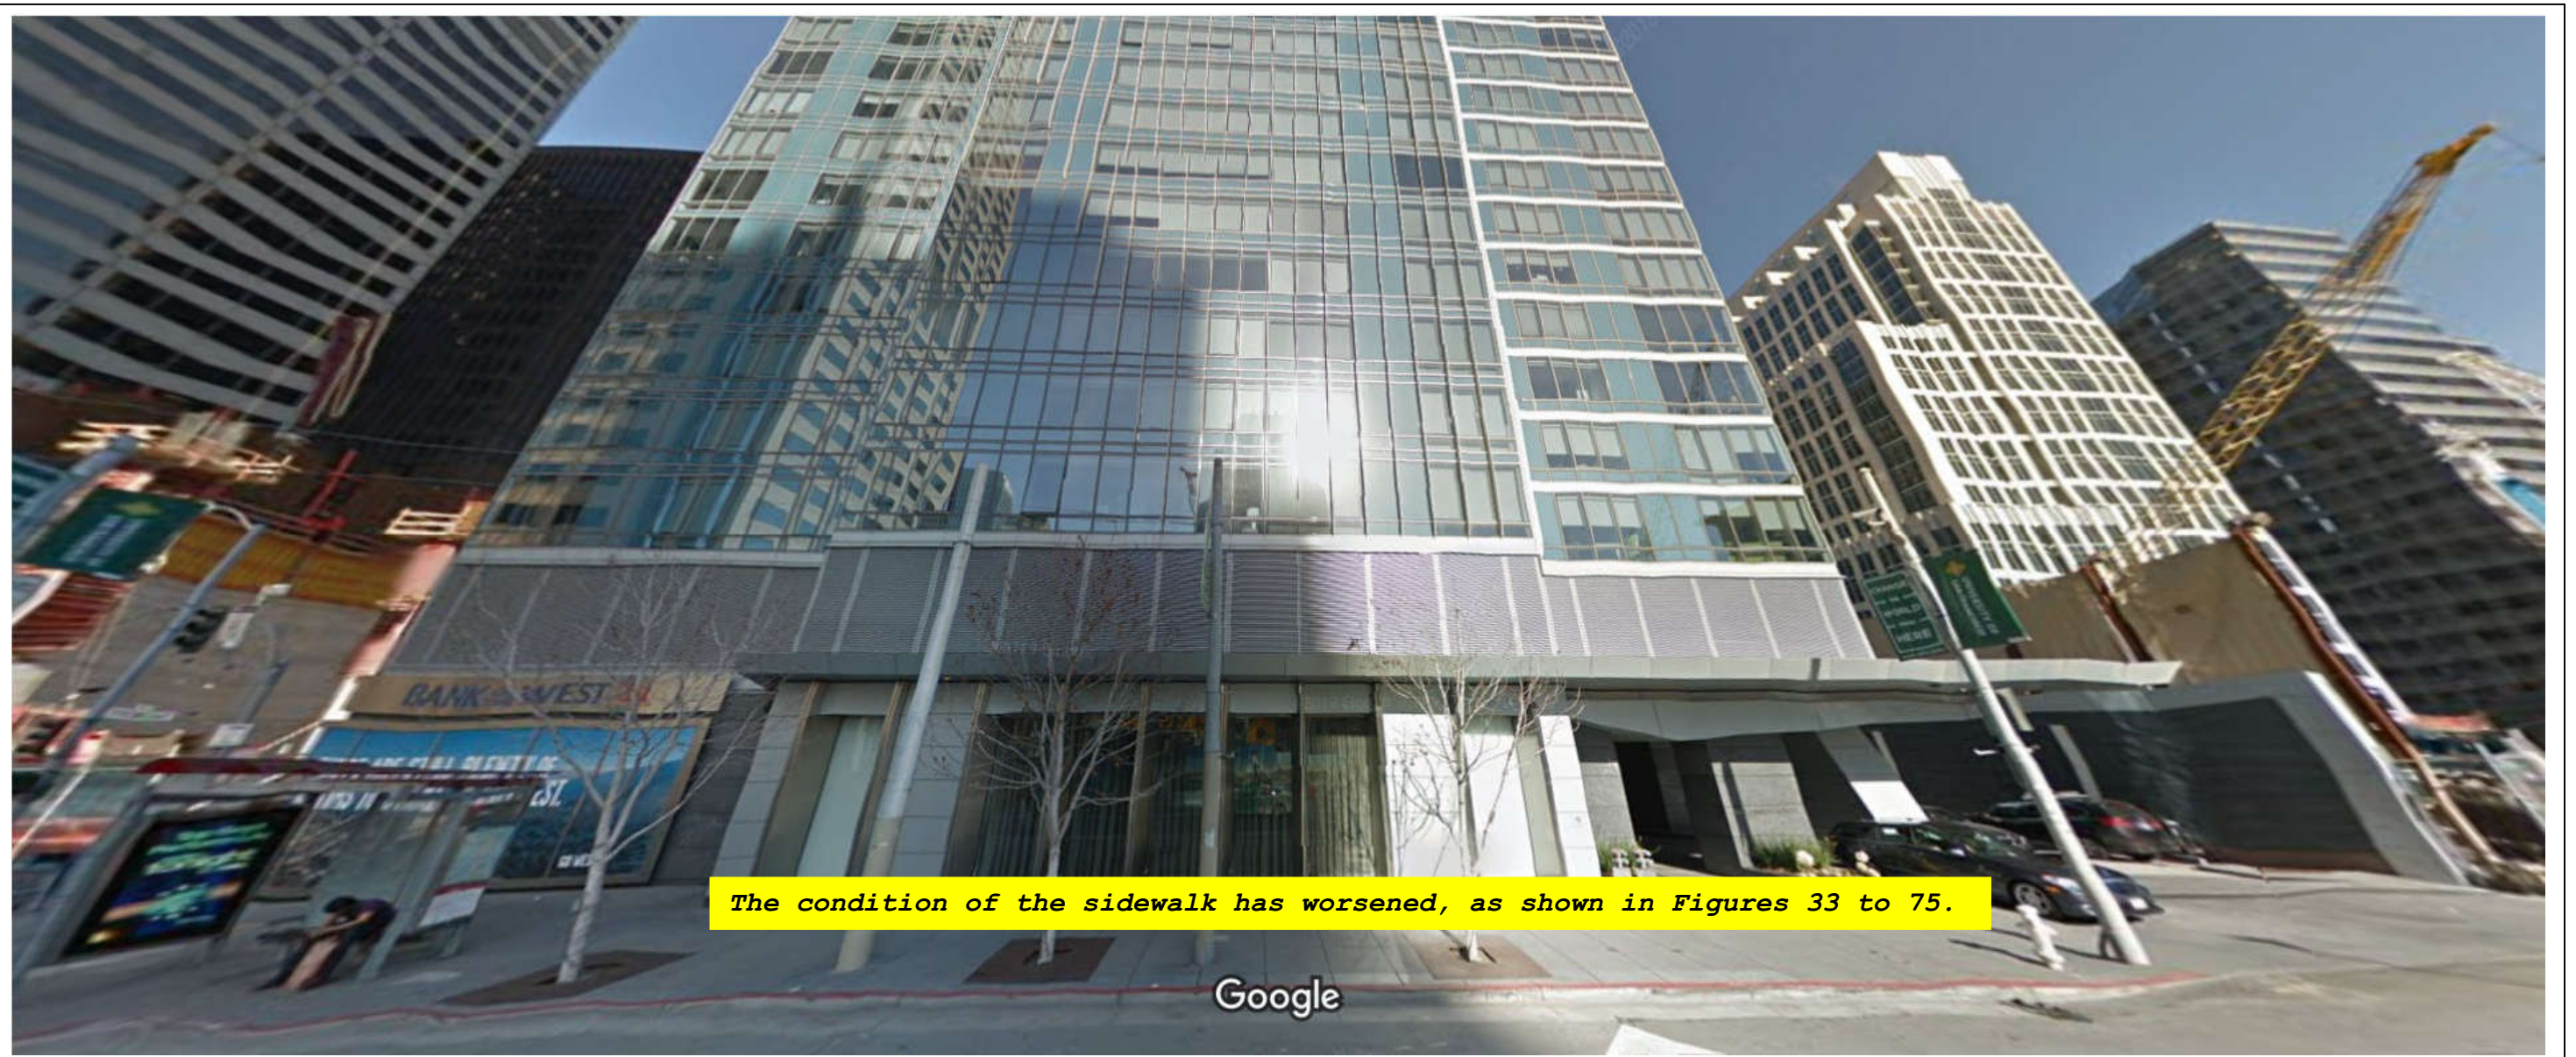
Figure 32: Photograph of the Millennium Tower facing Fremont Street, dated February 2014; downloaded from Google Maps, with annotations by Carl C. Chan.

Why was only minimal damage observed on the concrete sidewalk from 2009 (see Figure 32), when the tower was newly completed, to 2014, when damage accelerated (see Figures 33 to 75)?

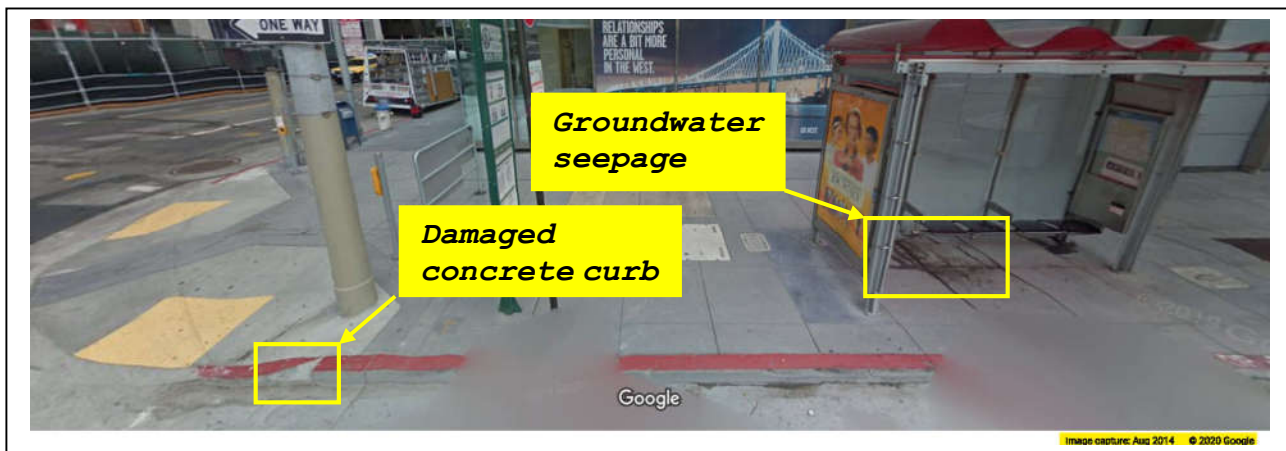
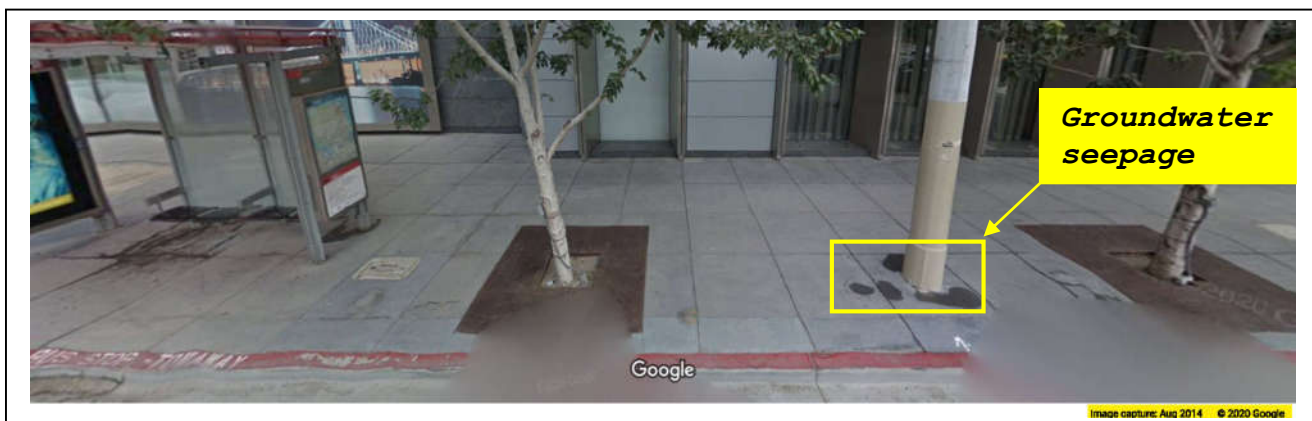
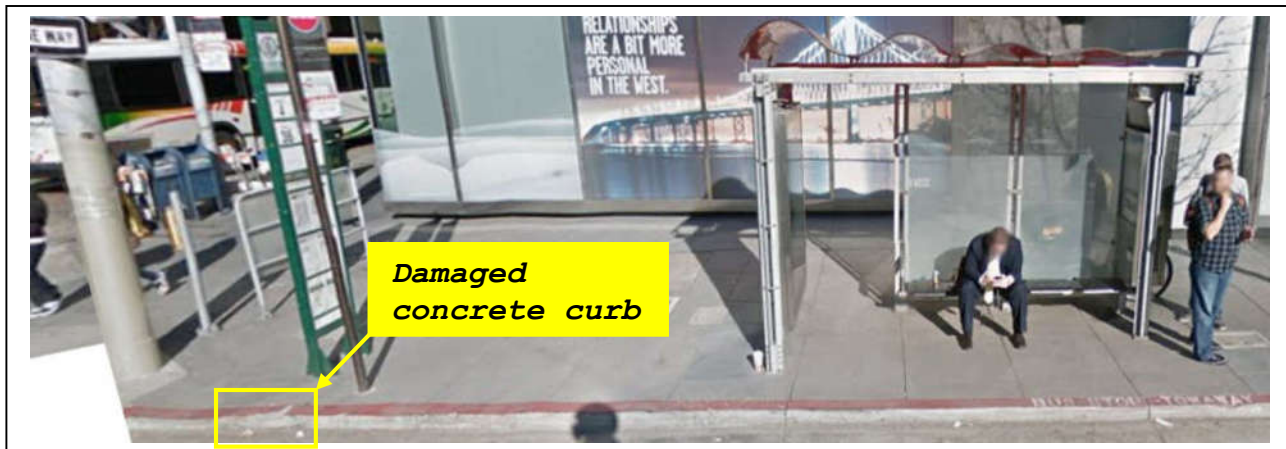
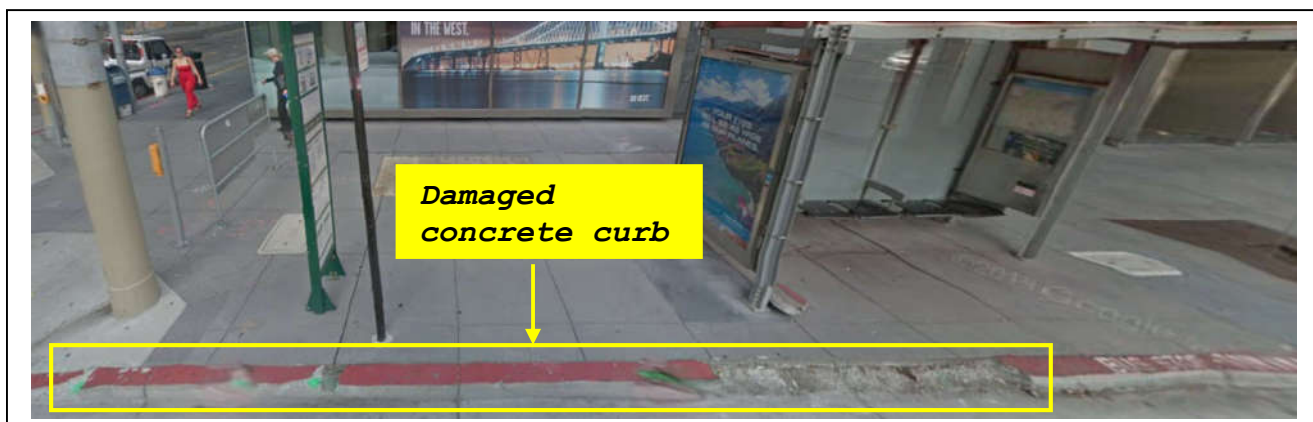
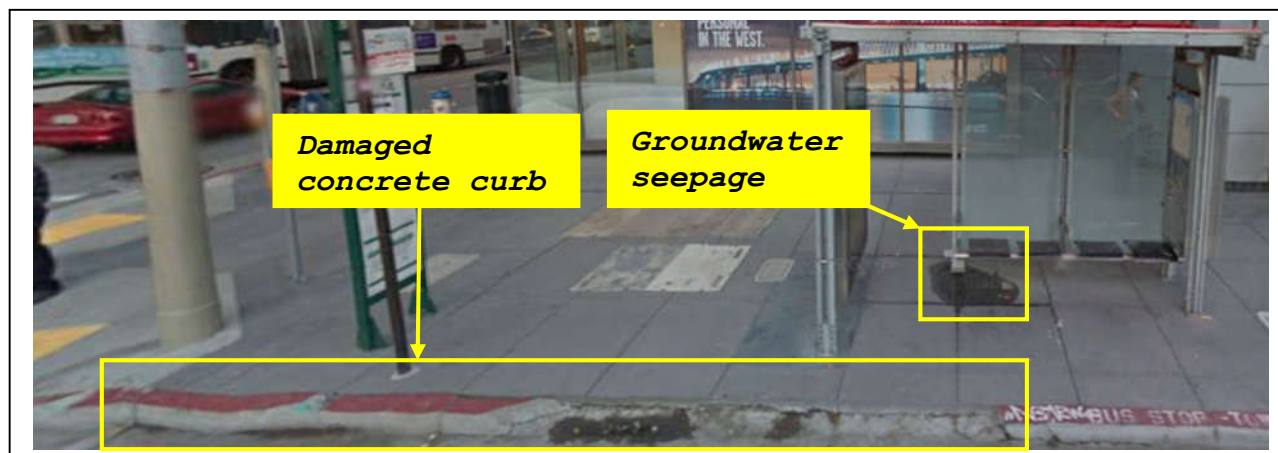
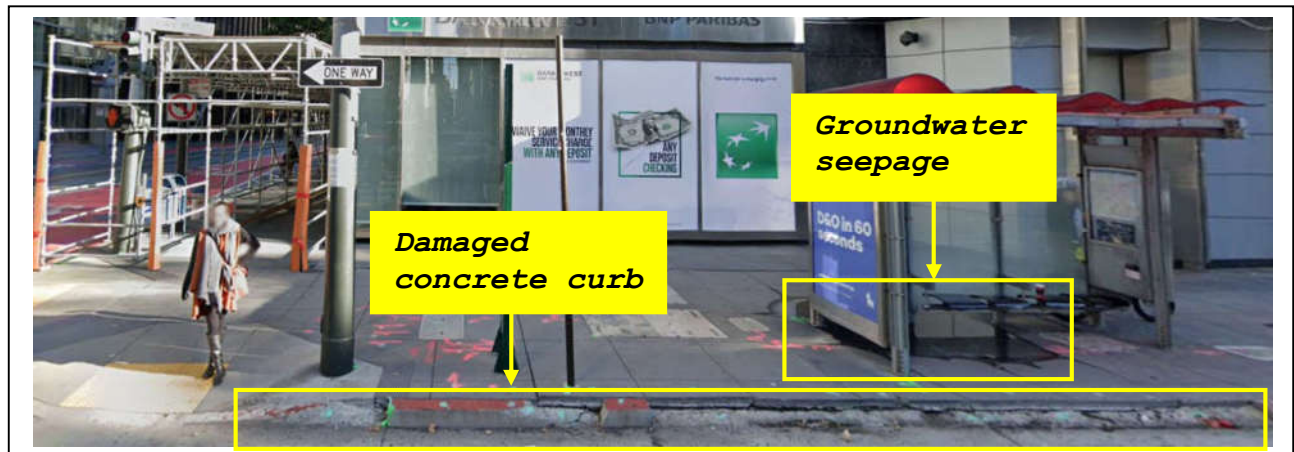
Figure 34: Annotated photograph of Fremont Street at the northern end of the block, dated August 2014; downloaded from Google Maps.

Figure 35: Annotated photograph of Fremont Street at the northern end of the block, dated August 2014; downloaded from Google Maps.

Figure 37: Annotated photograph of Fremont Street at the northern end of the block, dated January 2015; downloaded from Google Maps.

Figure 38: Annotated photograph of Fremont Street at the northern end of the block, dated July 2015; downloaded from Google Maps.

Figure 39: Annotated photograph of Fremont Street at the northern end of the block, dated November 2015; downloaded from Google Maps.

Figure 46: Annotated photograph of Fremont Street at the northern end of the block, dated December 2018; downloaded from Google Maps.

Based on Figures 33 to 75, the observed groundwater seepage onto the Fremont Street sidewalk and the damaged concrete curbs started from the north end of Fremont Street at Mission Street and proceeded southward along Fremont Street. It appears that the groundwater seepage onto the sidewalk preceded the damage to the concrete sidewalk curb.

Figures 33 to 75 are further proof that the pressure imposed by the tilting of the Millennium Tower, via its foundation wall, squeezed out the groundwater onto the sidewalk.

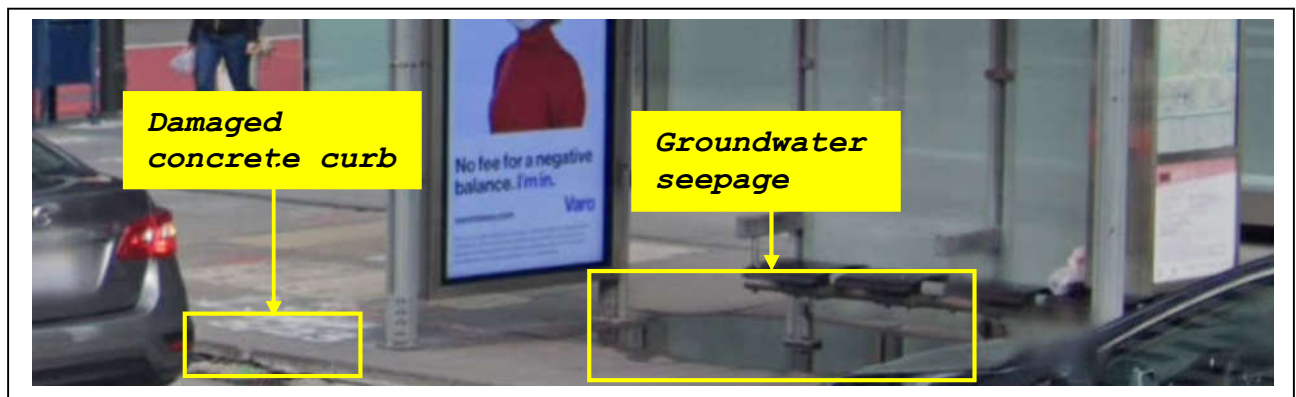
Figure 50: Close-up of groundwater seepage in Figure 49, viewed from a different angle.

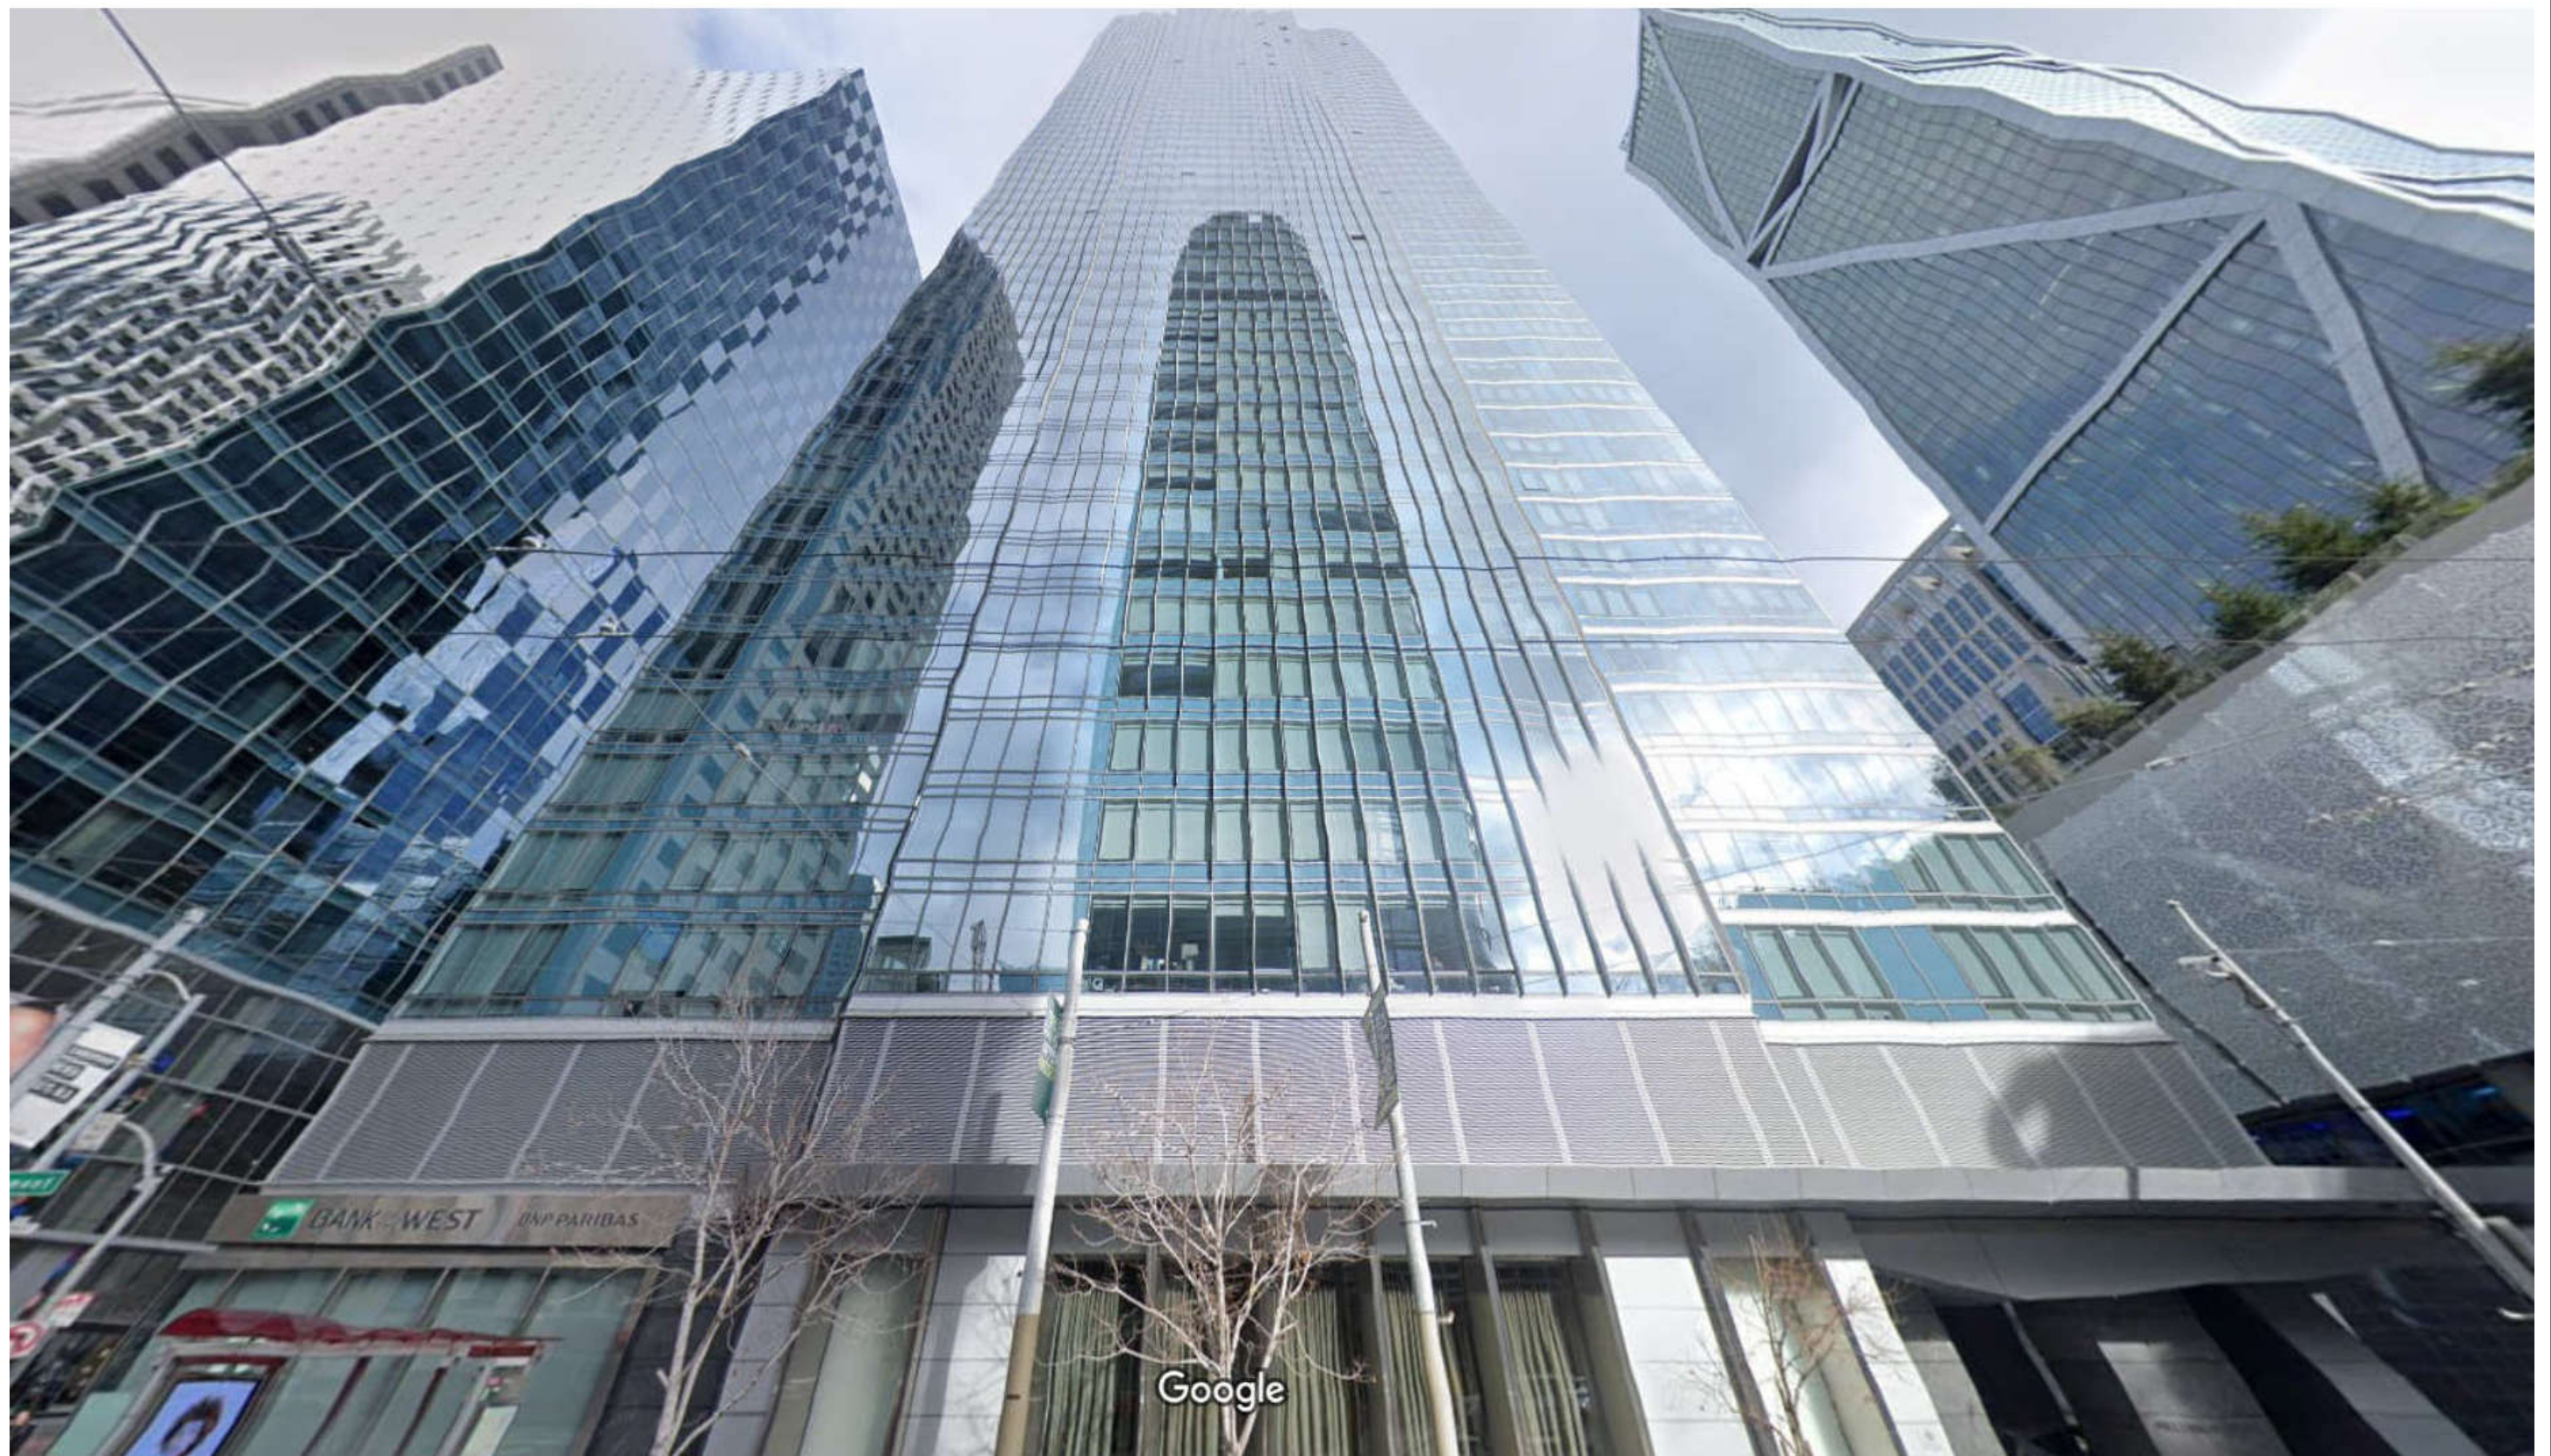
SEE FIGURES 33 TO 50 FOR GROUNDWATER SEEPAGE AND DAMAGED CONCRETE CURB.

SEE FIGURES 51 TO 59 FOR GROUNDWATER SEEPAGE BUT LACK OF DAMAGED CONCRETE CURB.

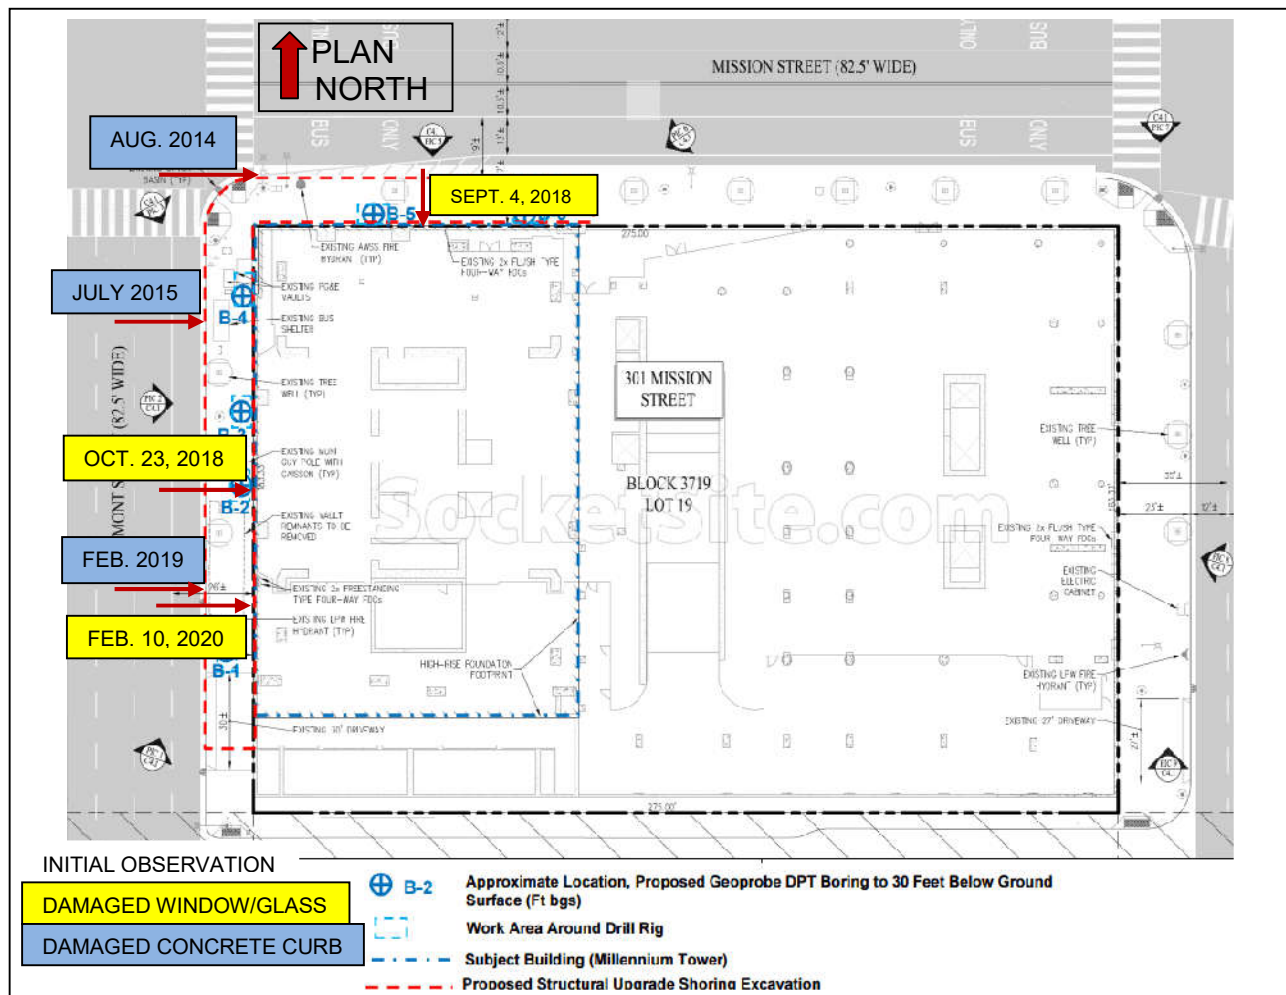
Figure 92: Extract from the plan to fix the Millennium Tower, article dated March 12, 2019; downloaded from www.socketsite.com, with annotations by Carl C. Chan.

Figure 92 summarizes the approximate dates and locations of damaged windows/glass as reported on the NBC Bay Area website and damaged concrete curbs as shown in images on Google Maps.

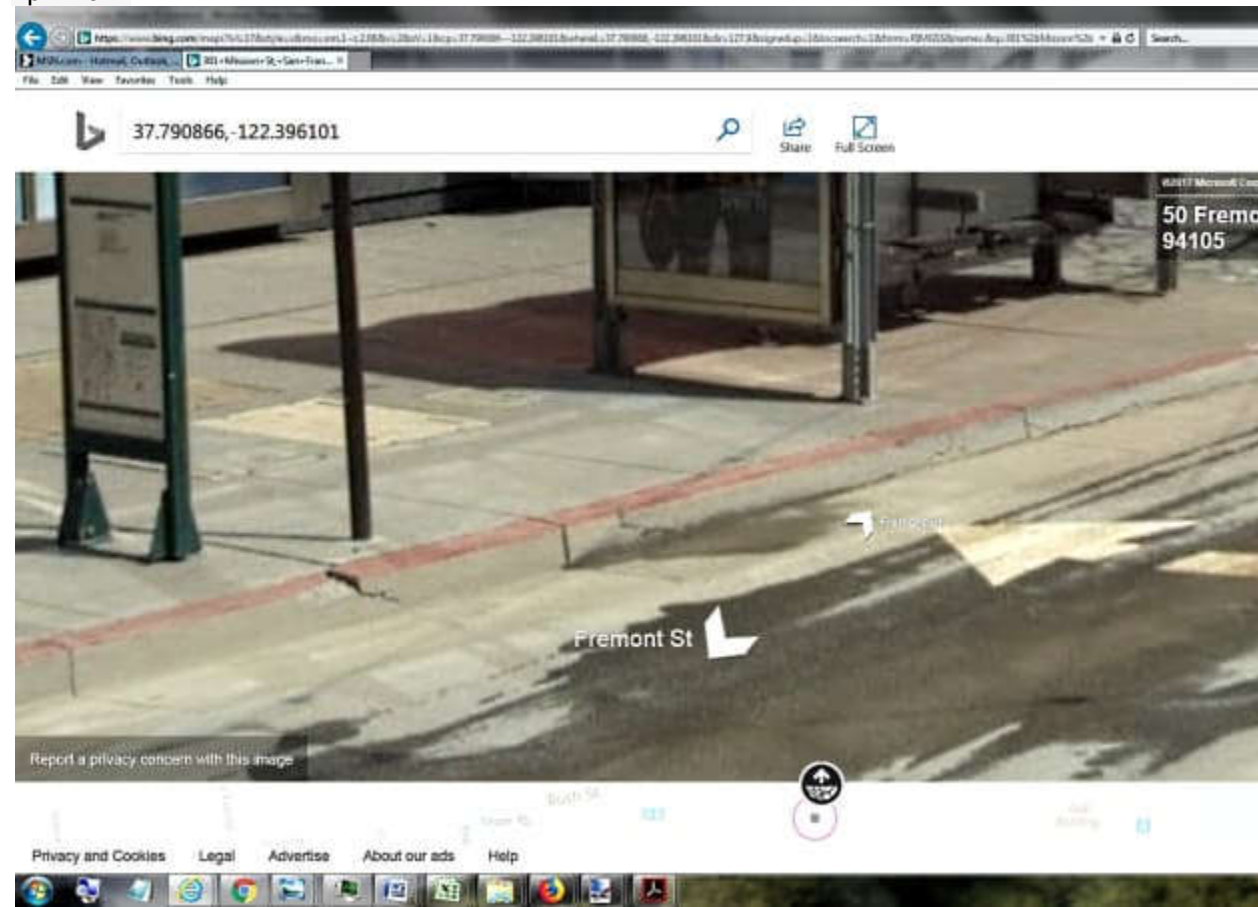
Figure 94: Posting dated April 2, 2018, on www.eng-tips.com by "epoxybot," with annotation by Carl C. Chan.

In 2014 the City of SF replaced the sewer line in Fremont St, claiming it was old and had probably needed to be replaced for some time but in 2011 in preparation for the Transbay Center project, utility lines were run immediately adjacent to the sewer line and if it was in such a bad state, it would have been dealt with then. It is more likely that the sewer line was damaged by the rotation of the Millennium Tower. Here is an April 2014 on the Microsoft Map page suggesting rotation, more are found on Google Maps in Nov. 2014 & later. The curb in front of the bus stop on Fremont St was in a preliminary state of failure. Even for the curb to be in this condition in 2014 took at least a year or two for this degree of deterioration to manifest. It has progressively been snapping like a candy cane for the last 4 years. It begs the question, what do the people at the SFPUC & SFPDW know and how long have they known. Has anyone been hurt at this bus stop? Why has it gone untended for so long? The building appears to be plowing a 35 foot wall of fill and mud in front of it.

Do Figures 96 to 103 prove that the replacement of the sewer pipe under Fremont Street circa February 2015 resulted from pressure imposed by the tilting Millennium Tower, as concluded by "epoxybot" in Figure 94, dated April 2, 2018?

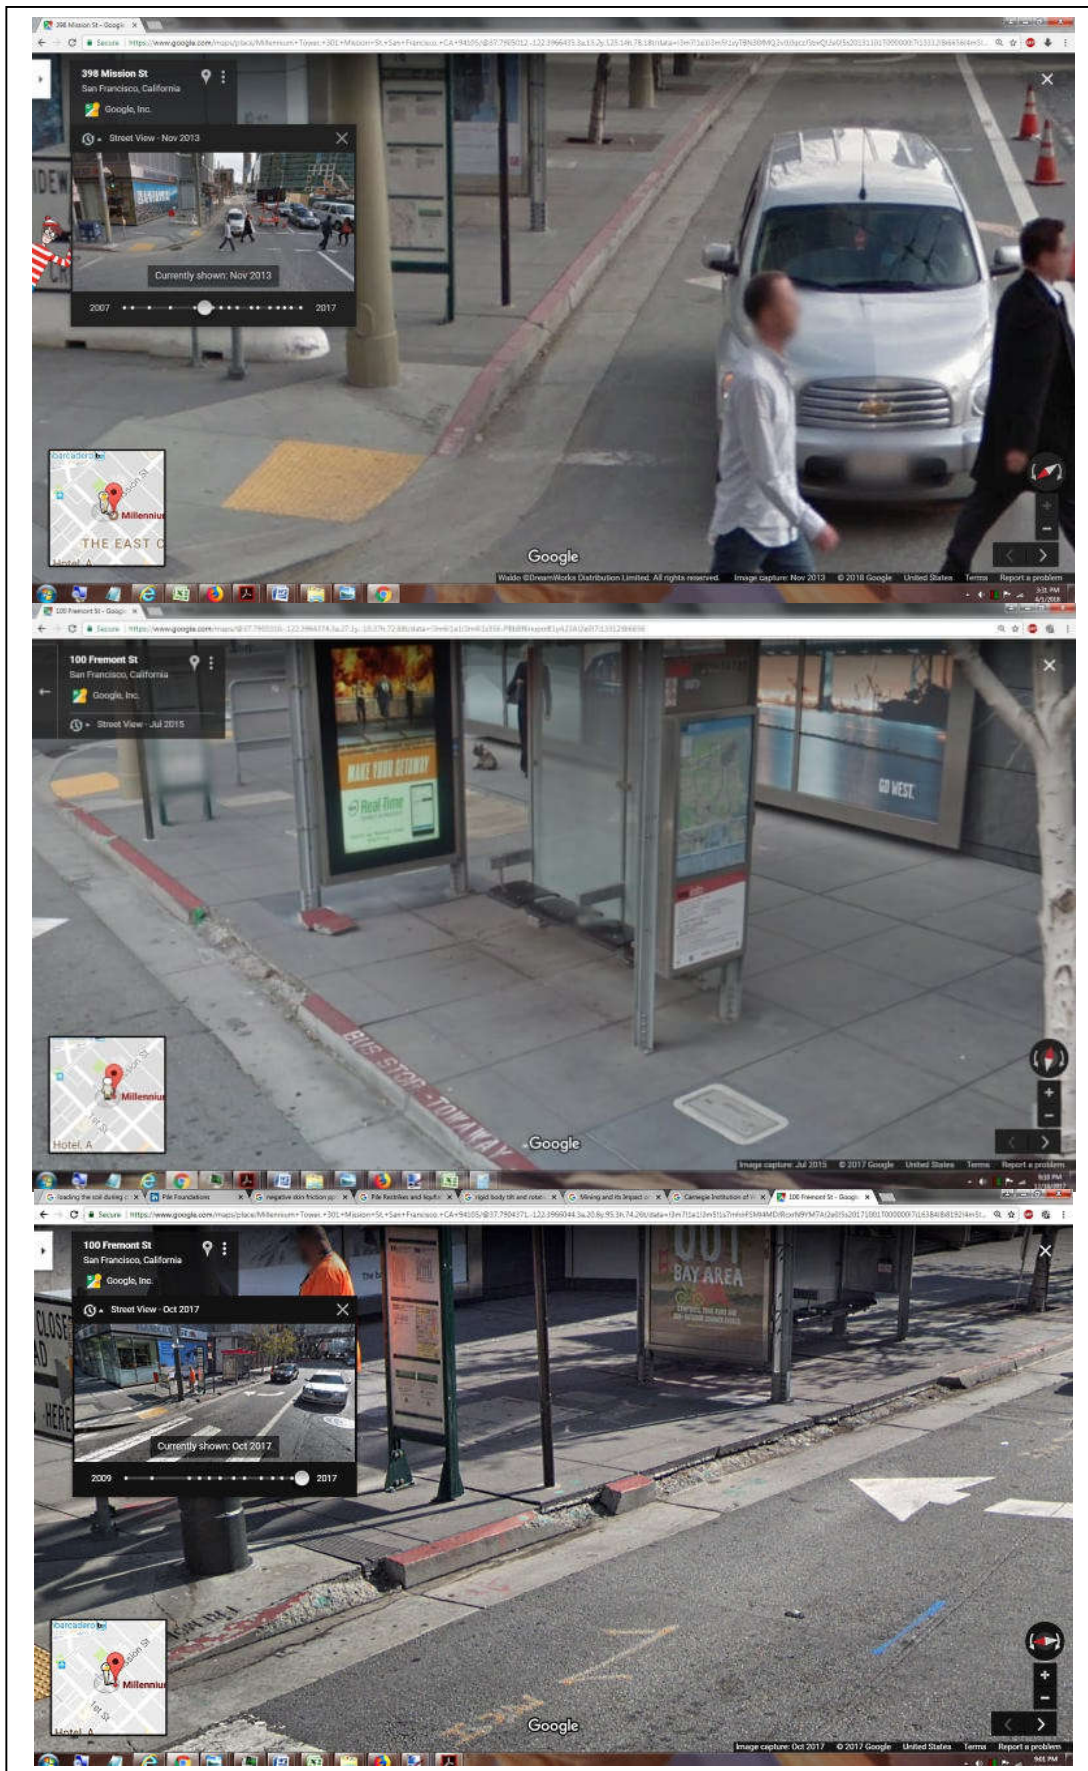
**Figure 95: Posting dated April 2, 2018,
on www.eng-tips.com by "epoxybot."**

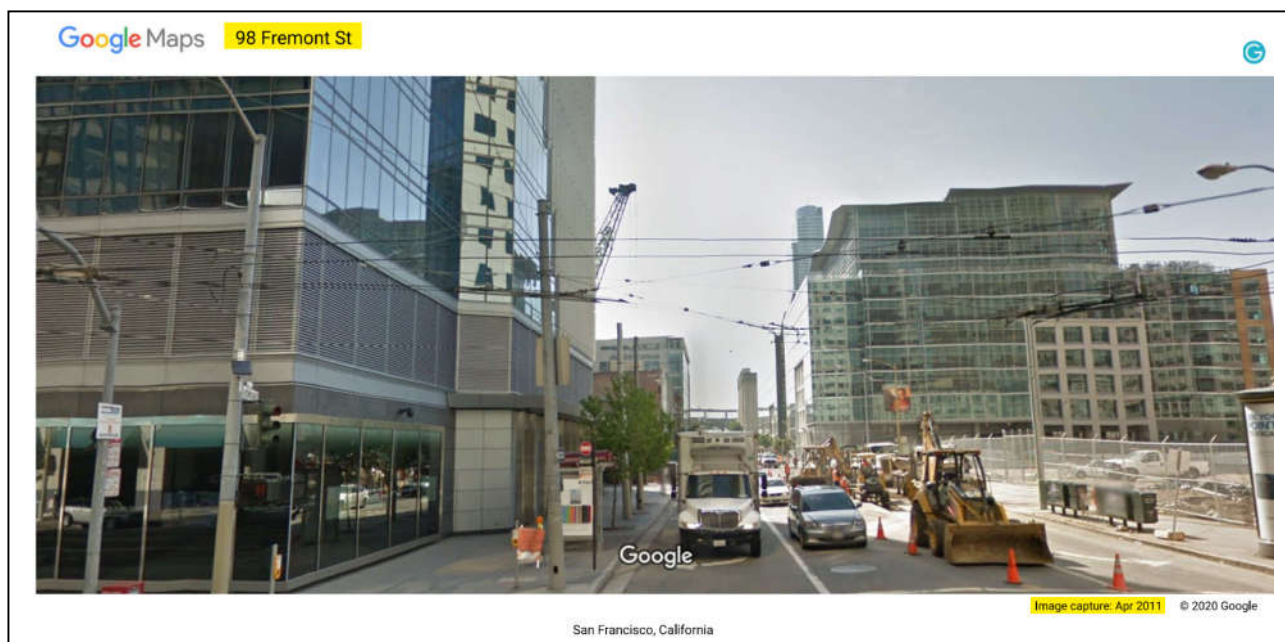
Figures 96 through 99 show that underground utility work was being performed circa April 2011 under Fremont Street, across from the Millennium Tower, as described by "epoxybot" in Figure 94.

Figure 96: Photograph of Fremont Street at Mission Street, dated April 2011; downloaded from Google Maps.

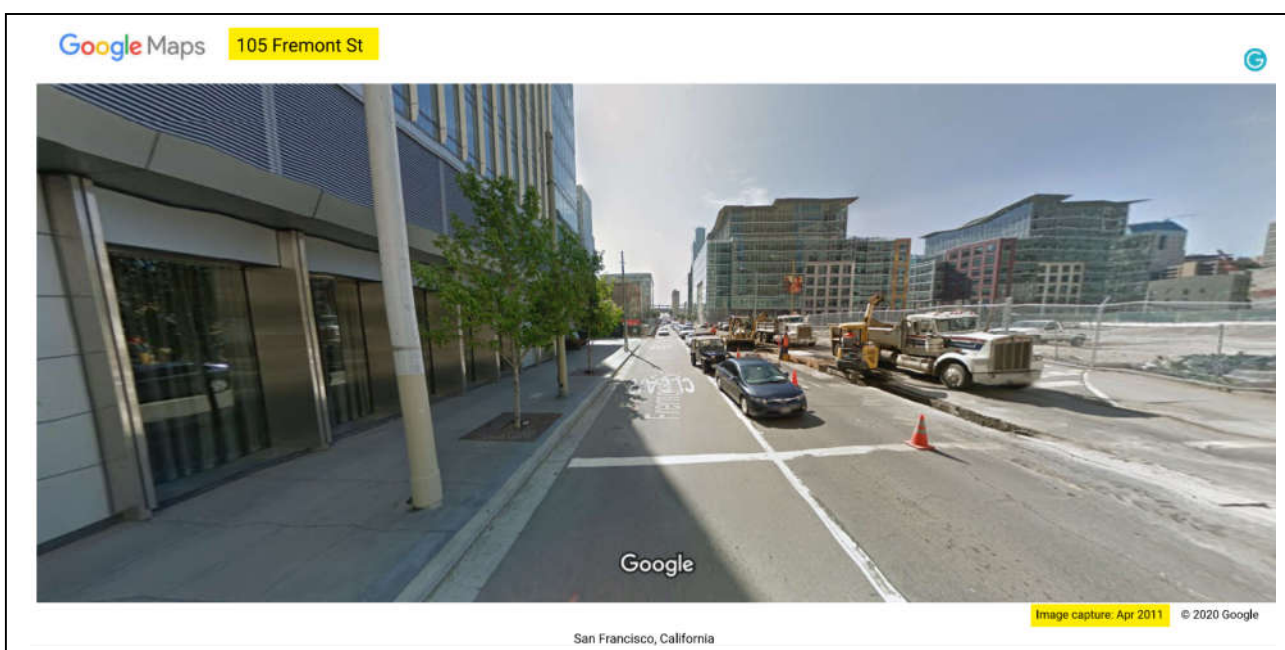
Figure 97: Photograph of underground utility work activity across from the northern end of the Millennium Tower, dated April 2011; downloaded from Google Maps.
