301 MISSION STREET SUPPLEMENT III

2-4-2021

Introduction

This report is the 19th in a series of engineering investigative reports on the conduct of the San Francisco Department of Building Inspection (DBI).

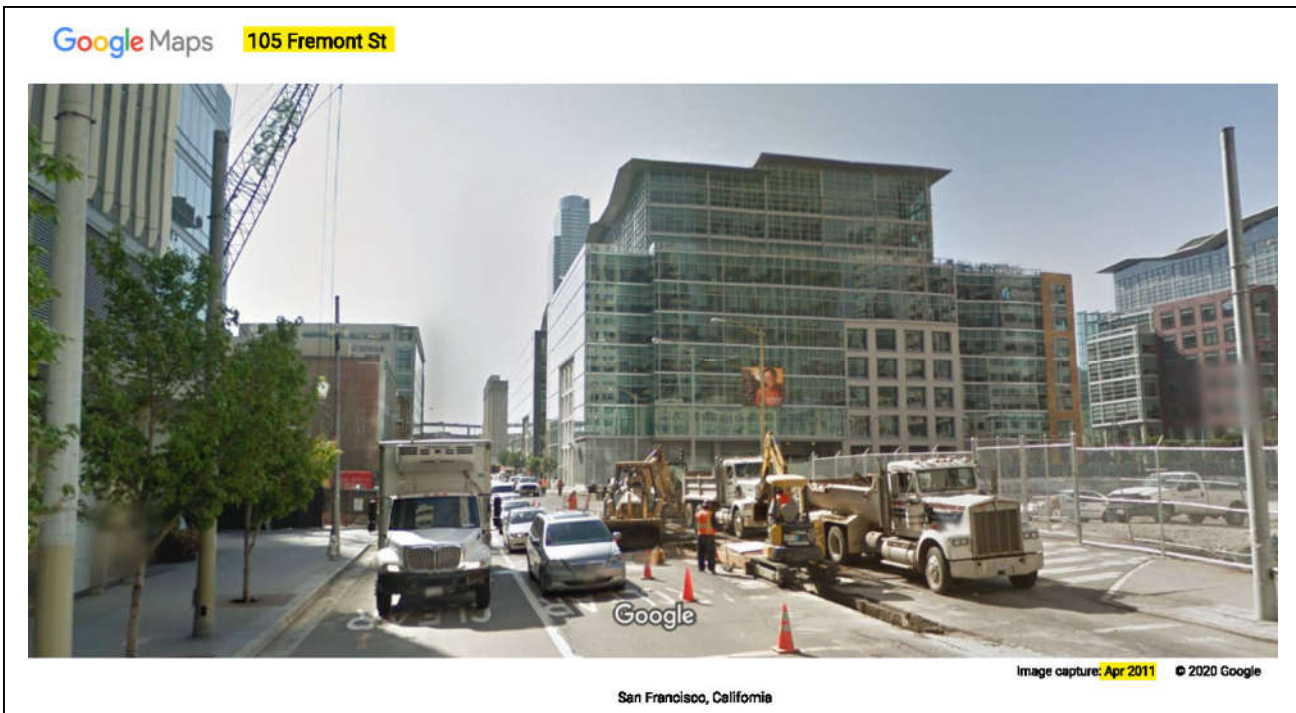
Figures 96 through 99 show that underground utility work was being performed circa April 2011 under Fremont Street, across from the Millennium Tower, as described by "epoxybot" in Figure 94.

Figure 98: Close-up photograph of underground utility work activity across from the northern end of Millennium Tower, dated April 2011; downloaded from Google Maps.

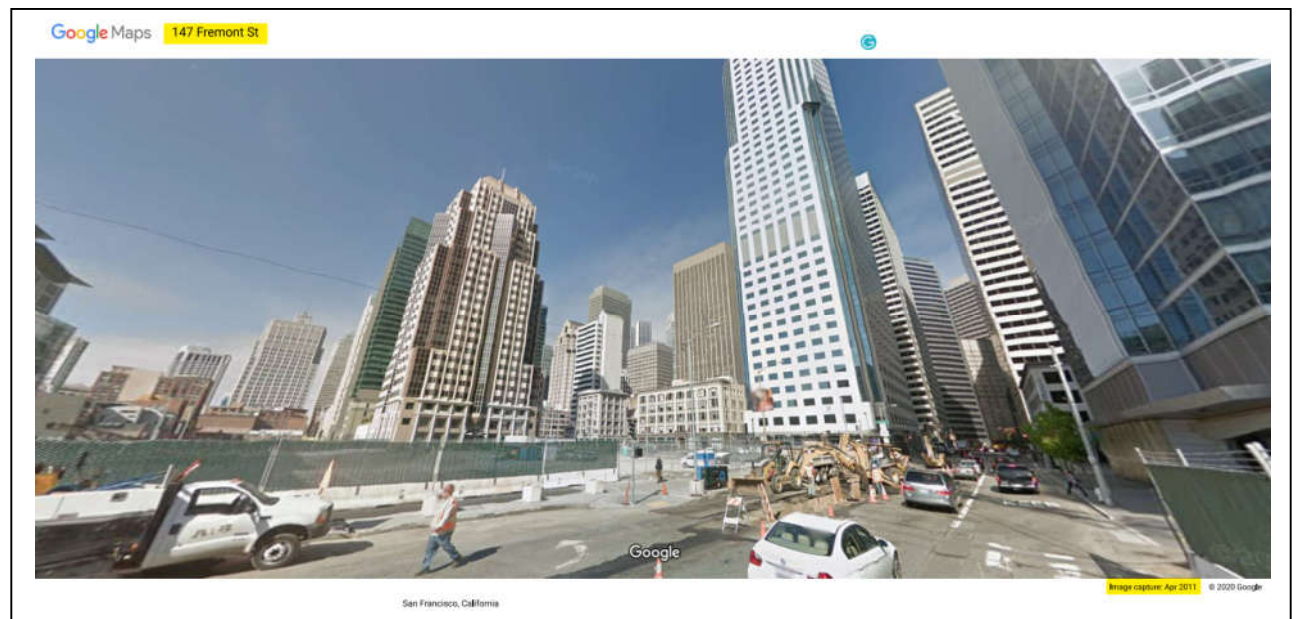
Figure 99: Photograph of underground utility work activity across from the southern end of Millennium Tower, dated April 2011; downloaded from Google Maps.

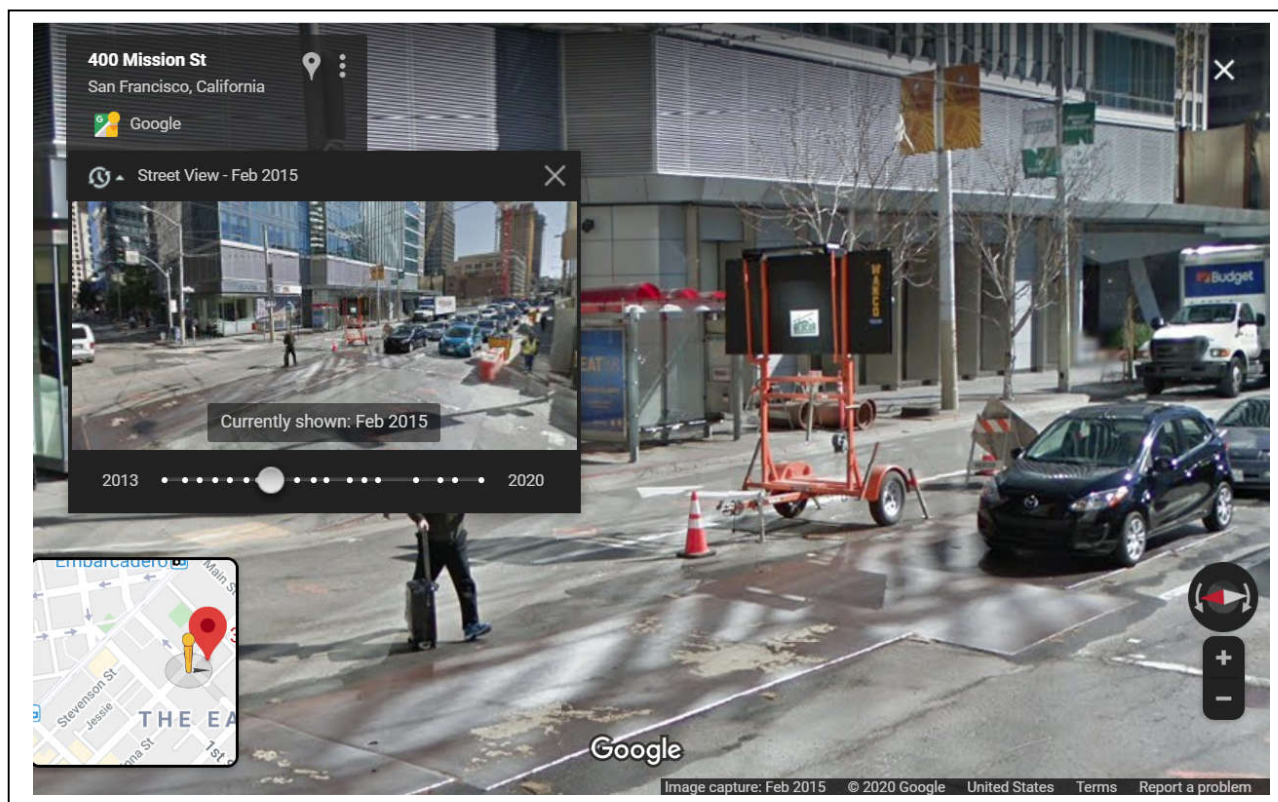
Figures 101 and 102 are images from Google Maps that show an underground sewer pipe being replaced at the northern end of the Millennium Tower circa February 2015, as described by "epoxybot" in Figure 94.

Figure 101: Photograph of sewer pipe replacement on Fremont Street, dated February 2015; downloaded from Google Maps.

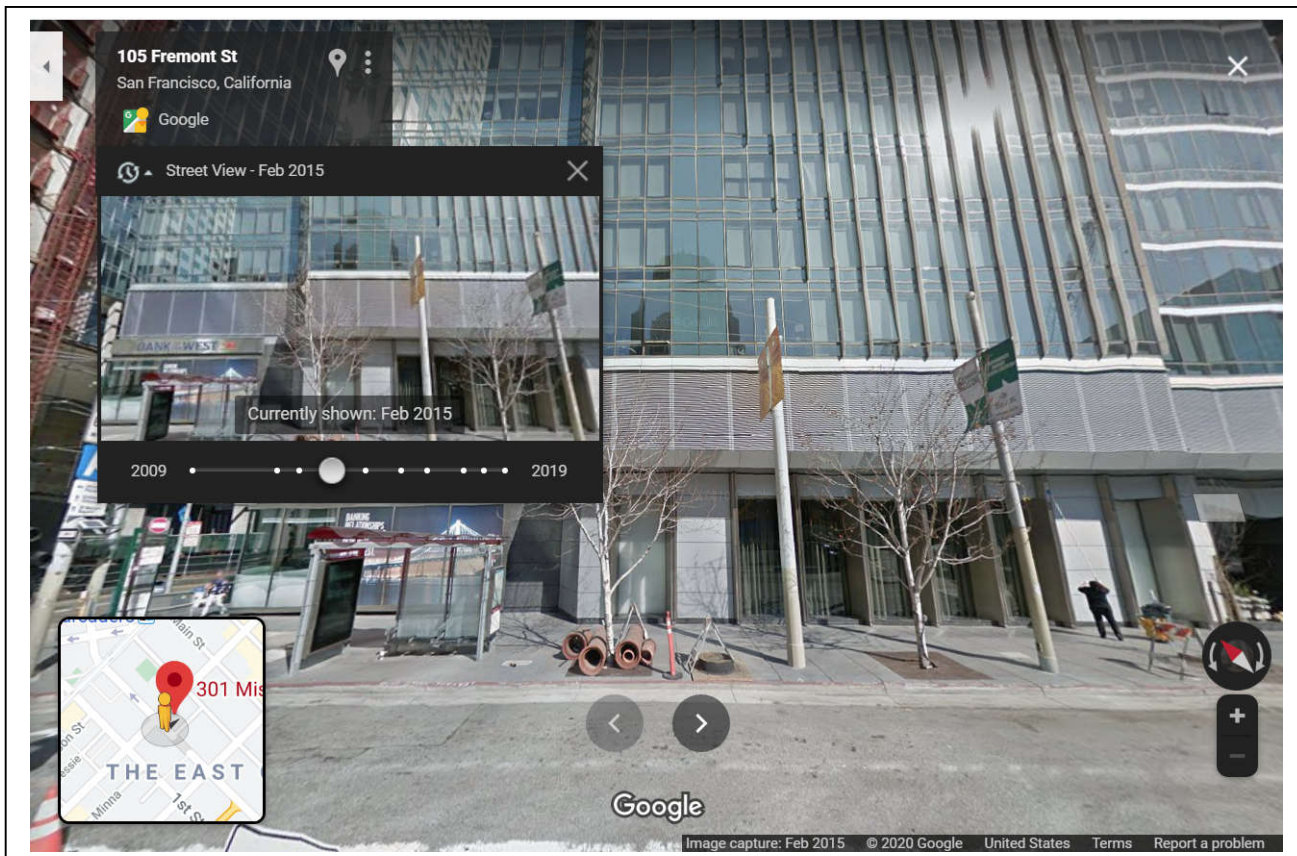
Figure 102: Photograph of new sewer pipes and manhole stored on Fremont Street sidewalk, dated February 2015; downloaded from Google Maps.

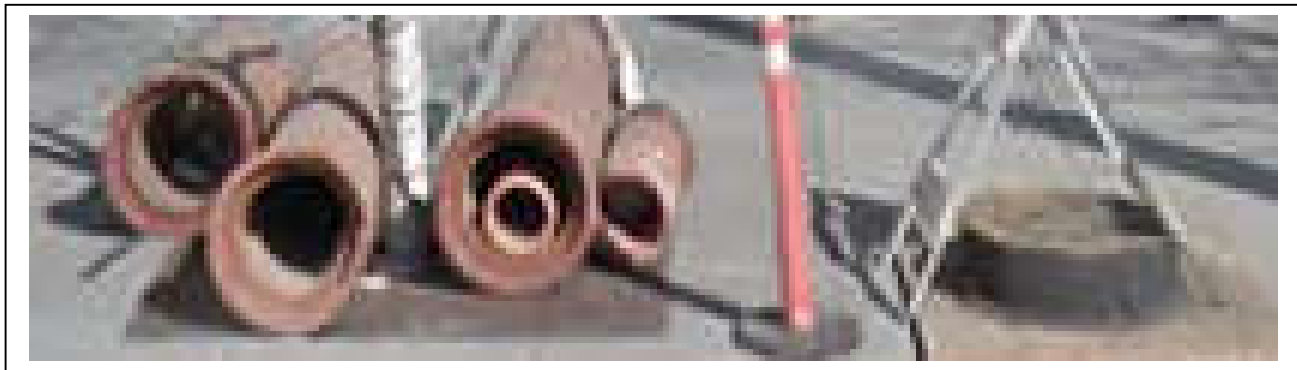
Figure 103: Close-up of Figure 102 showing new sewer pipes and manhole cover.

Do Figures 96 to 103 prove that the replacement of the sewer pipe under Fremont Street circa February 2015 resulted from pressure imposed by the tilting Millennium Tower, as concluded by "epoxybot" in Figure 94, dated April 2, 2018?

The assessment by "epoxybot" can be further verified by the San Francisco Department of Public Works requirement for pre- and post-installation video inspection of sewer pipes where temporary tiebacks are used, such as for the construction of the Millennium Tower circa 2005. Along with the mandated video inspection, the documented timing of damage to the sewer pipe under Fremont Street will provide leads as to the cause of the damage.

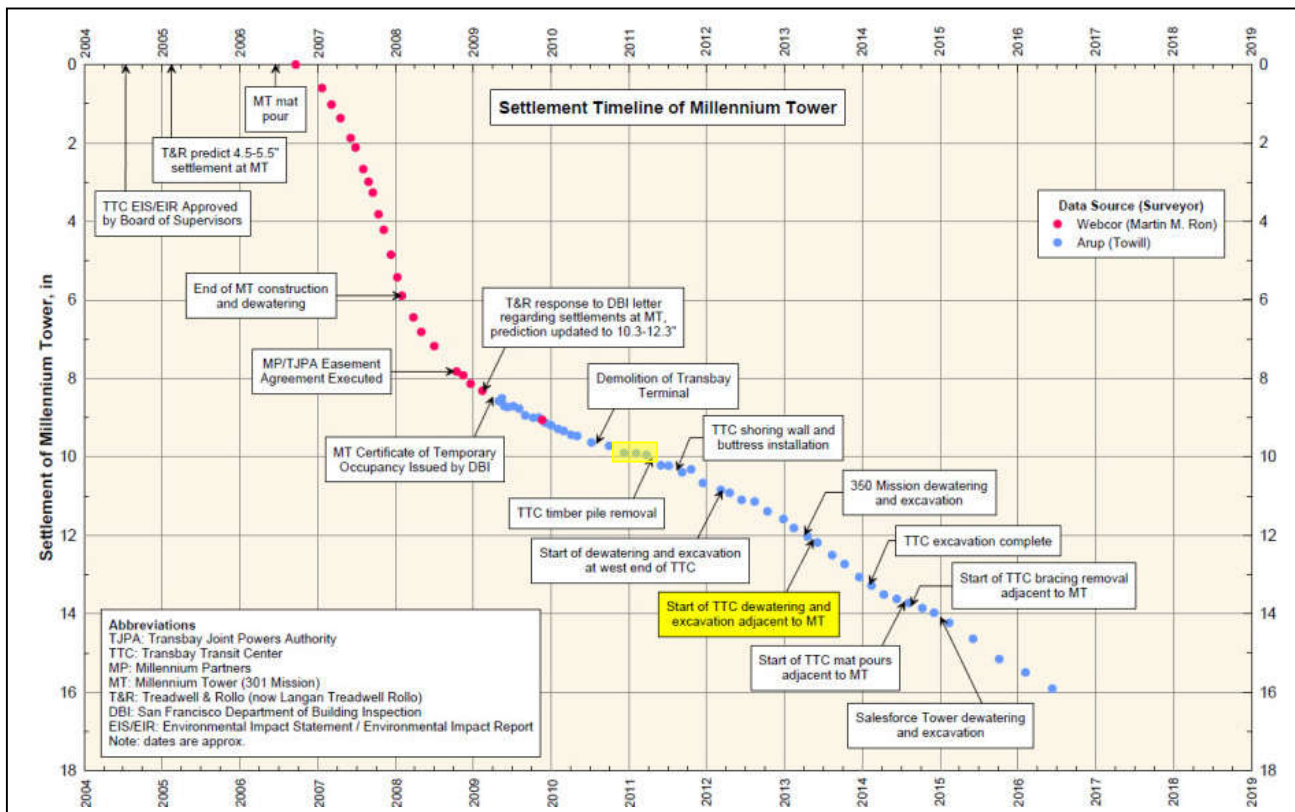
Could it be a coincidence that all these events occurred after the excavation at the Transbay Transit Center, which was completed circa 2014, as shown in Figure 107?

Figure 107: Settlement timeline of the Millennium Tower, issued by the Transbay Joint Powers Authority (TJPA).

It is important to reiterate the significance of the short period during early 2011 that is represented by the short horizontal yellow block in Figure 107. A brief but crucial discussion of the early 2011 period was presented on page 51 of the investigative report titled "Transbay Transit Center Temporary Shoring of 301 Mission Street."
