Subject: Metallurgical Evaluation of Indications on Steel Sample: [REDACTED]

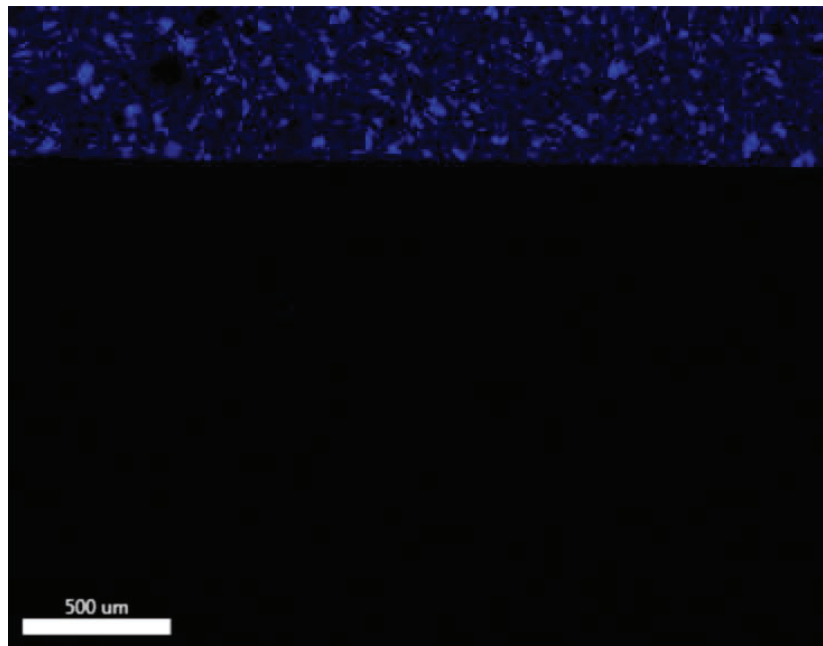
**Fig. 10** The EDS elemental map, originally shown in Figure 9, is presented to only reveal the regions where carbon was the predominant element detected.

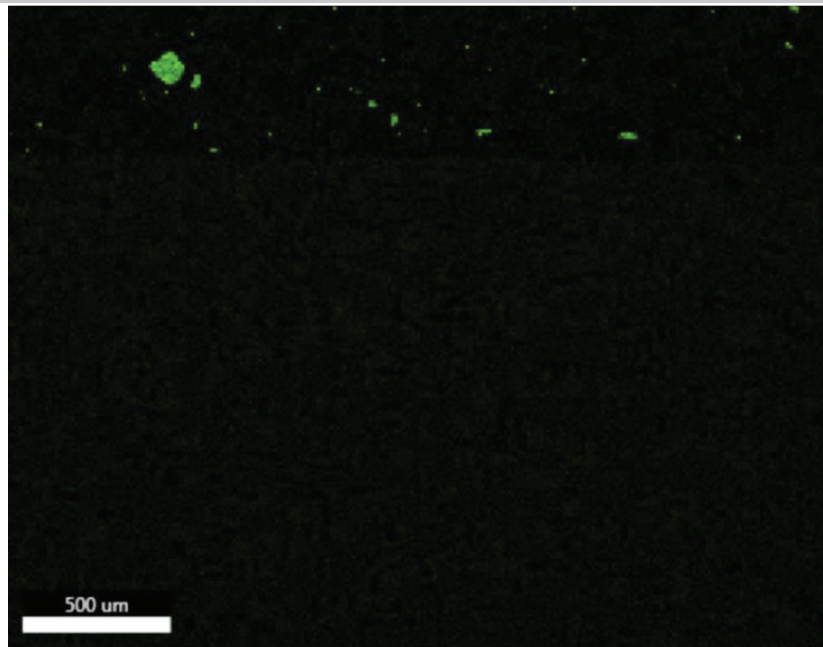
**Fig. 13** The EDS elemental map, originally shown in Figure 9, is presented to only reveal the regions where aluminum was the predominant element detected.

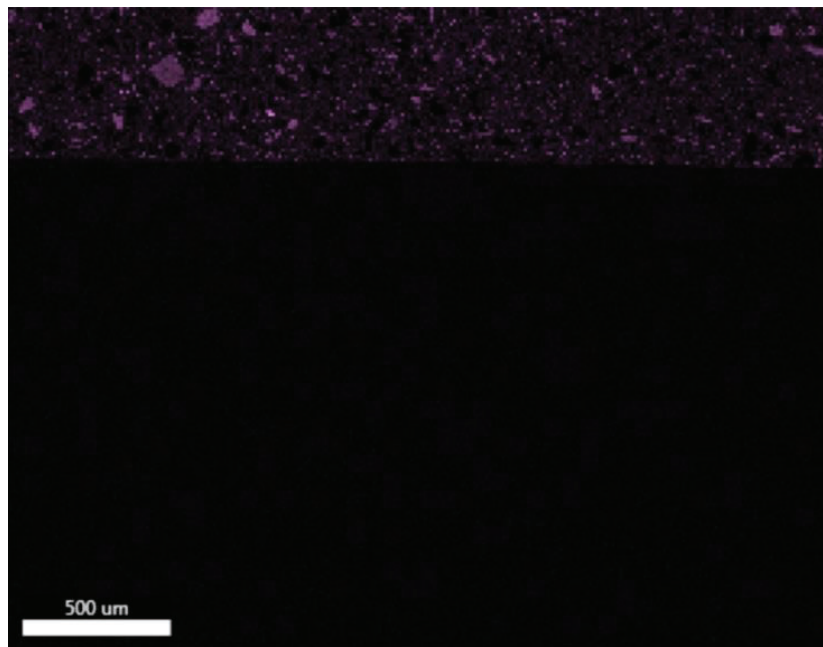
**Fig. 14** The EDS elemental map, originally shown in Figure 9, is presented to only reveal the regions where silicon was the predominant element detected.

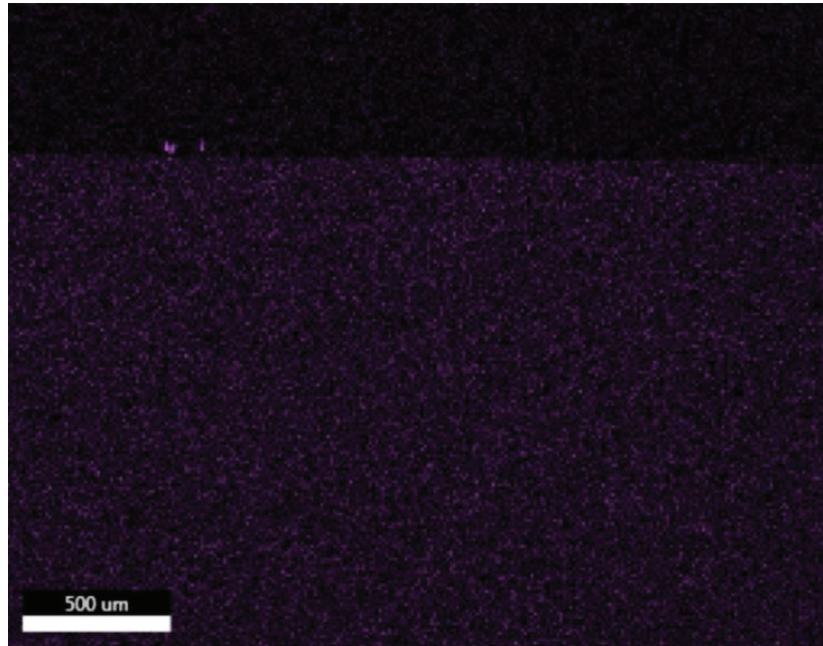
**Fig. 15** The EDS elemental map, originally shown in Figure 9, is presented to only reveal the regions where sulfur was the predominant element detected.

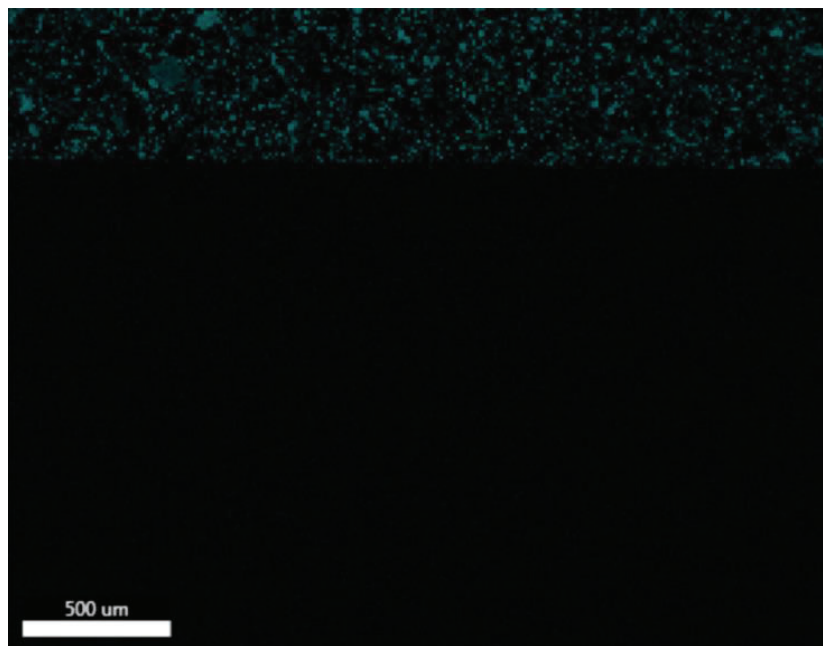
**Fig. 16** The EDS elemental map, originally shown in Figure 9, is presented to only reveal the regions where calcium was the predominant element detected.

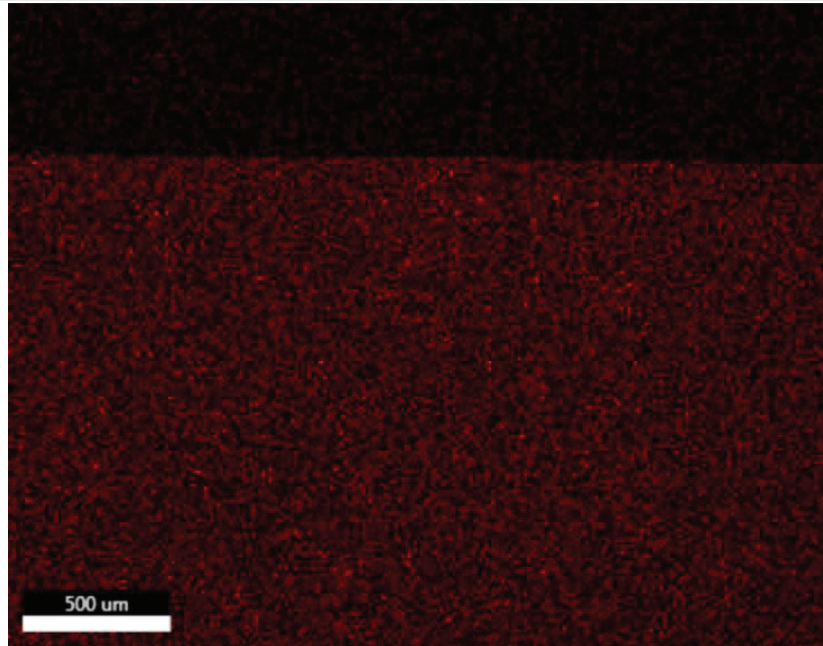
**Fig. 17** The EDS elemental map, originally shown in Figure 9, is presented to only reveal the regions where chromium was the predominant element detected.

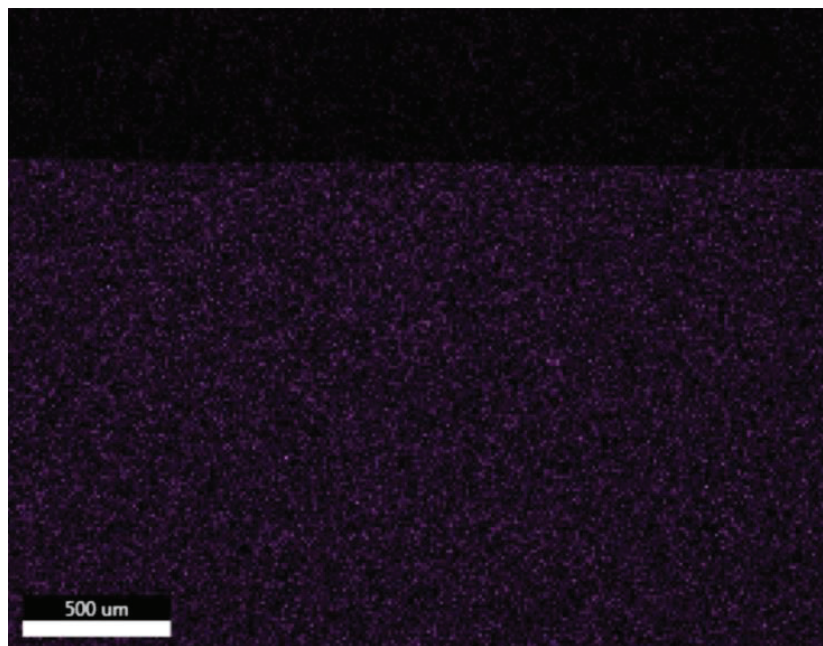
**Fig. 18** The EDS elemental map, originally shown in Figure 9, is presented to only reveal the regions where manganese was the predominant element detected.

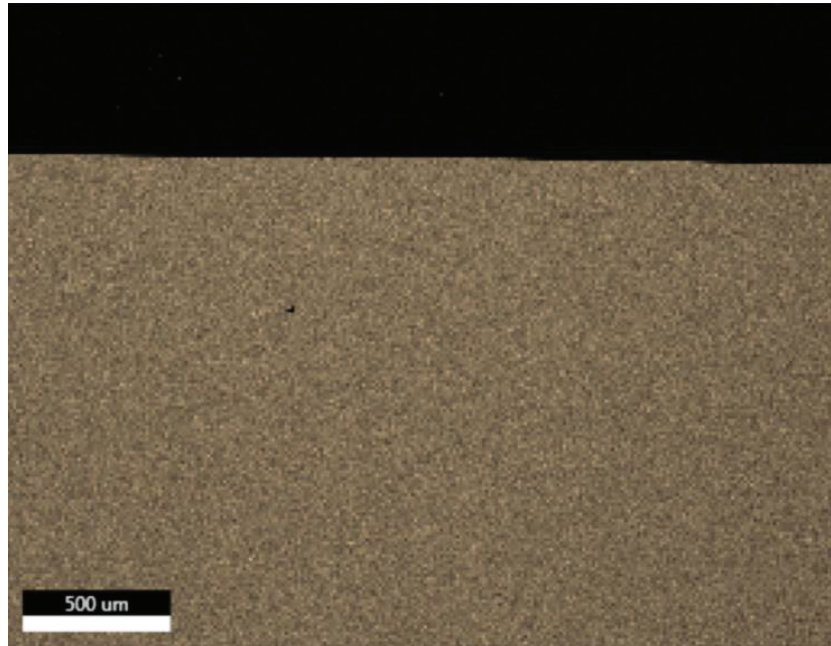
**Fig. 19** The EDS elemental map, originally shown in Figure 9, is presented to only reveal the regions where iron was the predominant element detected.

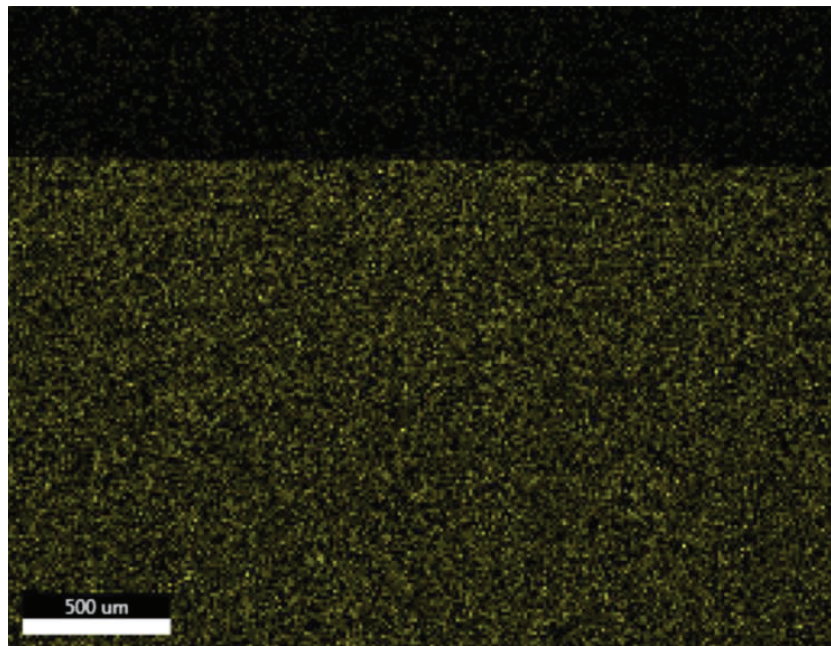
**Fig. 20** The EDS elemental map, originally shown in Figure 9, is presented to only reveal the regions where nickel was the predominant element detected.
