NBSIR 81-2374

# Investigation of Construction Failure of Harbour Cay Condominium in Cocoa Beach, Florida

September 1981

H. W. Lew  
N. J. Carino  
S. G. Fattal  
M. E. Batts

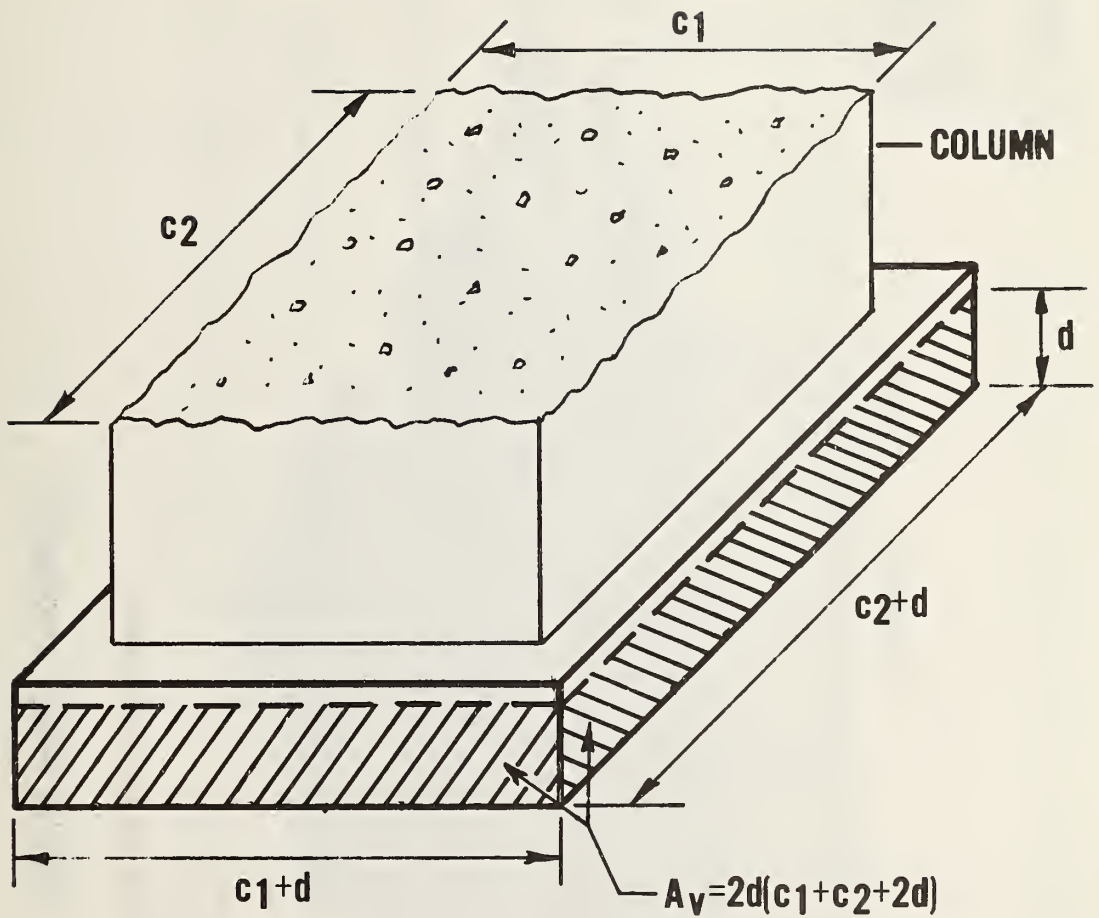
Figure 2.6 Area of critical section for punching shear

The importance placed on actual chair heights and their location is due to the fact that the effective depth of the slab is a critical parameter governing its punching shear and bending capacity. Figure 2.6 defines the critical shear area used in calculations of punching shear stresses in the slab at the periphery of a column. The punching shear area depends on the sectional dimensions  $c_1$  and  $c_2$  of the column and the effective depth,  $d$ , which appears in all three dimensions defining this area.

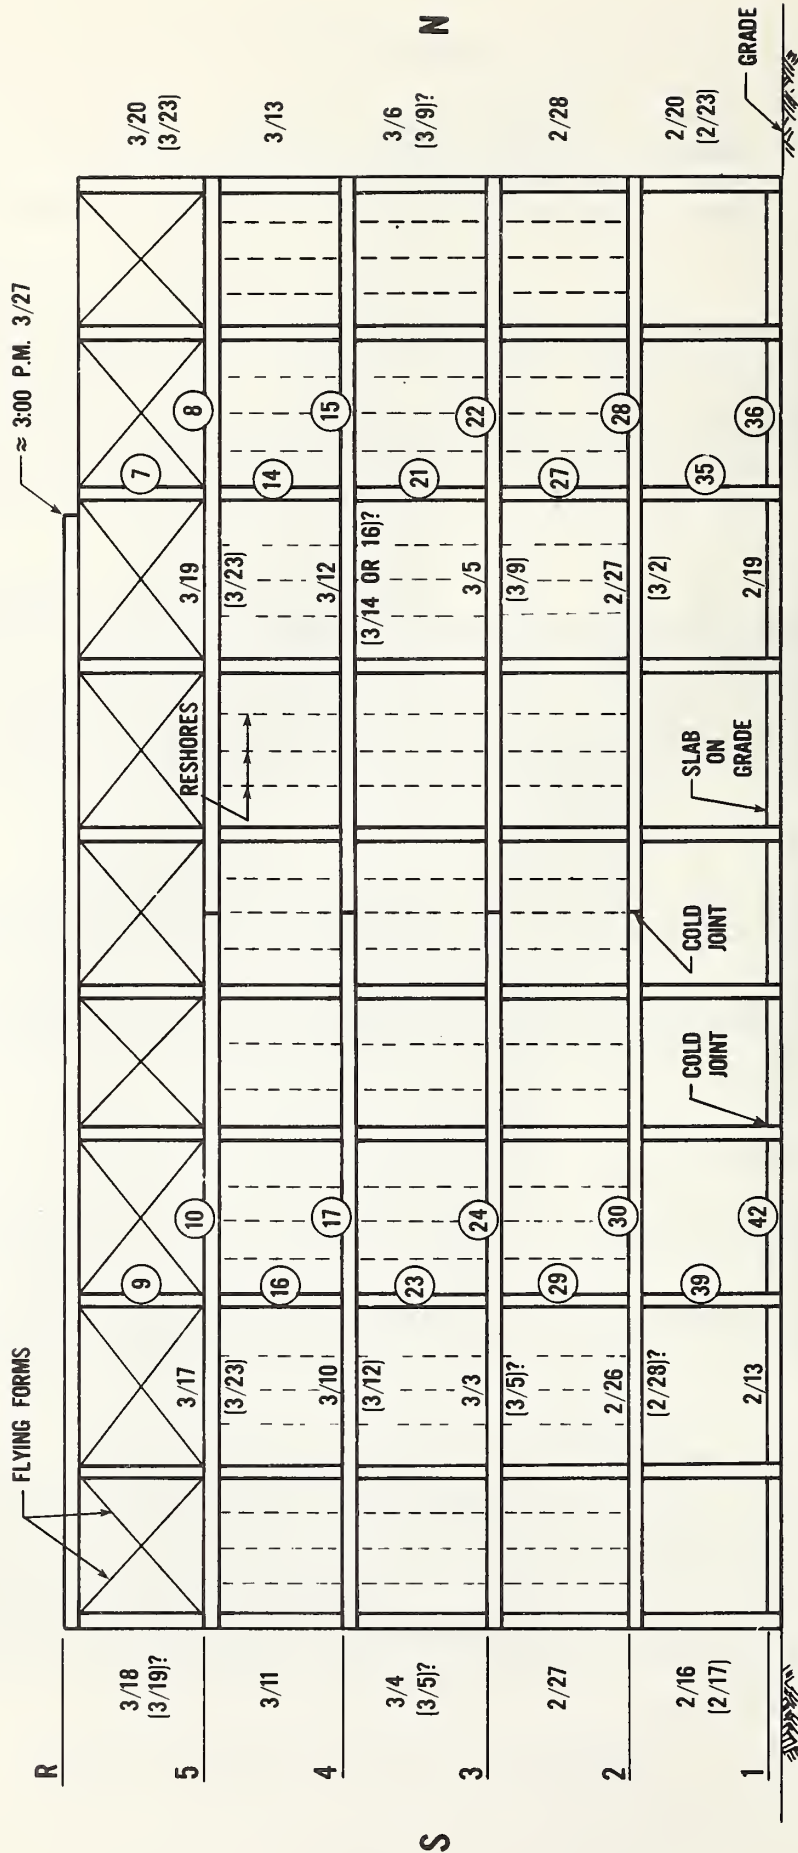
Figure 2.11 Assumed state of construction at time of the collapse

Figure 2.11 shows the various casting and stripping dates and the ages of the columns and floor slabs relative to the time of the collapse. In the case of incomplete information or conflicting witness statements regarding the date of a particular event, a question mark appears next to the specified date in the figure. Note that, unlike the lower story slabs, the roof slab was scheduled to be cast in one day. At the time of the collapse, all but the two north bays of the roof slab had been cast.

Figure 2.11 shows full reshores in the second through fourth stories. A fully reshored story conforms with the reshoring layout shown in figure 2.9. There is sufficient indication from worker statements to assume that the fourth story was fully reshored at the time of the collapse. Likewise, it is known that there were no reshores in the first story with the exception of some peripheral reshores under the balconies and walkways (see sec. 3.3 and fig. 2.11). Although there is a question as to when the first story reshores were removed, they would have been recovered for reuse when the fourth story forms were flown. Note that the removal of reshores from the first story marks the first time when the forces in the total shoring system will no longer have a direct path independent of the columns to the foundation (slab on grade, in this case).

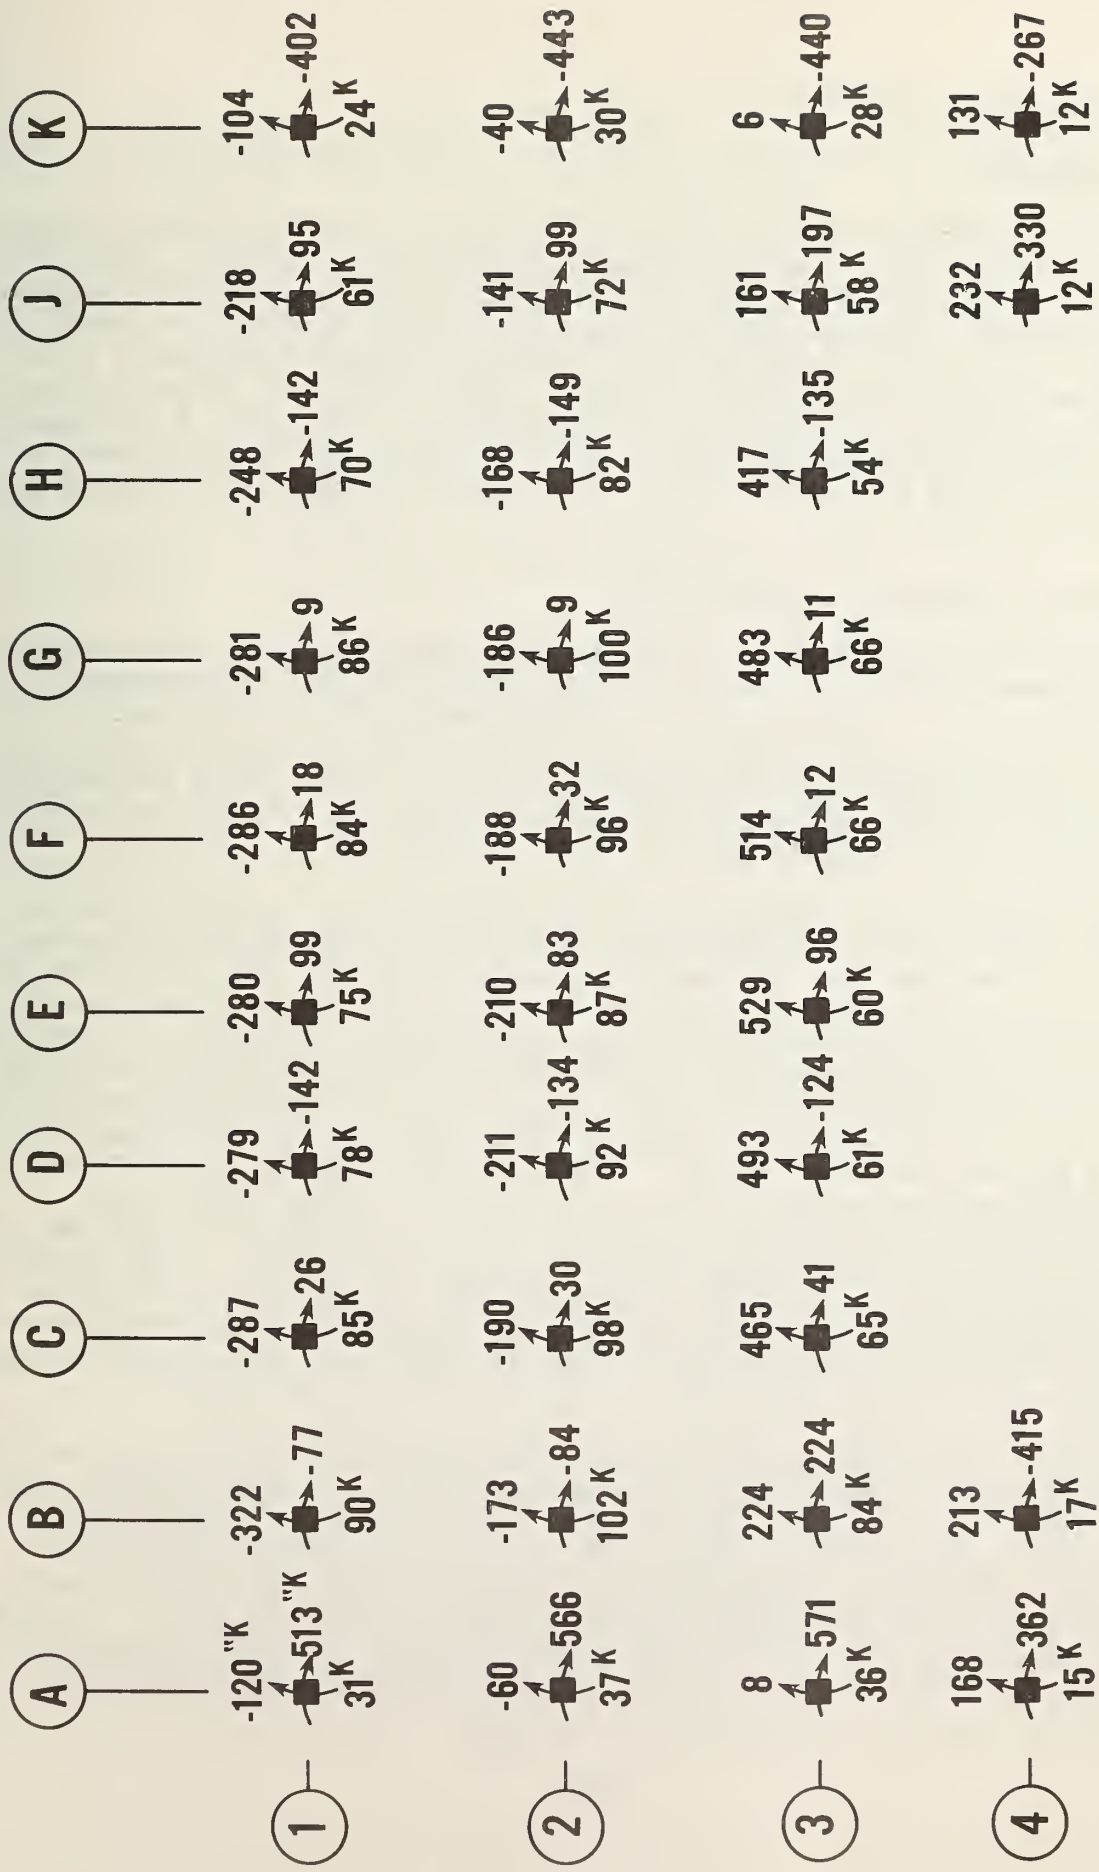
Figure 5.13 Fifth floor punching shear and column moments

To verify that such a failure had occurred, punching shear stresses resulting from direct shear forces and unbalanced moments were computed at slab-column connections using the shear and moment values for construction loads given in figure 5.13. These shear stress values were compared with the shear capacity of the slab based on the predicted in-place strength of concrete at the time of collapse. Because the punching shear stress values are maximum at the fifth floor level (see figures 5.12 and 5.13), the shear stresses are evaluated only for this level. The guidelines given in the ACI Code [2.1] are followed in computing the punching shear stress. Figure 6.1(a) shows the critical section in the slab around an interior column. The critical section where shear stresses are evaluated is taken perpendicular to the plane of the slab and a distance a half of the effective depth away from the periphery of the column. The assumed distribution of shear stresses at the critical section is shown in figure 6.1(b). The critical sections for edge and corner columns and corresponding assumed shear stress distributions at these critical sections are shown in figure 6.2(a) and (b) and figure 6.3(a) and (b), respectively.
