"Full" Reserve Study

Champlain Towers South Condominium Association, Inc. Surfside, FL

Report #: 38941-0
For Period Beginning: January 1, 2021
Expires: December 31, 2021

Date Prepared: March 20, 2020

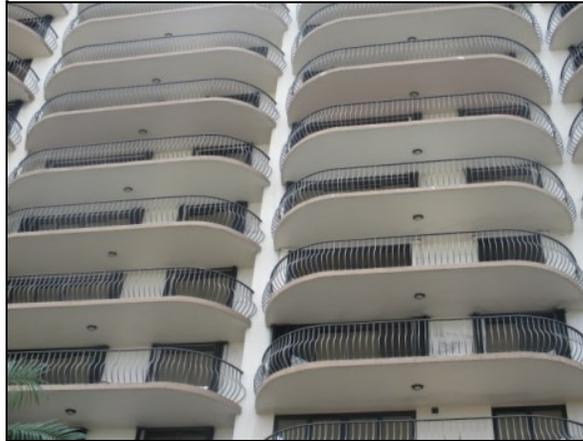
Comments: Approximately 11,700 LF of sealants noted at windows and door frames. Per information provided, concrete restoration project (see component #2341) will include painting of all exteriors. Based on this information, we have reset the remaining useful life.

There are two important reasons for painting and waterproofing a building: to protect the structure from damage caused by exposure to the elements, and to restore or maintain good aesthetic standards for curb appeal. As routine maintenance, we recommend that regular inspections, spot repairs and touch-up painting be included in the operating budget. Typical paint cycles can vary greatly depending upon many factors including; type of material painted, surface preparations, quality of material, application methods, weather conditions during application, moisture beneath paint, and exposure to weather conditions. Proper sealant/caulking at window and door perimeters and other "gaps" in the building structure are critical to preventing water intrusion and resulting damage. The general rule of thumb is that sealant/caulking should be in place wherever two dissimilar building material surfaces meet, such as window frame to concrete structure junctions. For best results, the client may want to consult with a paint company representative, building envelope specialist and/or structural engineer to specify the types of materials to be used and define complete scope of work before bidding. In our experience, cost estimates for painting and waterproofing can vary widely, even when based on the same prescribed scope of work. Estimates shown here should be updated and revised as needed based on actual bids obtained or project cost history during future Reserve Study updates.

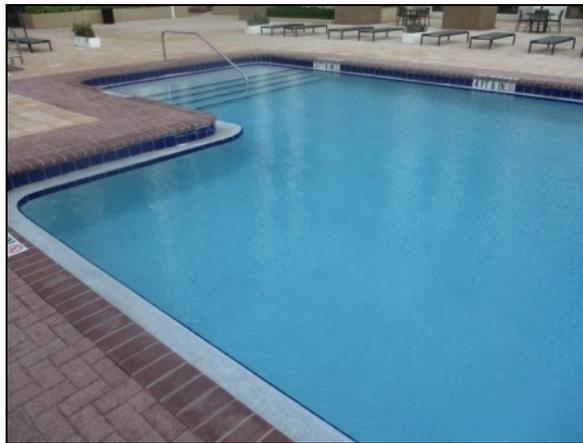
Fair condition: Swimming pools determined to be in fair condition typically exhibit some color fade/discoloration, and roughening of the surface, often more noticeable in the shallow areas and/or at steps. Waterline tiles are in fair condition. Generally believed to be aging normally.

Pool resurfacing will restore the aesthetic quality of the pool while protecting the actual concrete shell of the pool from deterioration. While drained for resurfacing, any other repairs to lighting, handrails, stairs, ladders, etc. should be conducted as needed. This type of project is best suited for slow/offseason to minimize downtime during periods when pool is used heavily. Should be expected at the approximate interval shown below; in some cases, schedule may need to be accelerated due to improper chemical balances or aesthetic preferences of the Client.

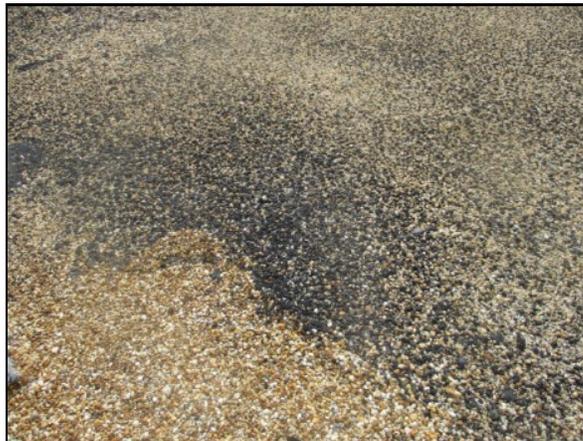
Comp #: 2380 Roofing (Coal Tar Pitch) - Replace

Comments: Per engineering report provided by management, roof was reportedly surveyed and appeared to be in satisfactory condition. It was reported that no active/present leaks were known to exist. However, it was mentioned that minor cracking was evident at the parapet walls and some minor spalling at the stair tower walls. It is recommended that all identified cracking should be routed and sealed with a urethane sealant, and repair spalls accordingly. It was also recommended that all mechanical equipment support steel be cleaned and coated with a zinc-rich galvanizing paint.

Poor condition: Coal tar pitch roofs determined to be in poor condition typically exhibit many areas of exposed tar membrane or signs of persistent standing water. Replacement timeline is often dictated by age of the roof, and may take into account other information provided during site inspection, such as any history or pattern of significant leaks or other problems.

As of recent years, coal tar pitch roofs have been installed less frequently, but are traditionally known to be heavy-duty, long-lasting roofs. Unless otherwise noted, costs for replacement shown here are based on replacement with a conventional modified bitumen roof system. Our inspection is limited to a visual evaluation of accessible areas and is not a substitute for a comprehensive inspection including destructive testing, sub-surface moisture evaluation, core sampling, etc. As routine maintenance, many manufacturers recommend professional inspections at least twice annually and after storms. Promptly repair any damaged sections or any other repairs needed to ensure waterproof integrity of roof. Keep scuppers, drains, gutters, and downspouts clear and free of debris to allow proper drainage and prevent the ponding of water on the roof surface. We recommend using walk pads or extra roofing material to provide pathways in high-traffic areas, such as around HVAC units or other equipment. Take care to minimize any penetrations in the roof system, and to properly waterproof and all drains, vent pipes, conduit penetrations, etc. For more information, we recommend consulting with independent roofing consultants or with organizations such as the Roof Consultant Institute <http://www.rci-online.org/> and the National Roofing Contractors Association (NRCA) <http://www.nrca.net/>. If the roof has a warranty, be sure to review terms and conduct proper inspections/repairs as needed to keep warranty in force.

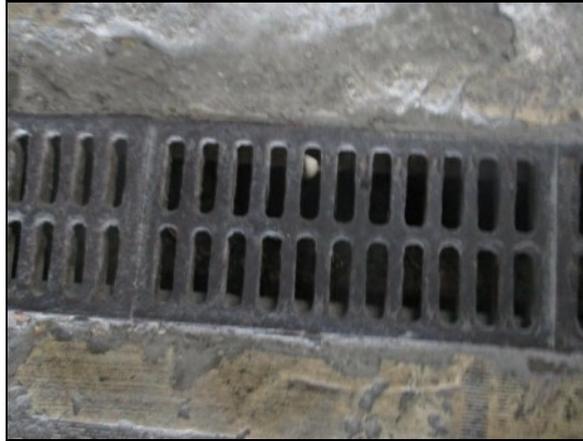
Comp #: 2113 Site Drainage System - Clean/Repair

Comments: No access to inspect in-ground drainage infrastructure. Annual preventive maintenance work is typically performed as part of a Client's general maintenance/operating fund. Under normal circumstances, site drainage components are constructed of very durable materials which should have a very long useful life (often assumed to be 50 years or more). Repairs may occasionally be required, but timing and scope of work is too unpredictable for Reserve funding in accordance with National Reserve Study Standards. If there are specific, known concerns with drainage system, we recommend further investigation using cameras or other means to document and identify conditions. Some clients consult with civil and/or geotechnical engineers in order to develop scopes of work for repair/replacement. If more comprehensive analysis becomes available, findings should be incorporated into Reserve Study updates as appropriate.

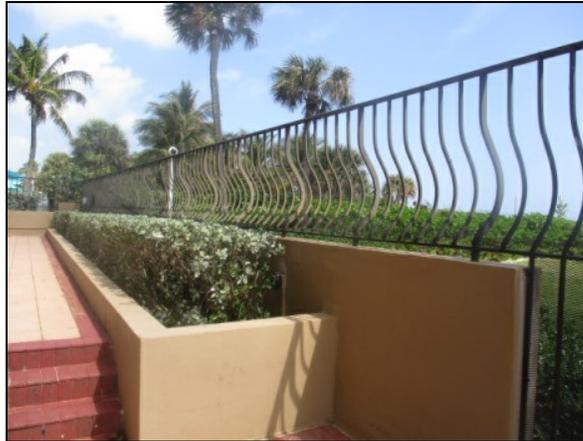
Comp #: 2137 Site Fencing (Metal) - Replace

Comments: Mix of 4' & 5' metal fencing, noted in fair condition. Metal fencing determined to be in fair condition typically exhibits some minor to moderate amounts of surface wear and other signs of age, which may include corrosion, loose or unstable pieces/sections or hardware, and/or overgrowth by surrounding vegetation. Overall, appears to be in serviceable but declining condition.

In our experience, metal fencing will typically eventually break down due to a combination of sun and weather exposure, which is sometimes exacerbated by other factors such as irrigation overspray, abuse and lack of preventive maintenance. For some types of fencing, complete replacement is advisable over minor repairs paired with recoating or refinishing due to relatively short lifespan of coatings and consideration of total life-cycle cost.

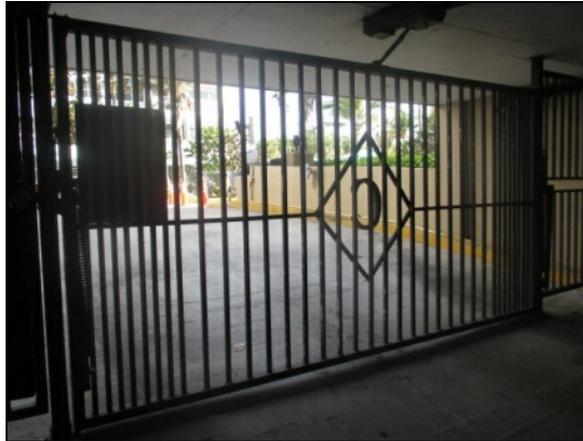
Comp #: 2144 Garage Gate - Replace

Comments: Approximately 12' x 8' tall, noted in poor condition. Gate(s) determined to be in poor condition typically exhibit more advanced surface wear/corrosion/rust and may have damage to frame/structural supports. Gate(s) may show excessive wear due to exposure and may have sustained vehicle damage. If structural/physical condition is still fair, some gates in poor condition should still require replacement primarily for aesthetic reasons.
