NUREG-1275  
Vol. 11

# Operating Experience Feedback Report—Turbine-Generator Overspeed Protection Systems

Commercial Power Reactors *~*

**U.S. Nuclear Regulatory Commission**

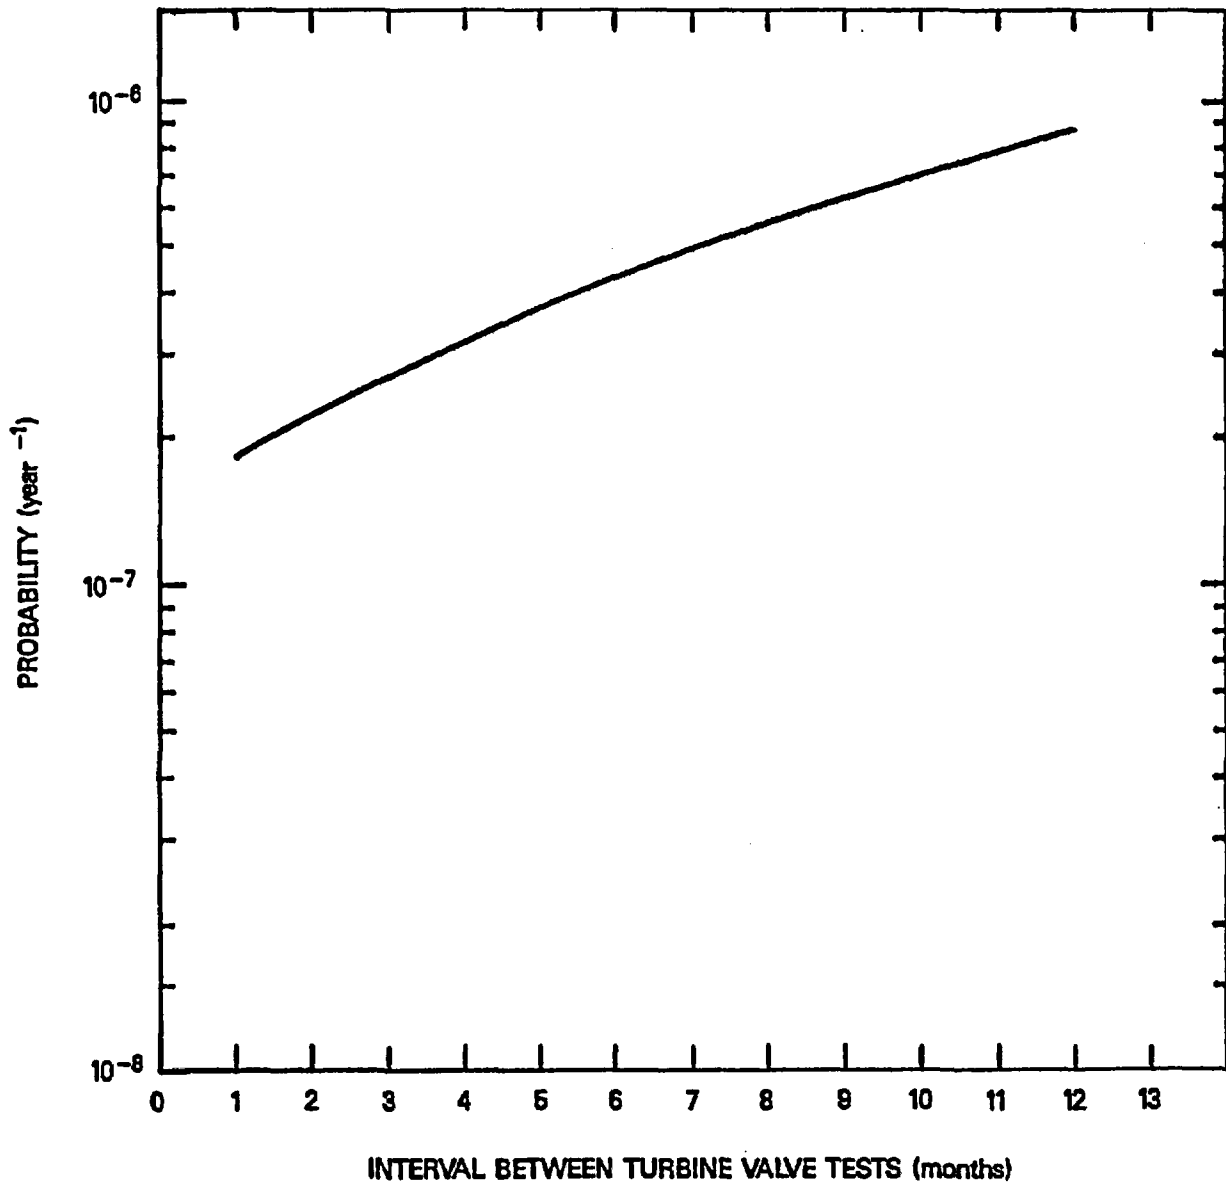
**Figure 1** W-estimated probability of missile ejection from Salem Unit 2 turbine as a function of valve test interval (reproduced with permission from Westinghouse Electric Corporation)

For Salem Unit 2 (assuming monthly valve exercise tests as presented in WCAP-11525 and shown in Figure 1 of this report), W estimated the probability of a missile ejection to be about  $2 \times 10^{-7}$  per year. The point estimate for a missile ejection from a W turbine at a U.S. nuclear plant is  $1.25 \times 10^{-3}$  per year (with a 90 percent confidence interval having a  $5.9 \times 10^{-3}$  upper bound and a  $6.4 \times 10^{-5}$  lower bound). The estimate is based on the Salem Unit 2 overspeed event with an experience base of about 800 turbine years at U.S. nuclear plants with W turbines. Thus the WCAP-11525 estimate is lower by a factor of about  $6 \times 10^3$  (it is 1/300th of the 90 percent confidence interval lower bound).

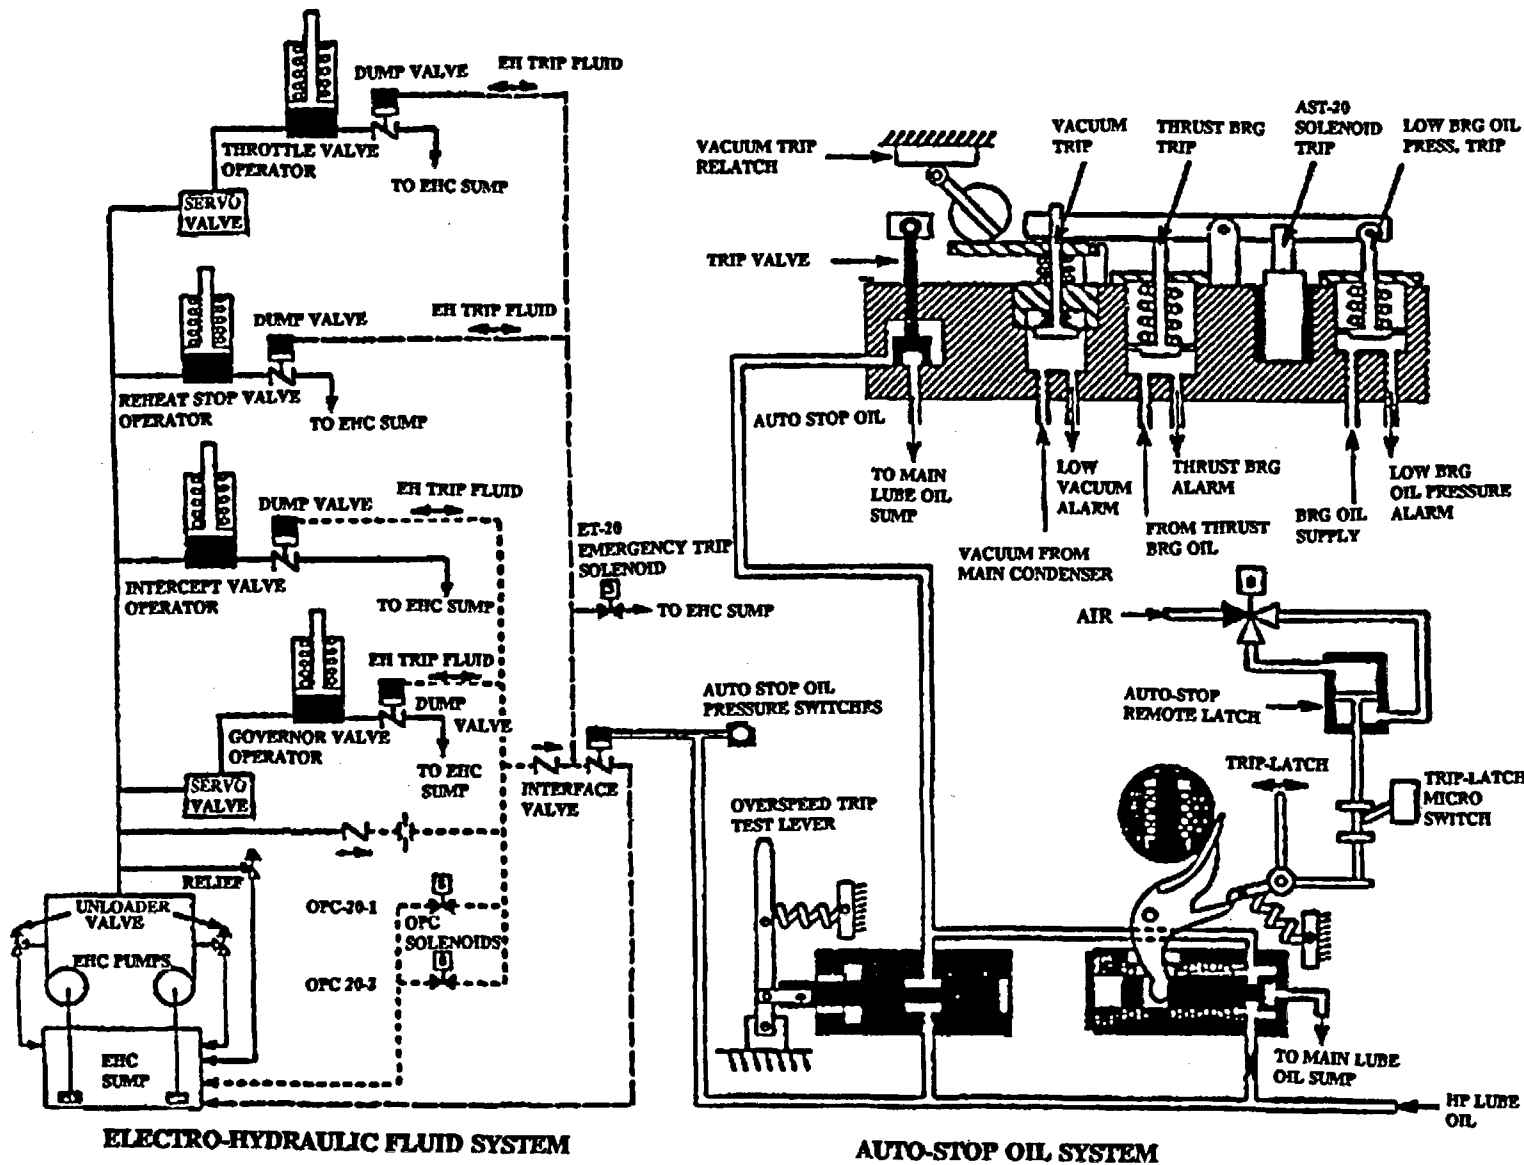
On November 9, 1991, the licensee had just successfully completed testing the mechanical protective devices when a momentary (1.5 second) drop in the AST system pressure occurred. The low AST system pressure caused the interface valve to open and relieve the electrohydraulic fluid pressure (see Figure 2). This fluid pressure drop was interpreted by the RPS as a turbine trip signal and generated a reactor scram, signaling the turbine stop valves (TSVs), governor valves, reheat stop valves, and intercept valves to close. The RPS signaled the EHC system to trip the emergency trip SOV, ET-20. However, ET-20 failed to respond to the demand signal.

Figure 2 Schematic of Salem turbine control system prior to November 1991

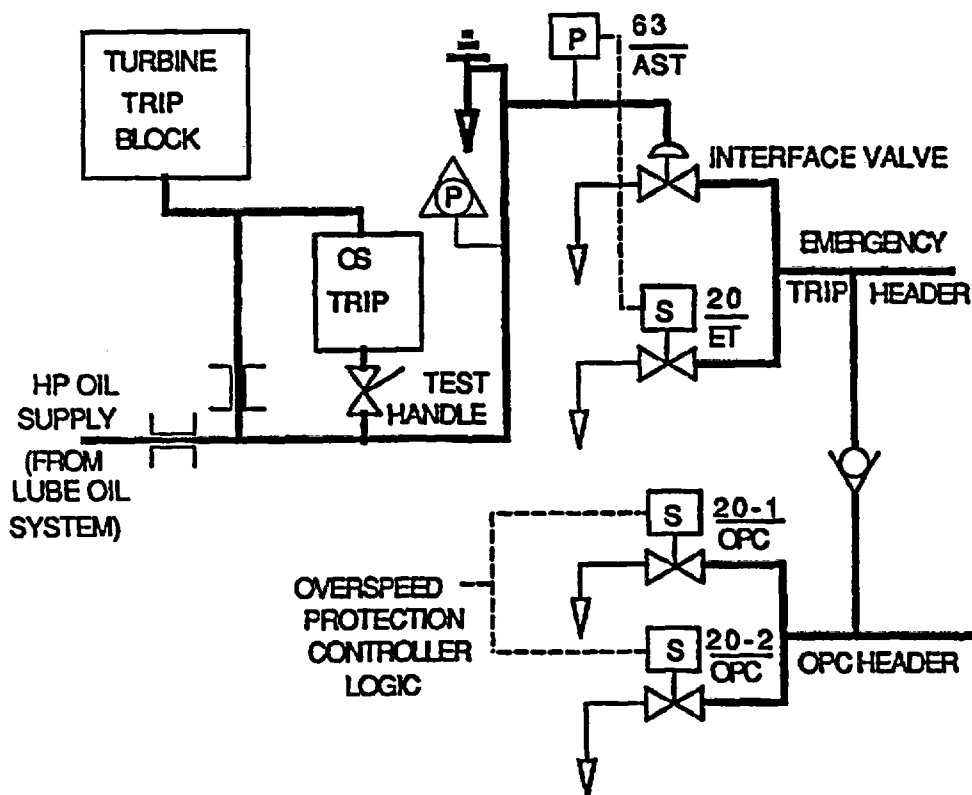
Salem Unit 2 is an 1106 MWe W PWR with a W turbine and a GE generator. On November 9, 1991, while the plant was operating at 100 percent power, the licensee was conducting a monthly test of turbine mechanical protective devices (overspeed trip, vacuum trip, low-bearing oil pressure trip, and thrust bearing trip). In order to perform the test without causing an unwarranted turbine and associated reactor trip, the testing required complete isolation of the AST system from the turbine control or trip function. An operator isolated the AST system by holding the turbine bypass lever (overspeed trip test lever) in the test position (see Figure 2). Disabling the AST system defeated the mechanical overspeed trip and 12 additional remote trip signals. During testing, while the mechanical overspeed trip is disabled, protection against overspeed is provided by three redundant SOVs: ET-20, which is designed to be actuated on a reactor scram, and OPC 20-1 and OPC 20-2, which are designed to actuate at turbine speeds of about 103 percent (see Figure 3).

Figure 3 Schematic of Salem type (generic) emergency and overspeed protection control system before November 1991

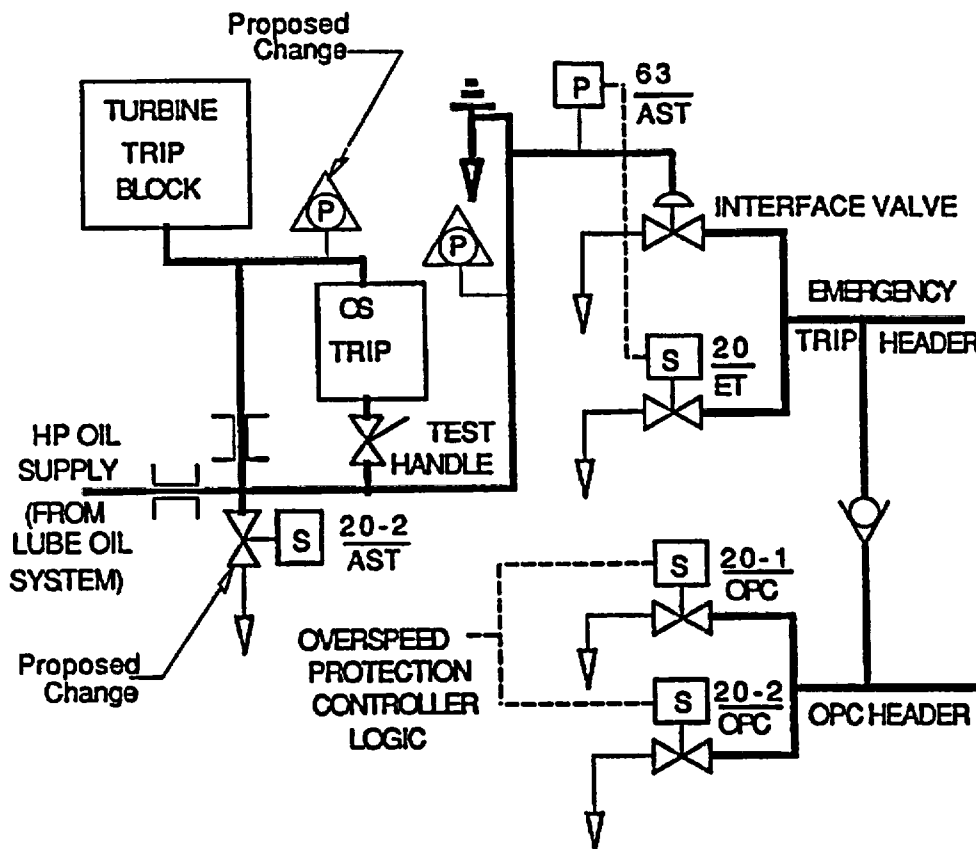
Figure 7 Proposed improvement of Salem type (generic) emergency and overspeed protection control system

valid turbine trip signals during turbine trip testing (see Figure 7). It is interesting to note that some W turbines had the second 20/AST as part of their basic design (e.g., Waterford Unit 3—see Section 4.6).

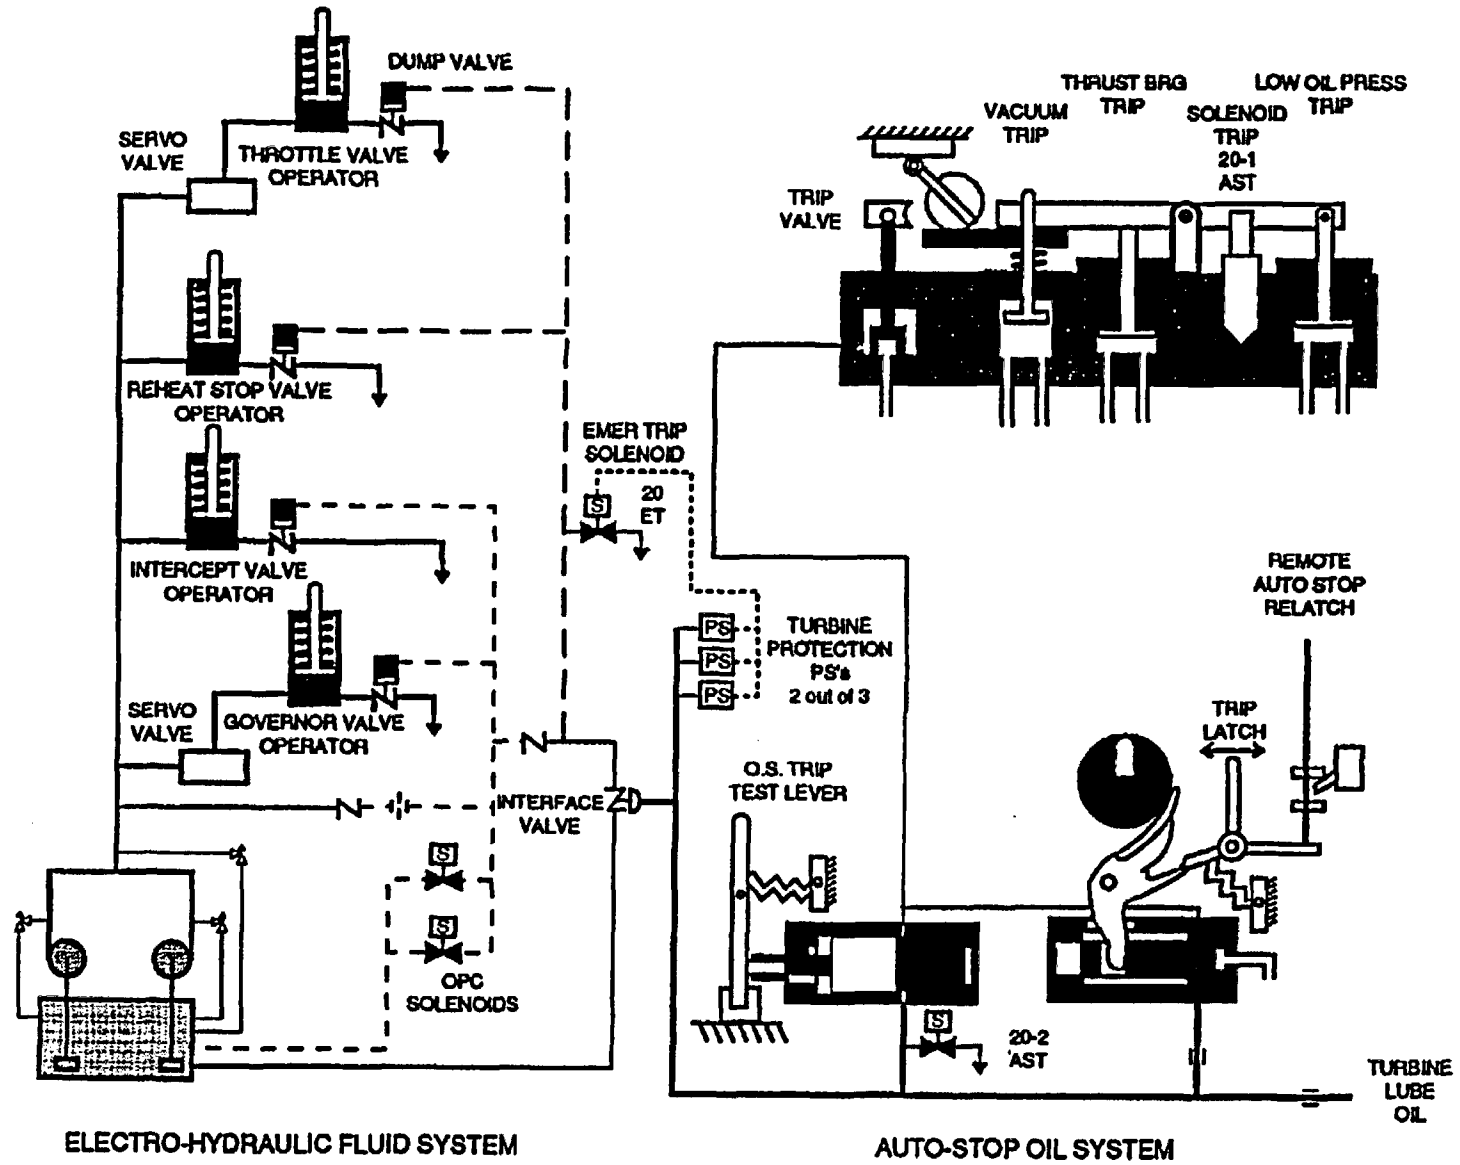
After the Salem Unit 2 overspeed event, Waterford Unit 3 performed an “applicability assessment” of the Salem Unit 2 overspeed event<sup>7a</sup>. The operators noted that the Waterford Unit 3 TOPS is very similar to Salem Unit 2’s but it did have a significant design improvement. As shown in Figure 8, an additional SOV, 20-2/AST to dump AST fluid and trip the turbine if a reactor scram or a valid turbine trip signal is generated by the AST system (i.e., vacuum trip, low bearing oil trip, thrust bearing trip) while the turbine’s mechanical protective devices are being tested (and the trip signals are bypassed by the operator holding the trip test lever). Consequently, the Waterford Unit 3 staff concluded that an overspeed event like the one at Salem Unit 2 could be averted by successful operation of the additional 20-2/AST SOV.

Figure 8 Waterford Unit 3 turbine control system

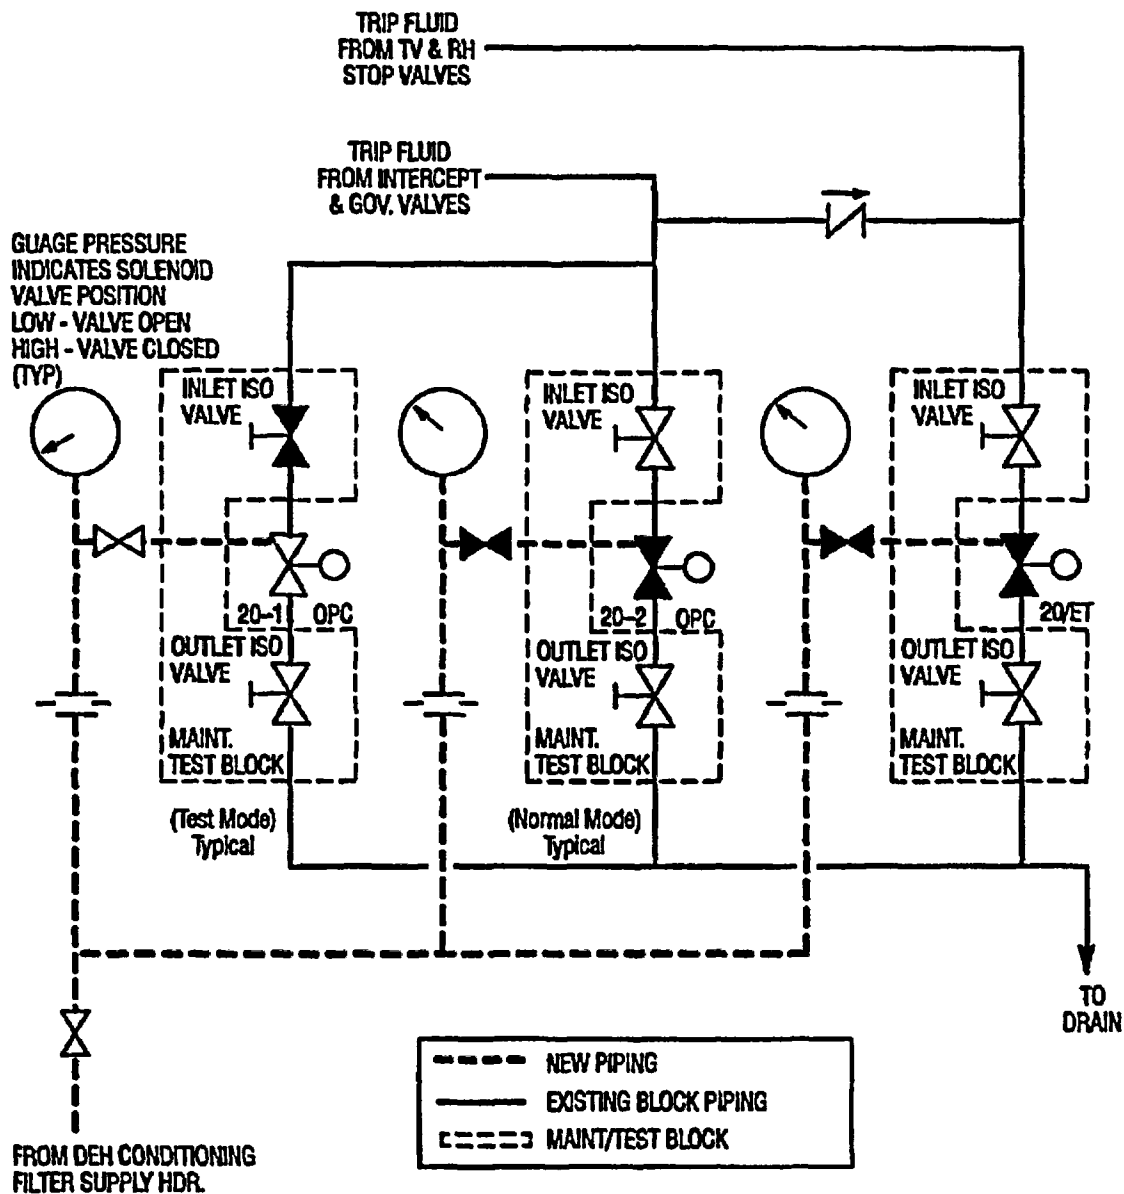
Figure 11 St. Lucie block for testing EHC system SOVs independently

As a result of the July 10, 1992, reactor scram, the licensee suspended the EHC SOV monthly testing until a reliable on-line testing method could be developed. Subsequently, the licensee redesigned the test and maintenance block to eliminate the pressure pulse (see Figure 11). The modified test and maintenance block isolates trip functions from the SOV being tested but remains available for the other two SOVs, introducing an alternate supply of EHC fluid from the EHC supply header. The alternate fluid supply eliminates the possibility of feedback to the emergency trip header on the RPS, thereby eliminating the possibility of causing an unwarranted reactor scram. To minimize human errors, the SOV testing requires the use of key switches. The revised test and maintenance block was tested extensively at Florida Power and Light Company's (FPL's) Manatee fossil plant. In April

CLOSING INLET ISOLATION VALVE ALLOWS TESTING OF ASSOCIATED SOLENOID VALVE.  
 CLOSING BOTH INLET AND OUTLET ISOLATION VALVES ALLOWS ASSOCIATED SOLENOID  
 VALVE REPLACEMENT WITH SYSTEM IN OPERATION.

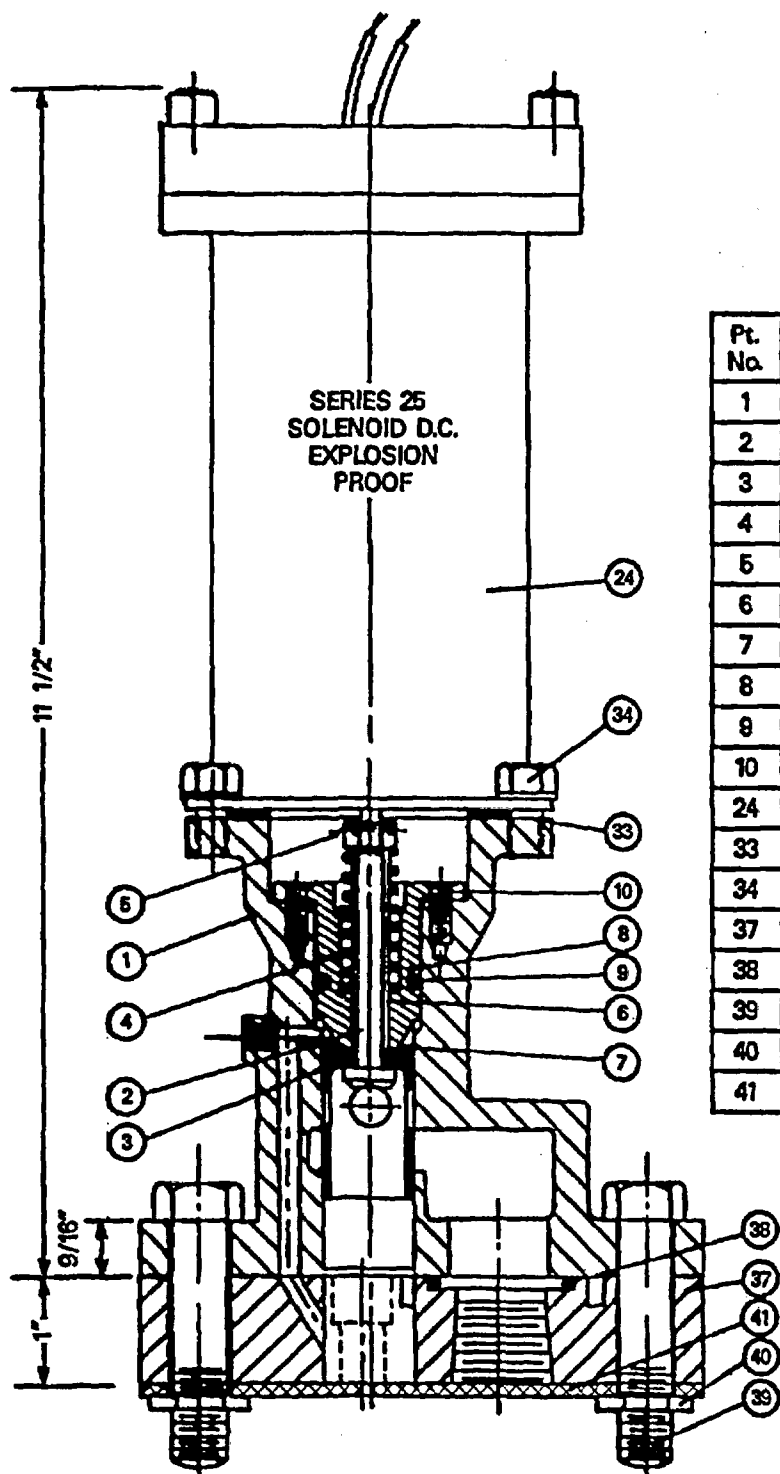
Figure 13 Big Rock Point—Replacement hand-trip solenoid valve

actions. For the short term, depending on the schedule, the licensee would either replace the HTS with a refurbished one or replace the HTS with another valve of a simpler type before power ascension (see Figure 13). For the long term, the licensee considered modifying the manifold block that housed the HTS to allow another valve to be added in parallel to the HTS. The extra valve would preclude another HTS failure from tripping the turbine.

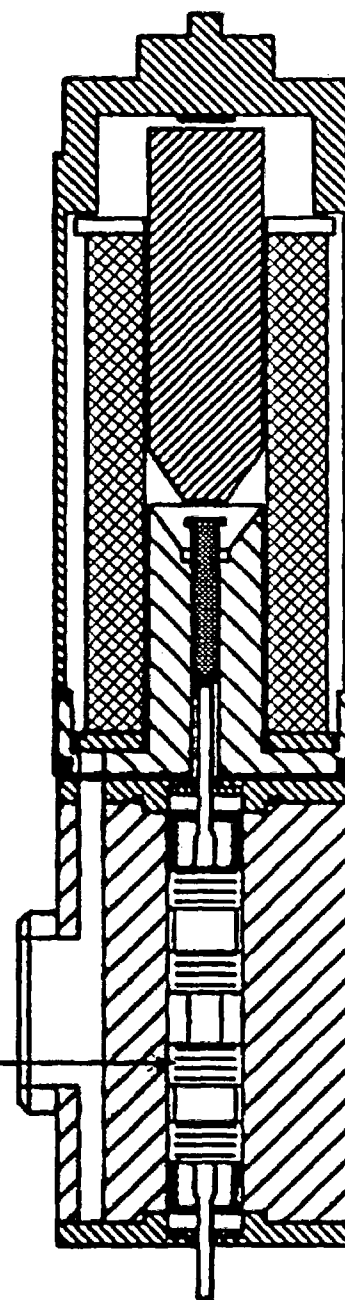
Figure 14 Cross-sectional drawing of Parker Hannifin SOV MRFN 16MX 0834

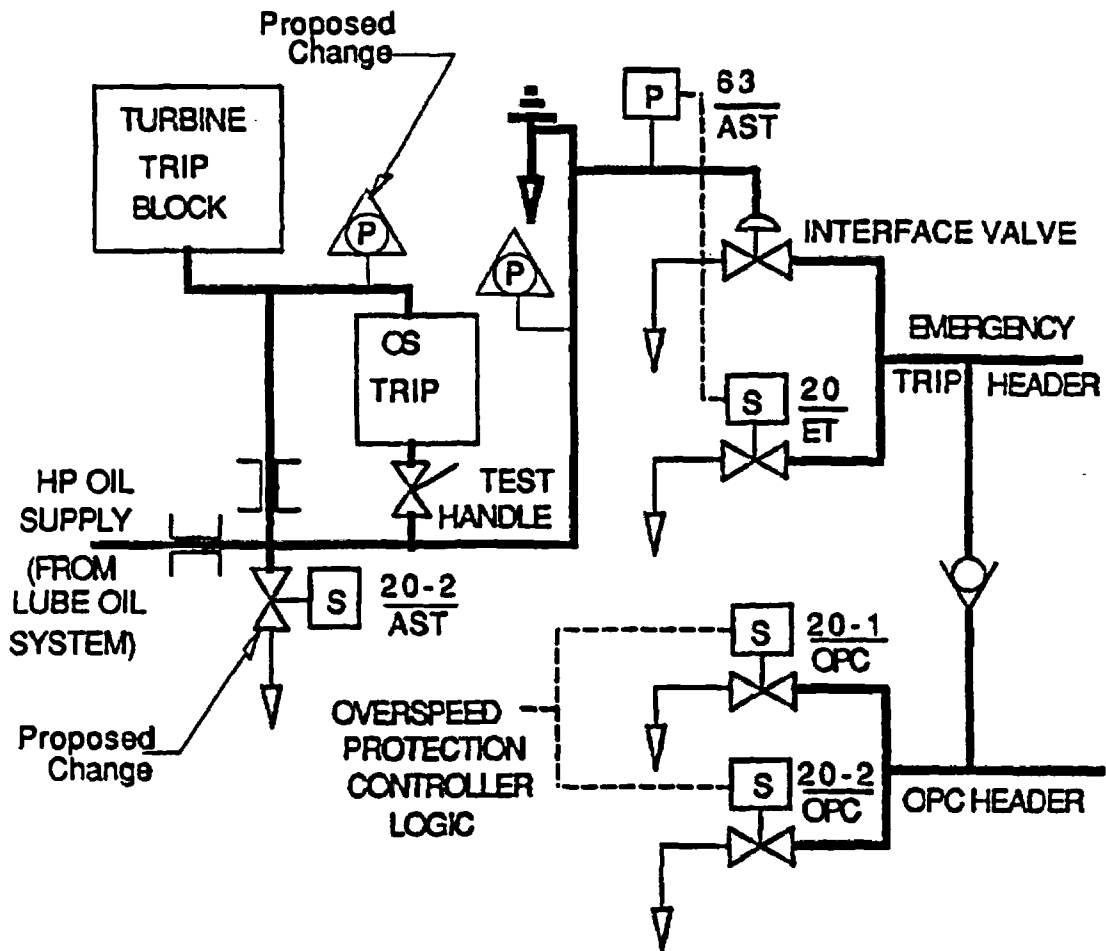
FIGURE 3.

# EMERGENCY AND OVERSPEED PROTECTION CONTROLLER SYSTEM (PROPOSED)

- 2.2.5 On units with mechanical trip systems, one 20/AST is standard. During trip testing at the front pedestal, this solenoid is made ineffective. A second 20/AST (style 387A995002) can be installed on the HP oil supply side of the test handle to allow electrical trips to be effective even when the test handle is held. Refer to Figure 3.

- 2.2.8 To reduce the possibility of tripping the unit during testing of the trips at the front pedestal, install a pressure gauge on the trip block side (mechanical trip system) of the test handle. See Figures 3 and 4. The operator should verify that autostop pressure has been re-established before releasing the test handle..

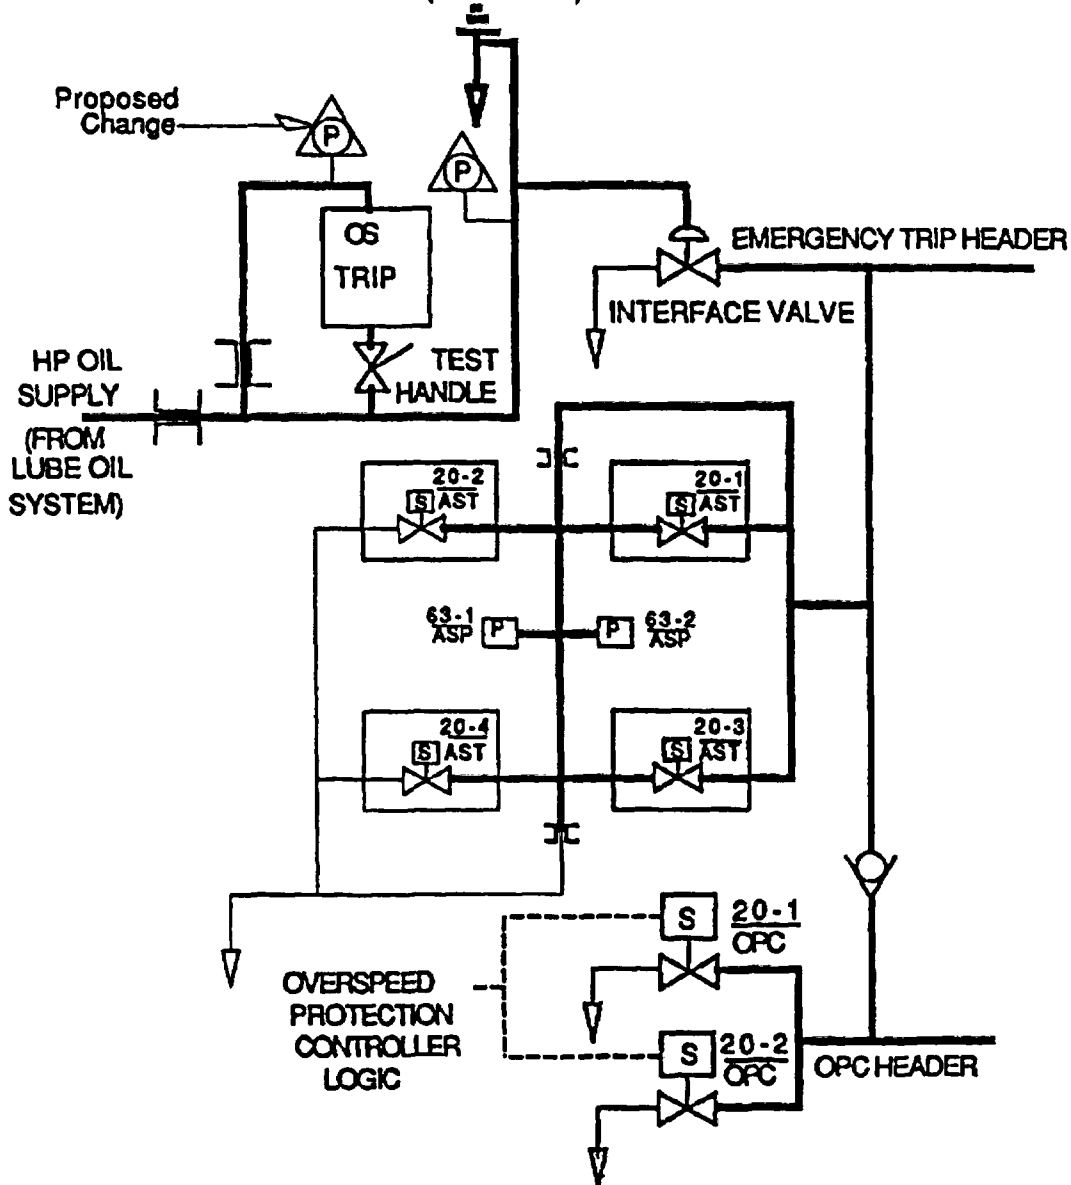
FIGURE 4.

# EMERGENCY AND OVERSPEED PROTECTION CONTROLLER SYSTEM

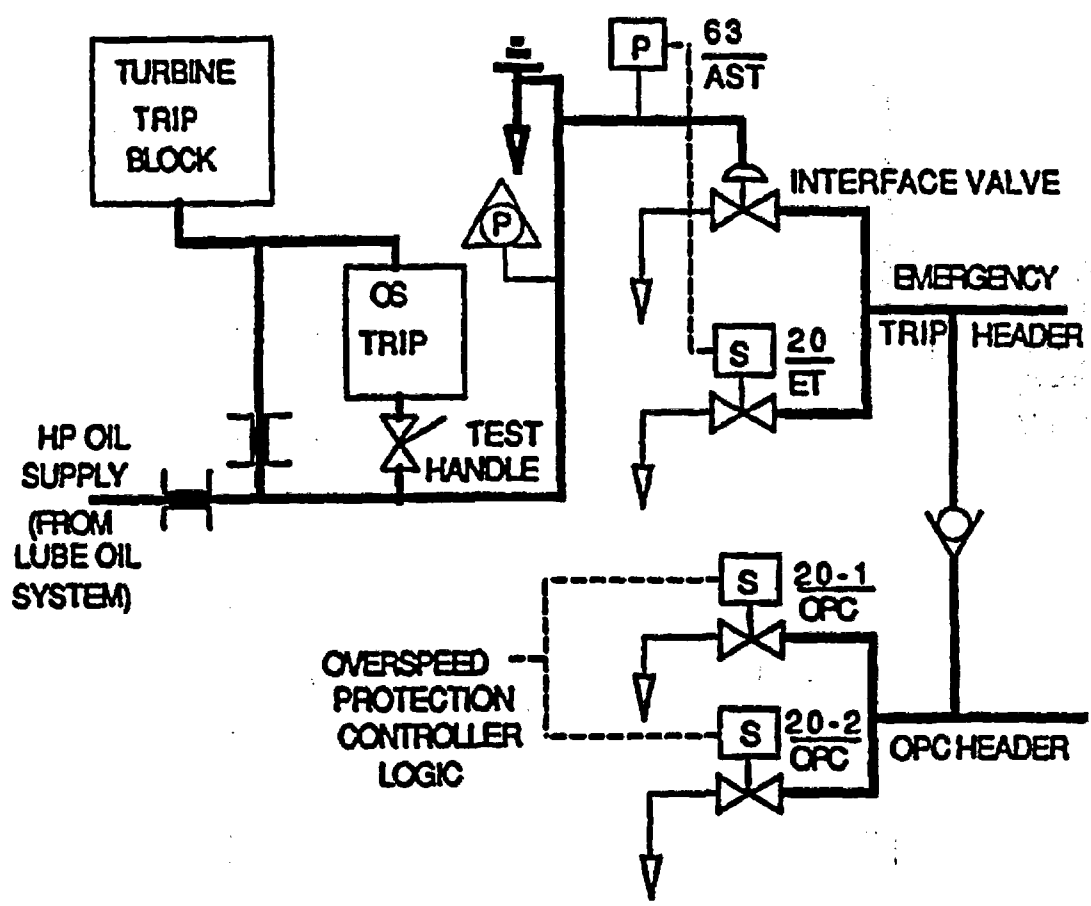
FIGURE 1

The solenoid valves involved were Parker-Hannifin Manatrol solenoid valves 20/OPC-1 and 20/OPC-2 (overspeed protection controller) and 20/ET (Emergency Trip solenoid valves) used with Electro-Hydraulic (EH) control systems. The above three solenoid valves are located on a machined block on the right side of the pedestal. In another arrangement there are four 20/AST (Auto Stop Trip) solenoid valves and two 20/OPC solenoid valves on a machined block on the right side of the pedestal. Refer to Figures 1 and 2.

# EMERGENCY AND OVERSPEED PROTECTION CONTROLLER SYSTEM

- A means of functional testing on-line is to be incorporated regardless of the methods chosen.
10. To reduce the possibility of tripping the unit during testing of the trips at the front pedestal, install a pressure gauge on the trip block side (mechanical trip system) of the test handle. Refer to Figures 1 and 2. The operator should verify that autostop pressure has been re-established before releasing the test handle.

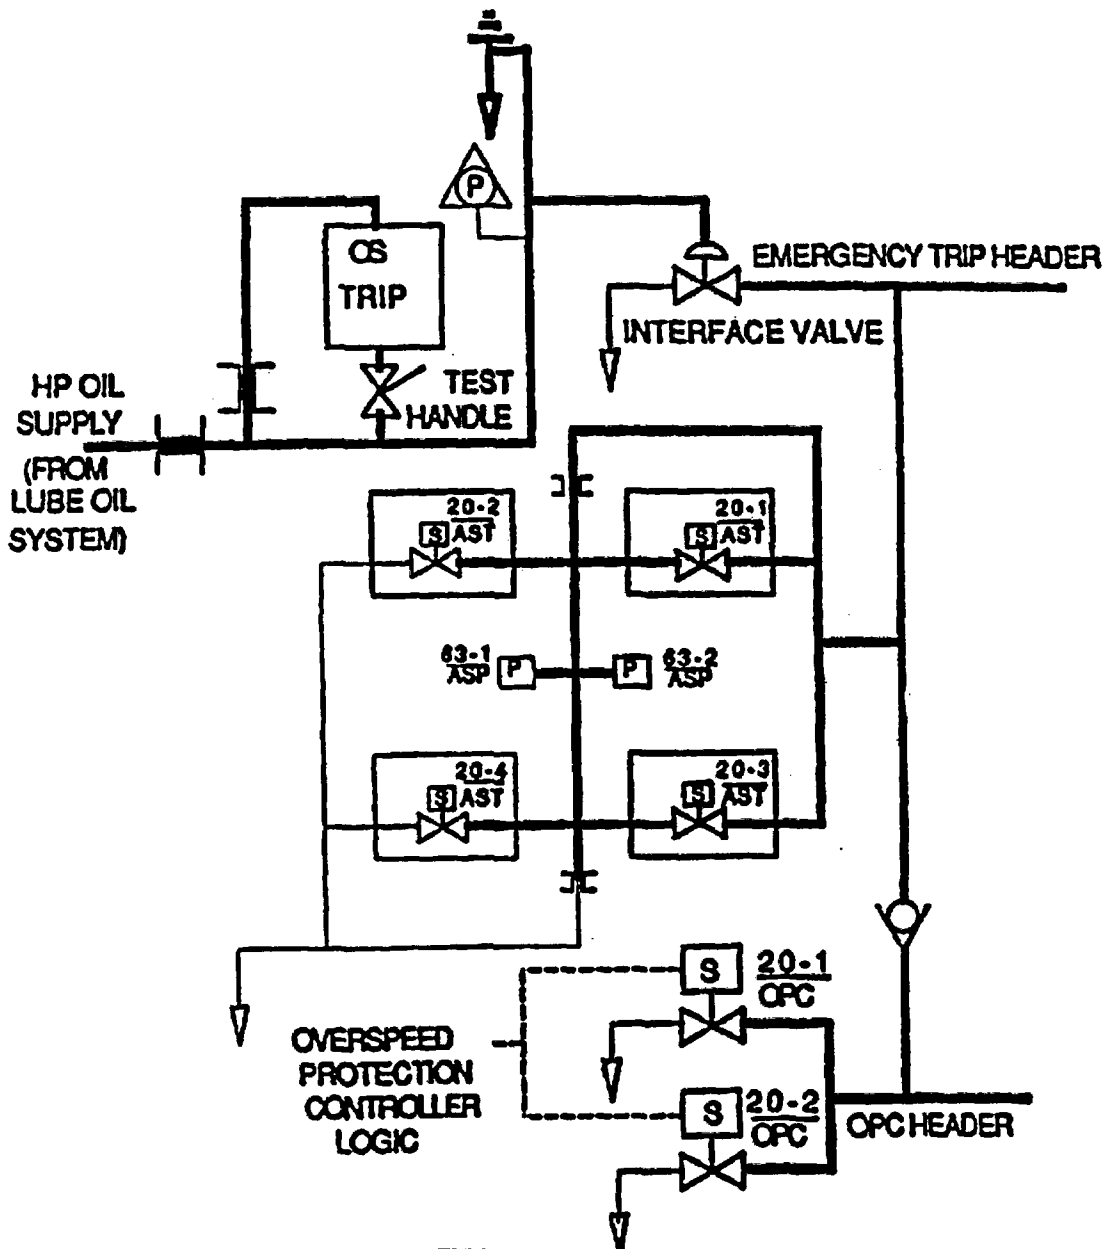
FIGURE 2

# EMERGENCY AND OVERSPEED PROTECTION CONTROLLER SYSTEM

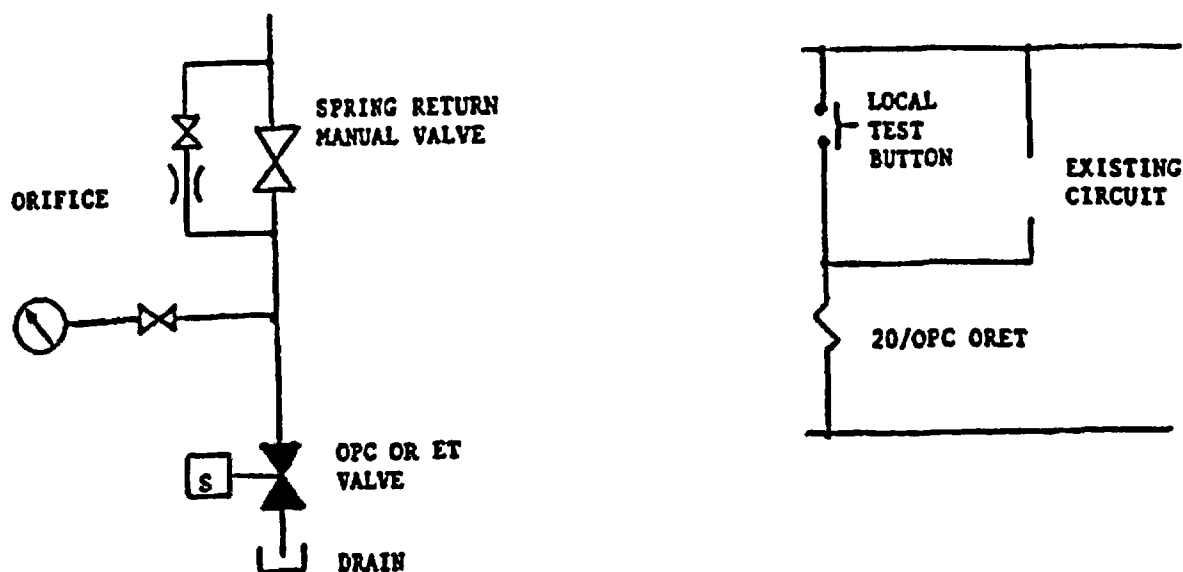
**FIGURE 3**

SOLENOID VALVE ADAPTER

- a. One method of accomplishing on-line testing is to install a test block between the present solenoid valves and the large machined block. (Refer to Figures 3 and 4). This test block can be used to individually test the solenoid valves on-line and could also allow on-line maintenance. For units with spool type pilot valves, this block can be sandwiched in with little effort. For units with solenoid valves that screw into the main block, a new block would be required. This method minimizes the modifications needed but requires local testing. Other methods could be used which range from coming off-line to test to remote testing capability involving blocking solenoid valves and pressure transducers.

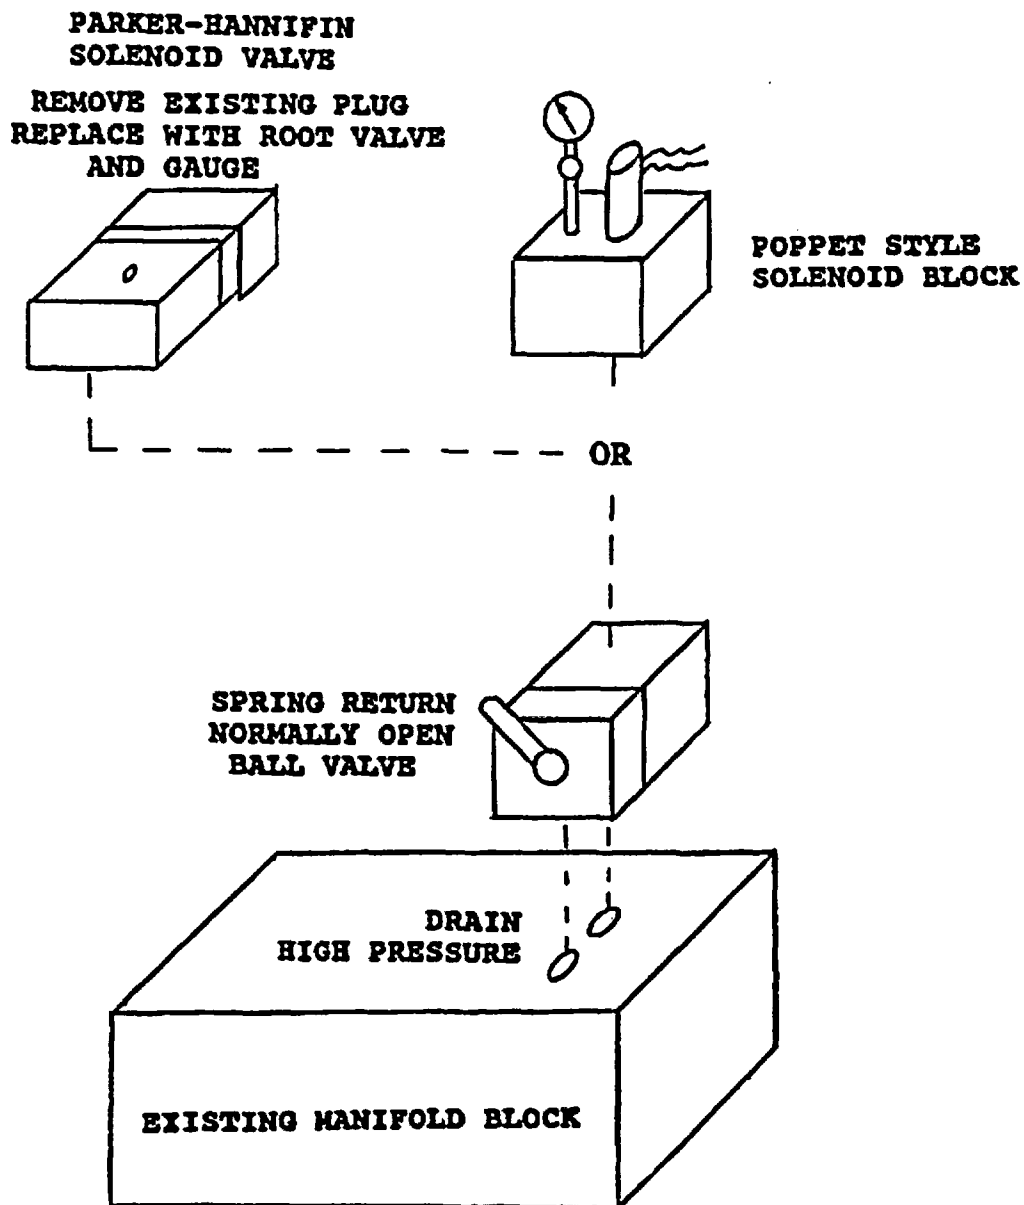
FIGURE 4

## SOLENOID VALVE ADAPTER

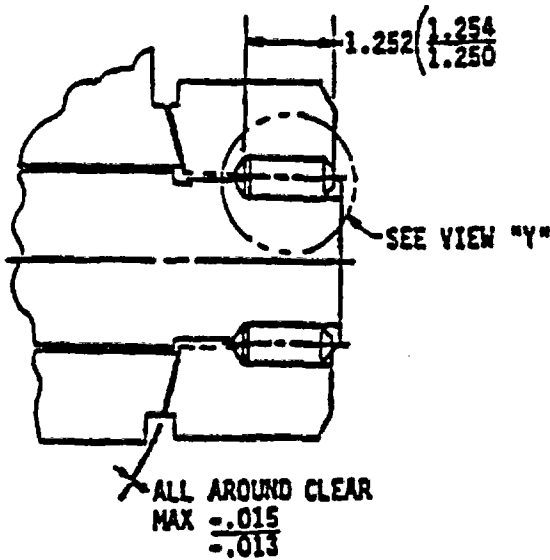
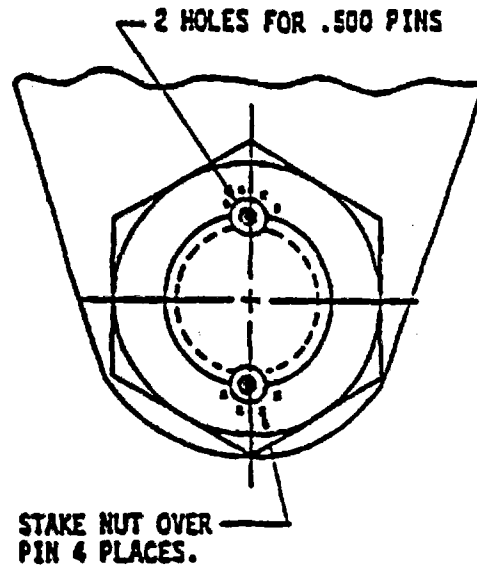
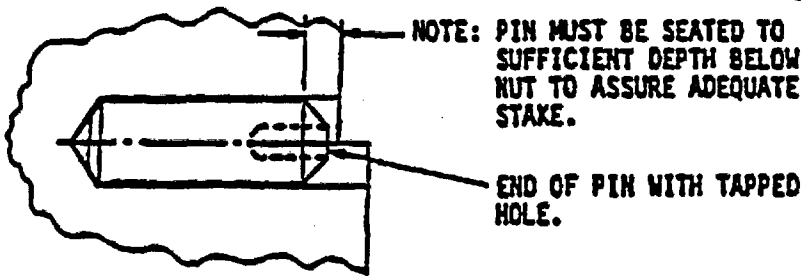
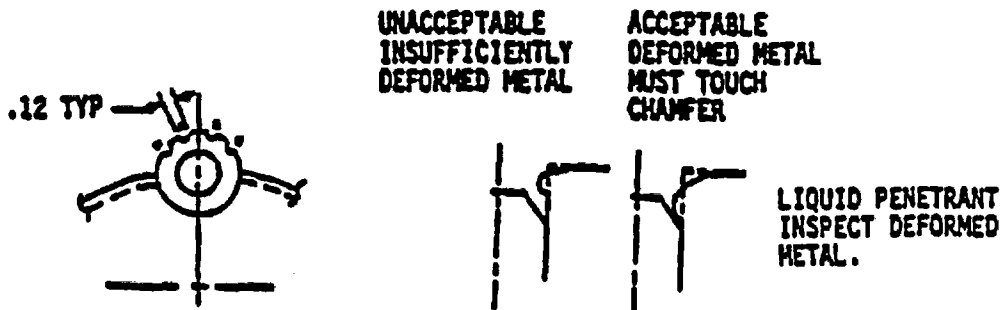
FIGURE 1

Incidents of clappers of main steam stop valves having come loose and separating from the clapper arm have been reported. This occurrence completely disarms the safety backup feature of the stop valve.

Remove the stop valve cover and inspect the stake (peening) of the clapper valve nut over the retaining pins. Requirements for position of pins and location and amount of staking are shown on Figure 1. If necessary, take corrective action to establish proper staking. Staking (peening) is to be done hot (500°F min - 1000°F max) with a peening tool having a 0.12 inch spherical radius tip.
