Construction Problems with an Earth and Rockfill Dam

Hasan Hejazi

Tennessee Technological University, Cookeville, Tennessee

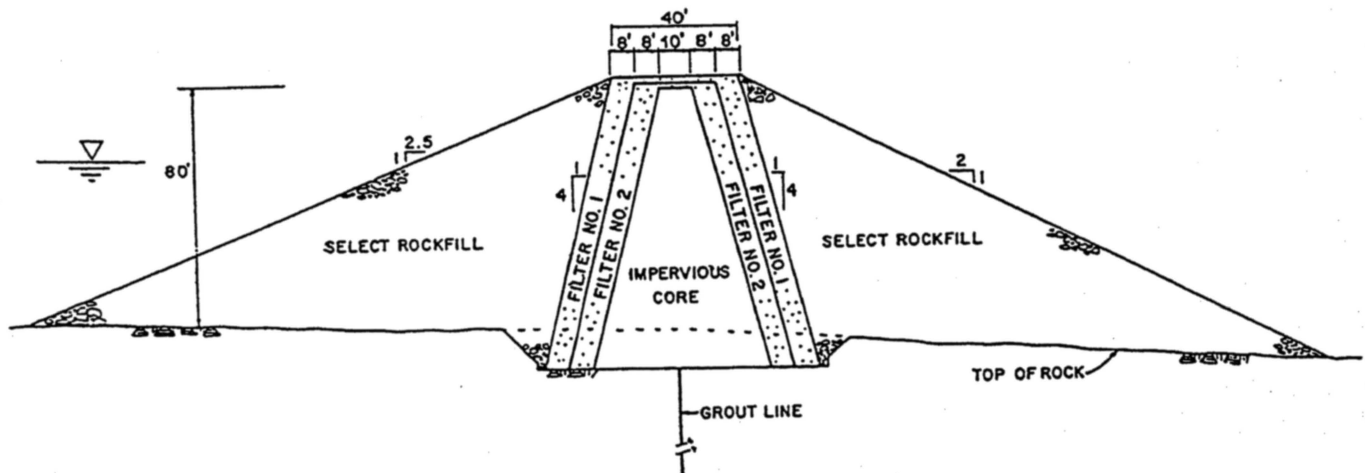
Figure 3. Section on Rock.

Bay Springs Dam has a zoned earth and rockfill embankment consisting of a central core, transition filters, select rockfill shells, and a cutoff trench, Figures 3 and 4.

The core has a top width of 10 feet with 4V on 1H side slopes. It consists of low plasticity clay compacted in a nine-inch loose lift by tamping or sheepfoot roller. The filters, fine and coarse, are eight feet wide with the fine filter No. 2, adjacent to the core, placed in 12-inch lifts compacted by a vibratory roller and having a gradation ranging from a No. 4 to a No. 100 standard sieve size. The coarse filter No. 1, between the shell and the fine filter is placed in 12-inch lifts compacted by a vibratory roller, and ranges in size from four inch to No. 4. The shells are placed in 24-inch lifts compacted by a vibratory roller and ranging in size from a maximum size of 16 inches to not more than 5% passing the 3-inch screen.

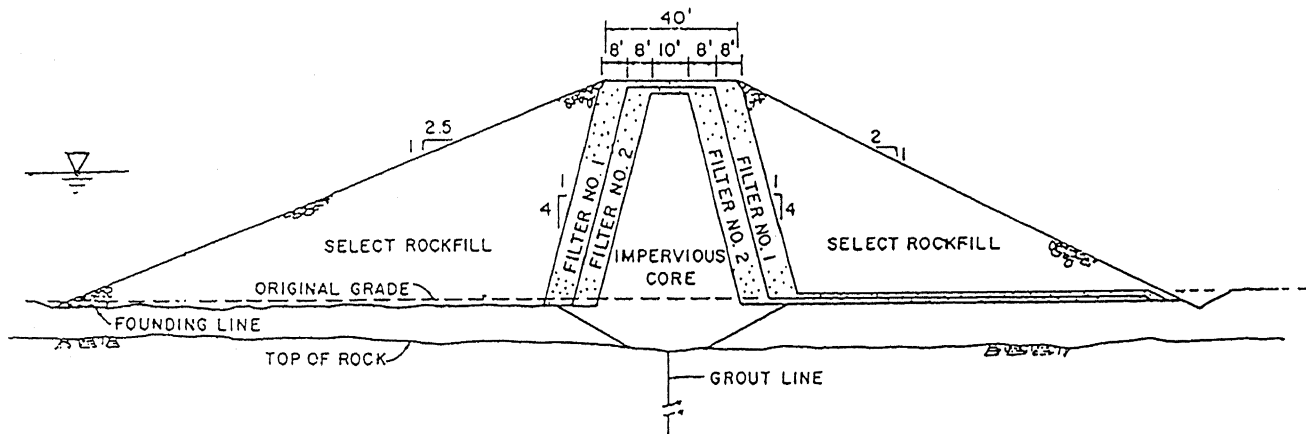
Figure 4. Section on Overburden.

A cutoff trench extends to rock in locations where the dam is founded on overburden. A grout curtain is provided to reduce seepage through the foundation. Measures were taken to dewater the area around the cutoff trench to reduce seepage during grouting and foundation preparation.
