Commutator Troubleshooting

Problems • Causes

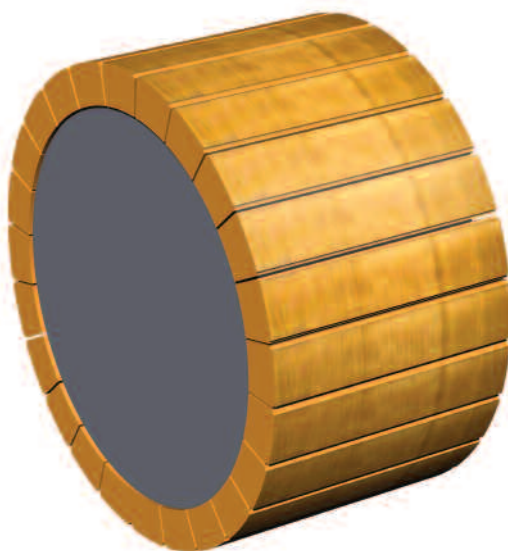
Possible causes are low humidity, low temperatures, light current loads and wrong brush grade. Light Film is considered acceptable providing film does not decline to point of copper dusting.

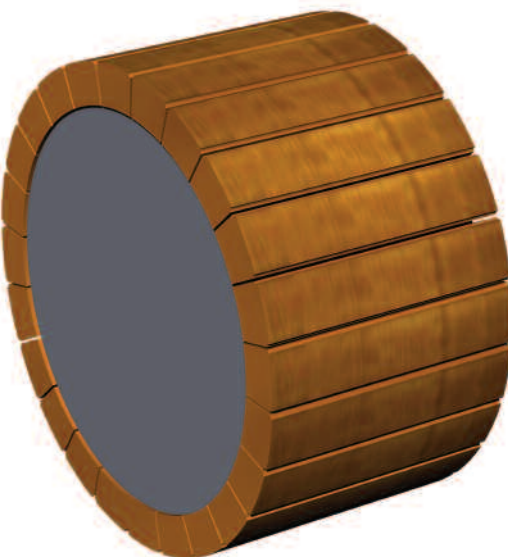
Good Film Coverage

How a Commutator should look

When a machine runs well, the patina/film or skin on a commutator will be even, slightly shiny and coppery brown to dark brown in color.

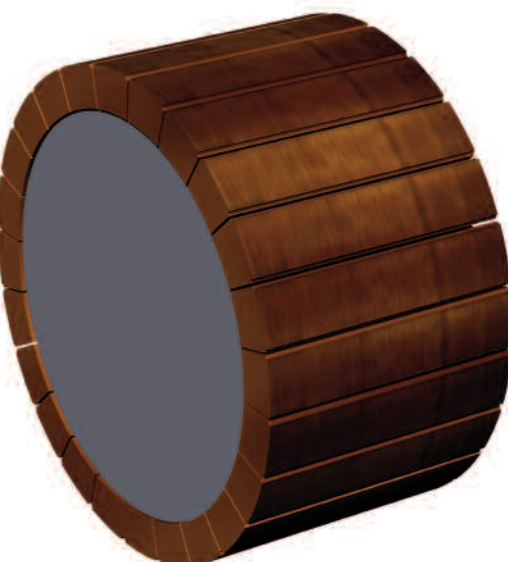
Heavy Film

Results from high load, high humidity or heavy filming rate grades. Colors not in the brown tones indicate contamination resulting in high friction and high resistance.

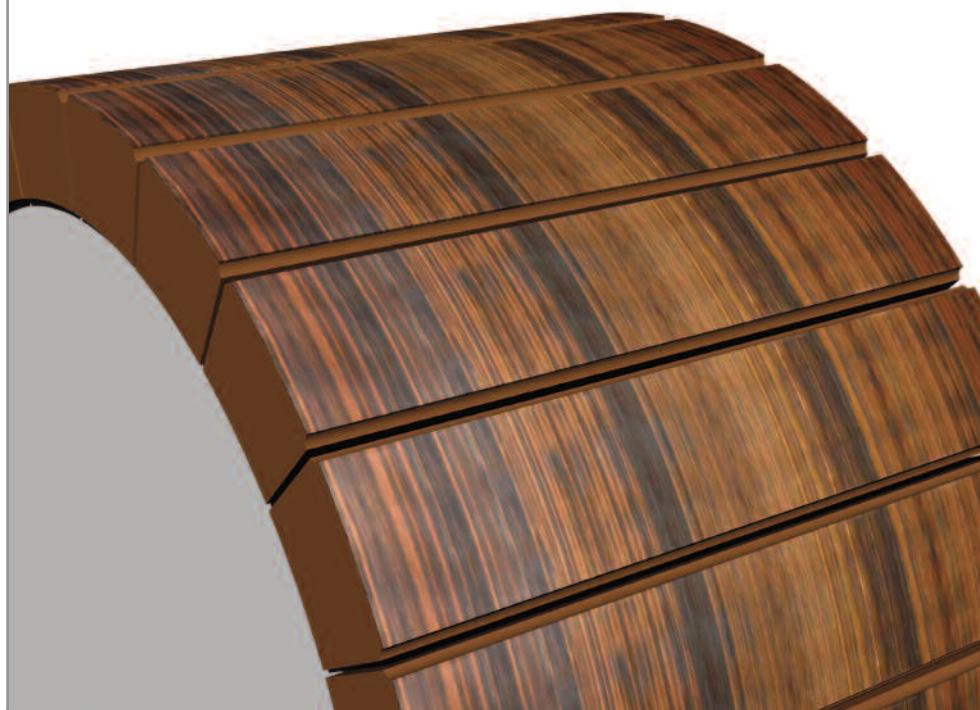
Streaking

Causes

- Light or unequal spring tension
- Light current loads
- Contaminated atmosphere
- Incorrect brush alignment / off neutral
- High humidity
- Oil vapor
- Uneven current distribution
- Copper particle pickup from a raw commutator

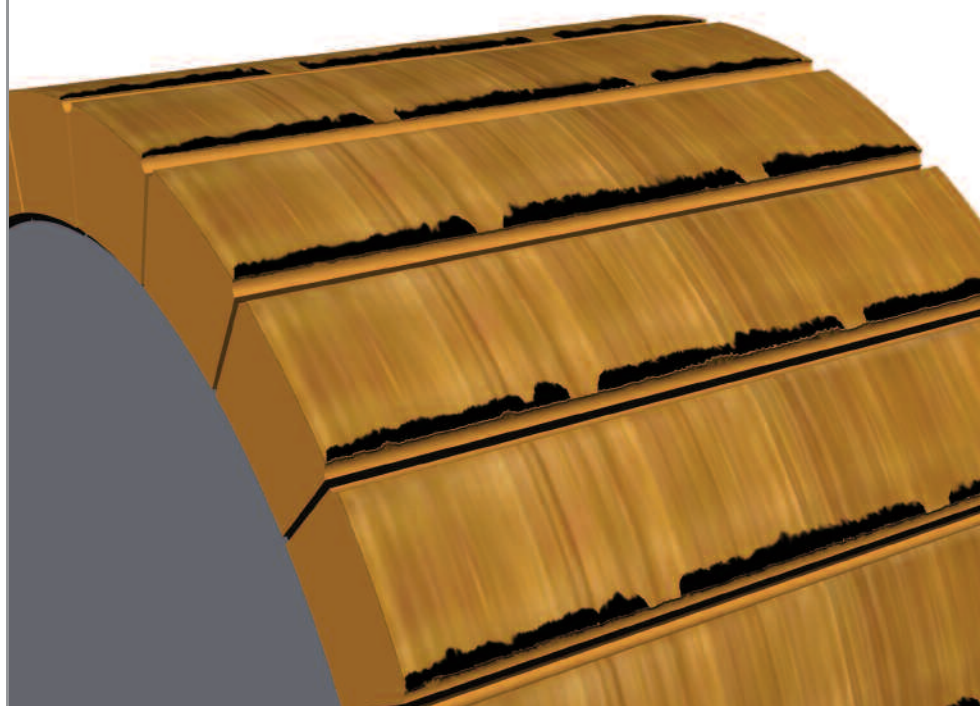
Bar Edge Burning

Causes

- Light or unequal spring tension
- Incorrect brush alignment / off neutral
- Wrong brush grade
- Sparking caused by commutation problems

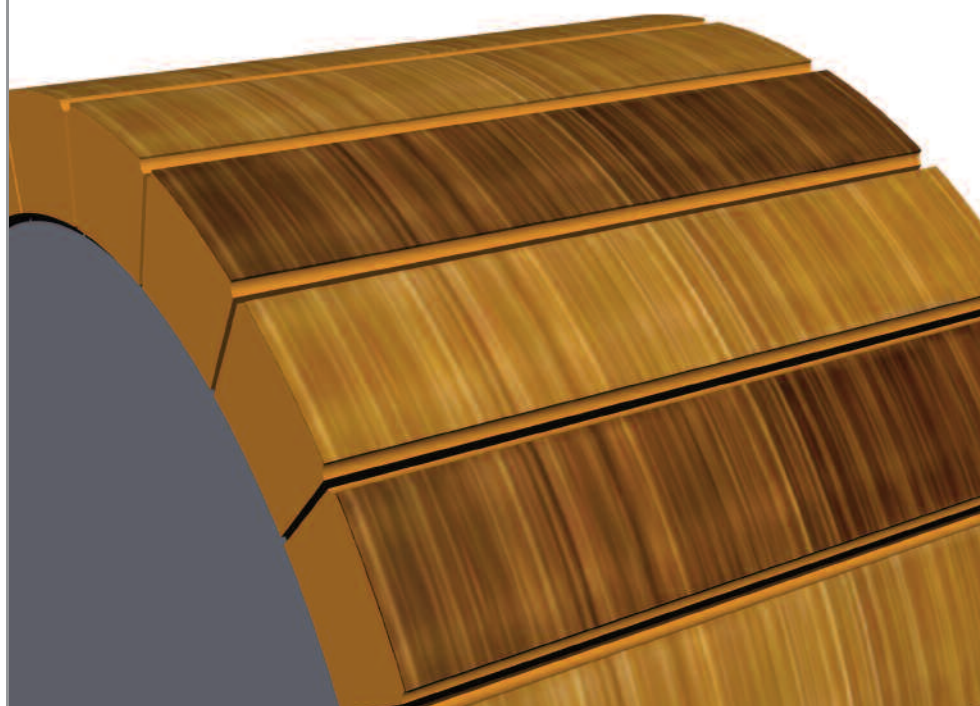
Slot Bar Marking

Causes

- Uneven current distribution
- The unequal number of windings in adjacent slots account for the variation of film color
- This is not considered a problem unless some bars become burnt
- Double windings cross-ing in the same slot

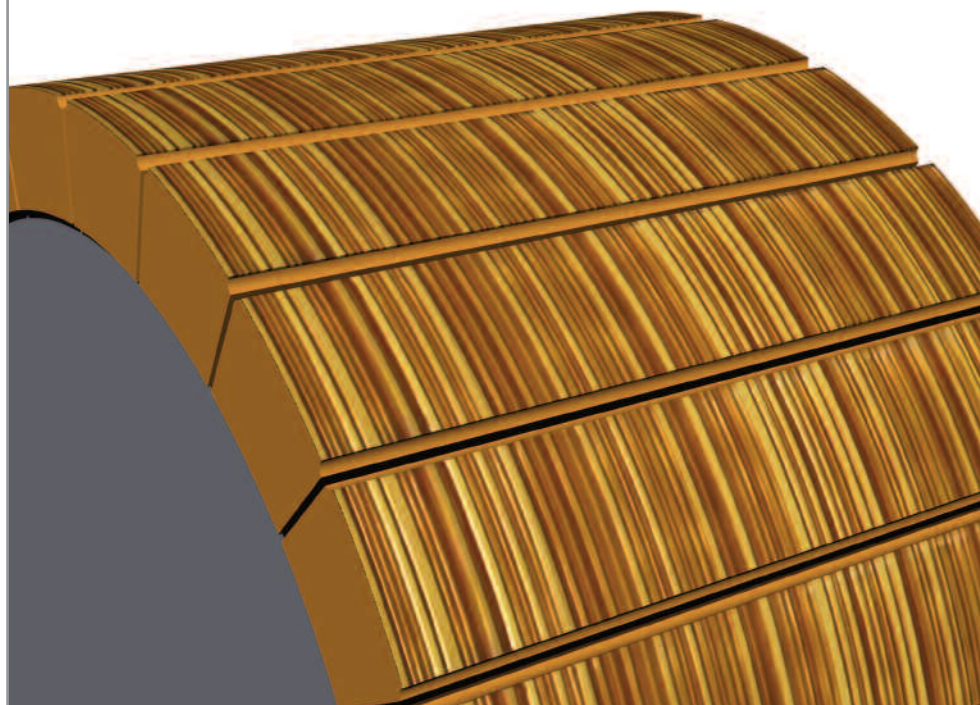
Threading

Causes

- Light or unequal spring tension
- Light current loads
- Contaminated atmosphere
- High humidity
- Oil vapor
- Uneven current distribution
- Conditions have been maintained for a long period of time and caused commutator damage

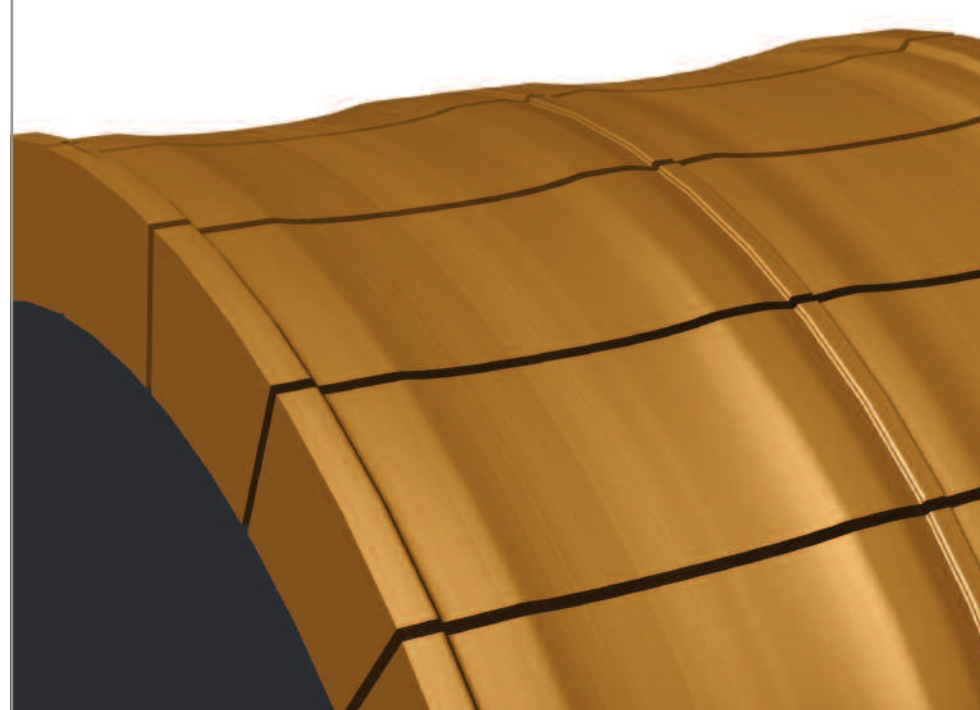
Grooving

Causes

- Light or unequal spring tension
- Contaminated atmosphere
- Incorrect brush alignment / off neutral
- Low humidity and temperature
- Wrong brush grade

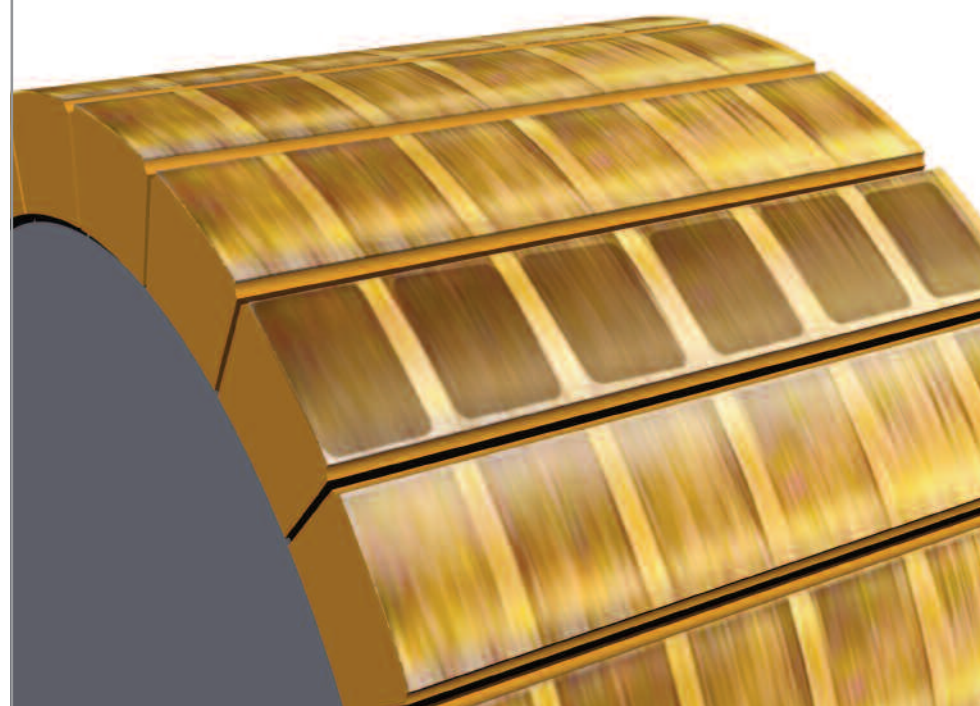
Photographing

Causes

- High humidity
- High resistance spot at the same point of rotation
- Mechanical problem that causes a jolt on the brushes and interruption of contact or electrical spike at same point in rotation

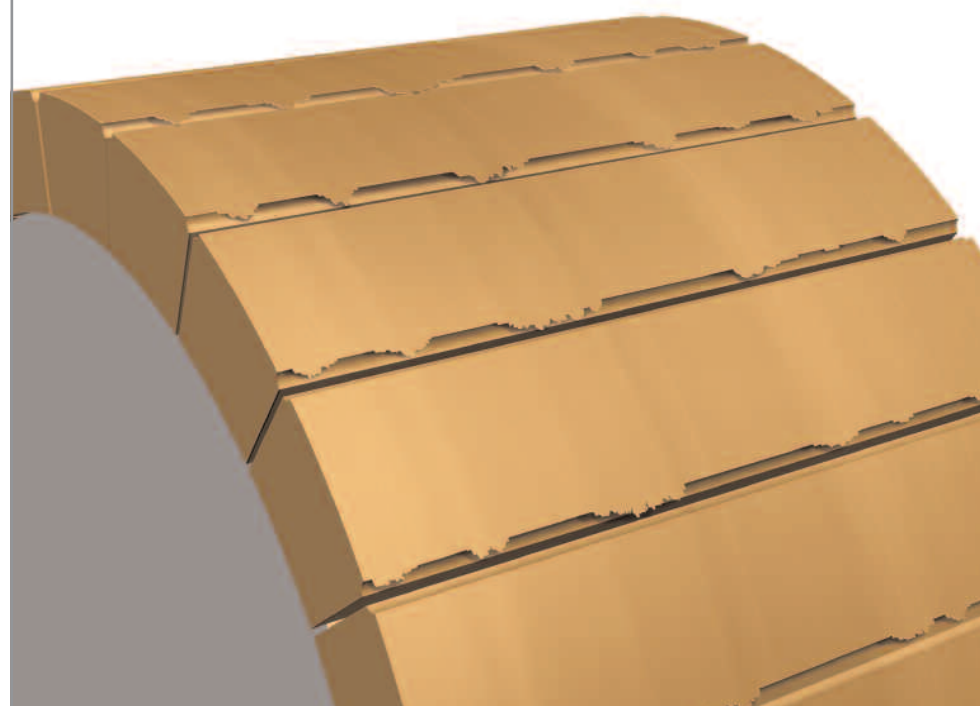
Copper Drag

Causes

- Light or unequal spring tension
- Excess vibration
- Wrong brush grade
- Commutator becomes overheated and softened
