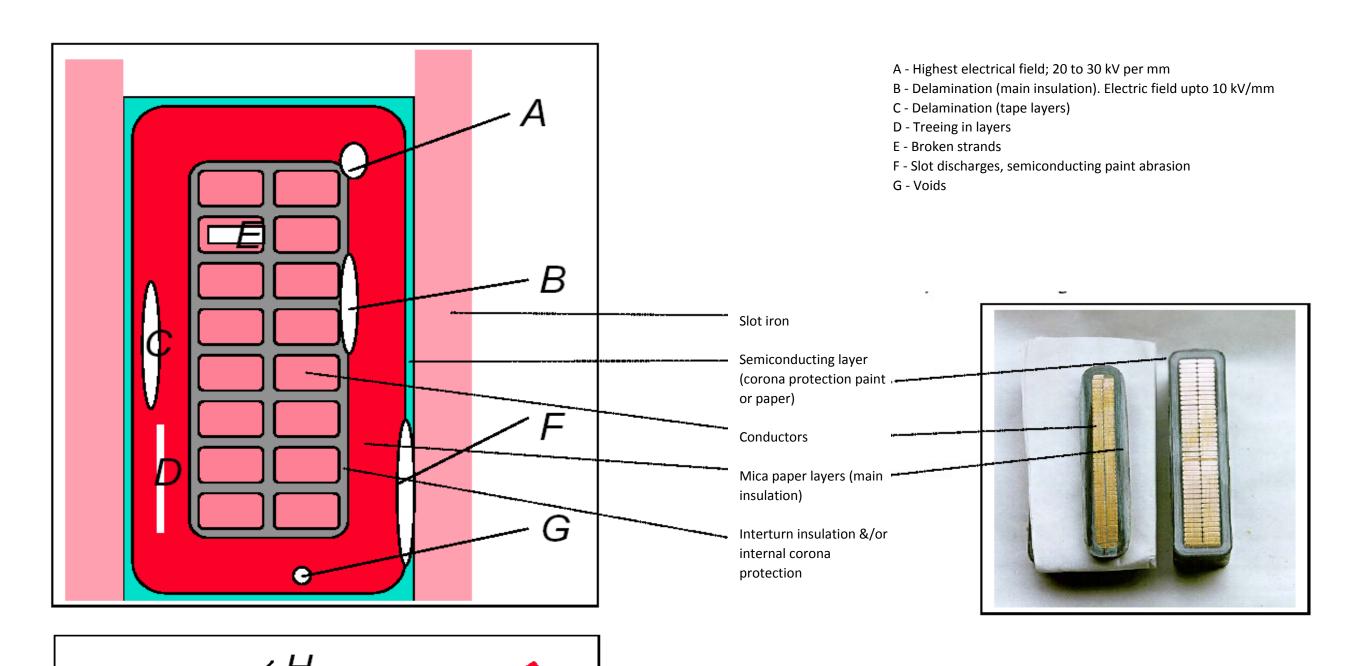
- H Discharges in Cooling Duct, mainly created by vibration & abrasion of corona protection layers
- I Delamination of insulation in Elbow, especially when manually manufactured
- J End winding discharge (contamination, etc.)
- K Insufficient spacing, tracking; especially between bars with big voltage difference, different phases
- L Connection area between slot corona protection & end winding corona protection
