Form 1 OPGP04-ZE-0309/R20		<b>DESIGN CHANGE PACKAGE (DCP)</b>				Page 1 of <u>13</u>									
DCP # 08-15484-2		Supp # 0	As-built: <input type="checkbox"/>	Trend Code: N/A	Unit: 2	System: RD									
Major Mod <input type="checkbox"/> JPR cert. 9017	Minor Mod <input type="checkbox"/> JPR cert. 9017	MC Enhancement <input type="checkbox"/> JPR cert. 9016	MC Other <input checked="" type="checkbox"/> JPR cert. 9016	Paper Chg <input type="checkbox"/> JPR cert. 9015	Admin <input type="checkbox"/>										
DCP Title: Rod Drive MG Set -Motor 21 Replacement				<u>32380365</u>											
TPNS / TAG #'s affected: 7Z172ERD101A				TPNS# continued on pg. <u>N/A</u>											
<b>DCP Scope Summary:</b> <b>Problem Statement:</b> While replacing the bearing for Rod Drive MG Set motors #1 and #2, small cracks were found in the red epoxy resin material between the stator bar slots of motor#1. Also, found some slots have the red epoxy resin material and some without it. In motor #2, red epoxy resin material found between the stator bar slots in a few places but no cracks were present. Contacted System Engineering for visual inspection. <b>Problem solution:</b> Replace the degraded motor (Westinghouse

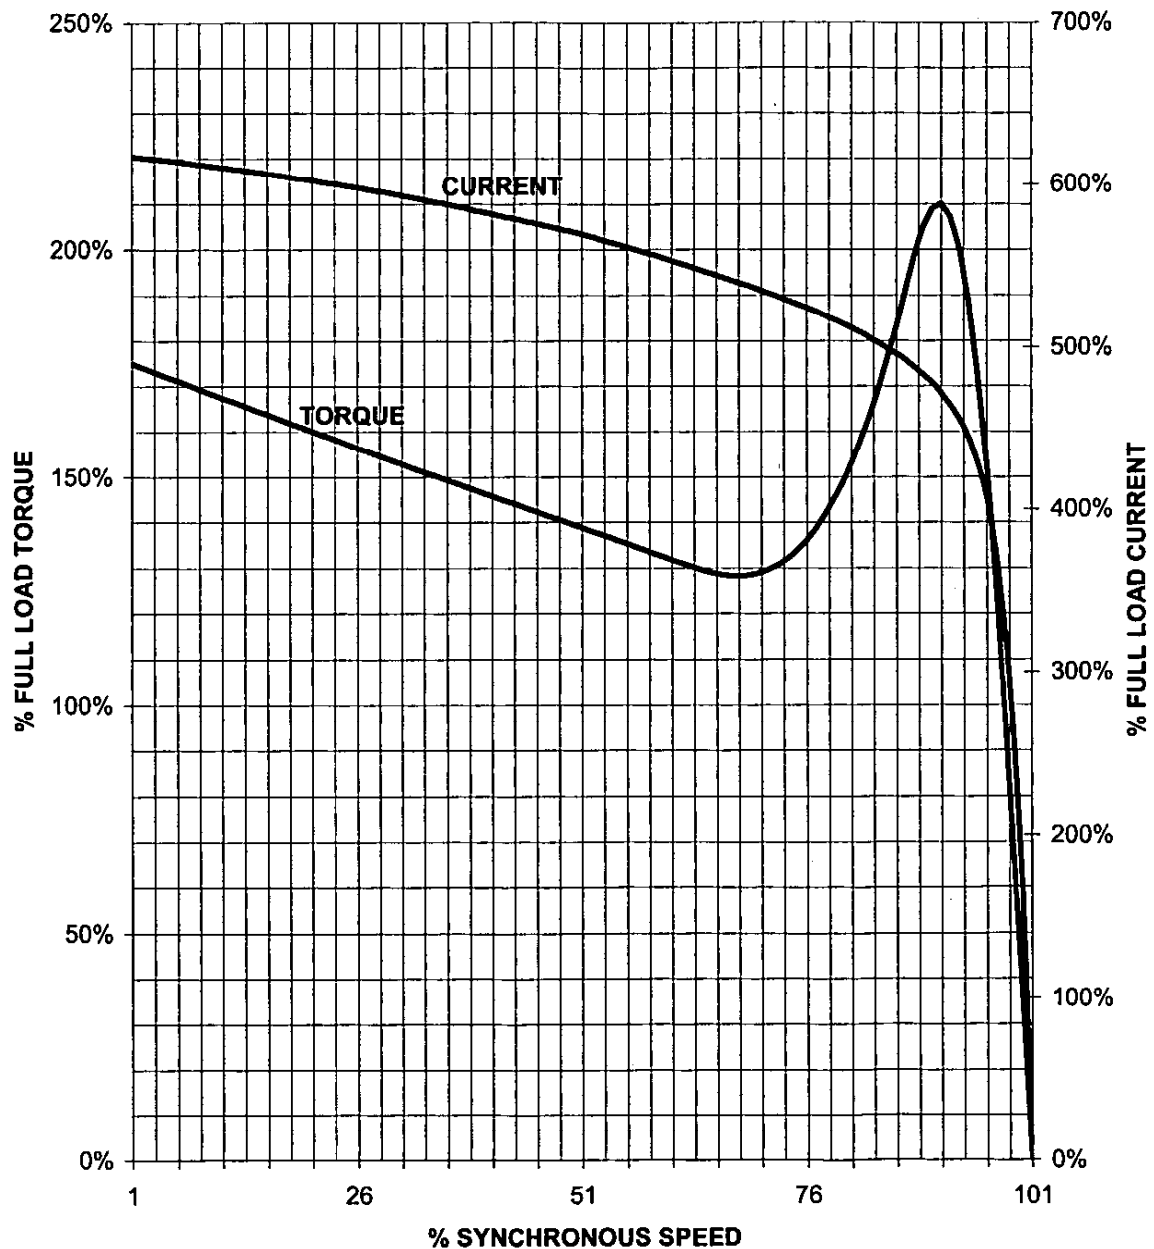
## TORQUE & CIRRENT VS. SPEED

HP 200 VOLTS 460 RPM 1800 TYPE DP10  
HZ 60 PHASE 3 FRAME 445 T/TS NEMA B

<b>Design Input</b>	<b>Source</b>
Breaker set point criteria	EC 5031, Section IV.
Motor data -kVA code 'G', Service Factor 1.15, S. F Amps 270 -FLA 235, HP 200, kW 149.2	New motor stock code 609-222.
Torque speed curves equivalency between new and old motor	Per telecon with Siemens. See attached e-mails.
480 load center and motor TPNS #s	9-E-PEAE-01#2 , Rev. 10

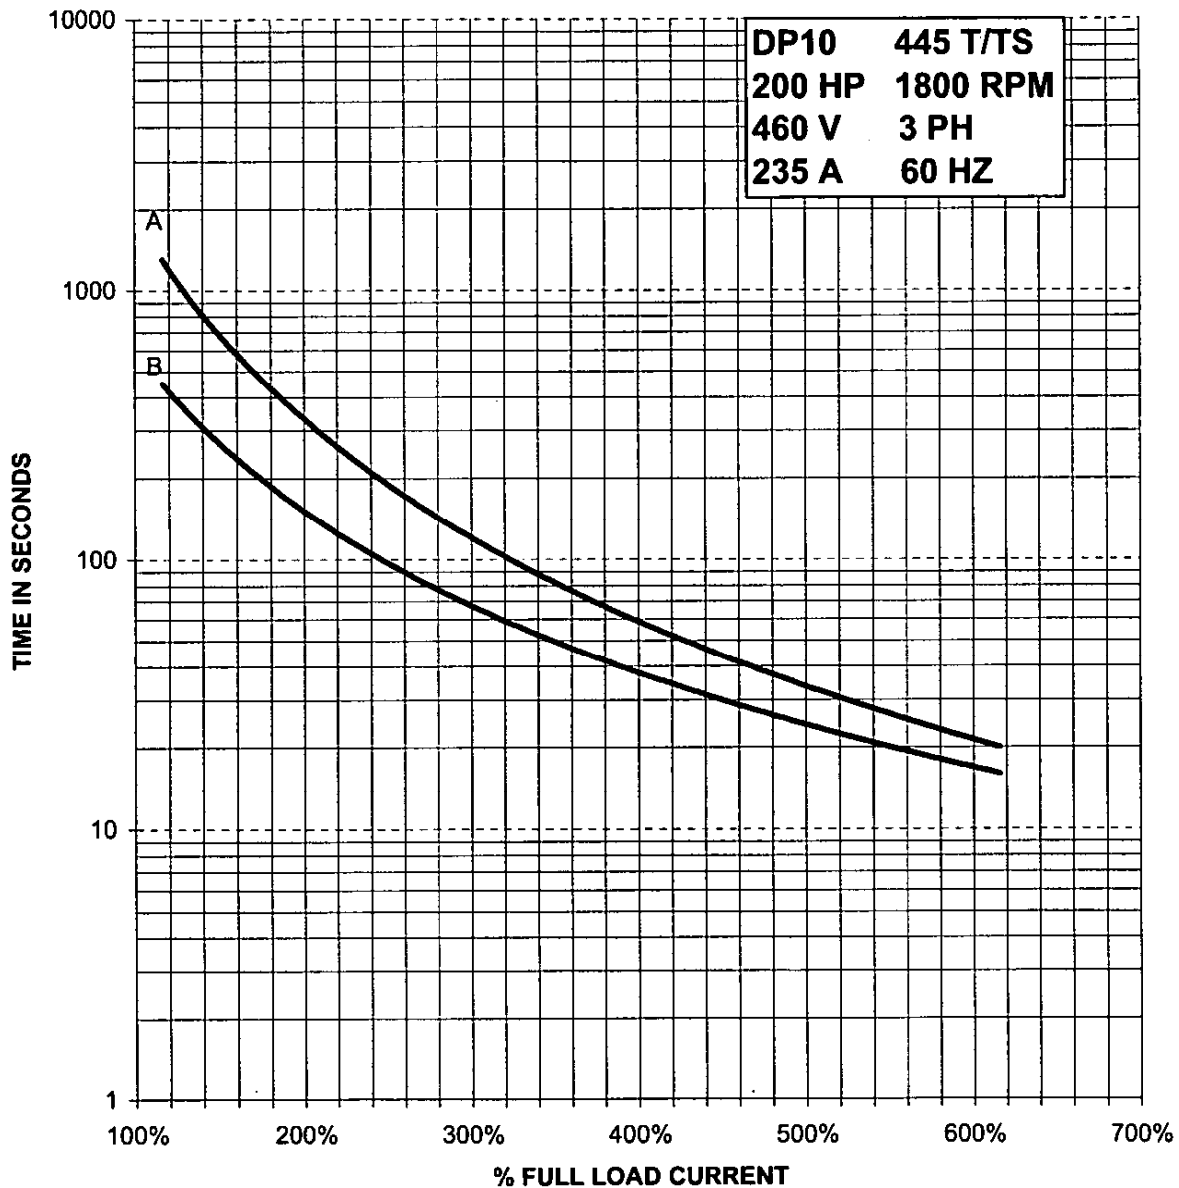
## STALL TIME VS. CURRENT CURVE

TIME MOTOR CAN RUN AT ANY GIVEN  
 AMPS STARTING WITH MOTOR AT:  
 A-AMBIENT TEMP. OF 40° C  
 B-FULL LOAD TEMP

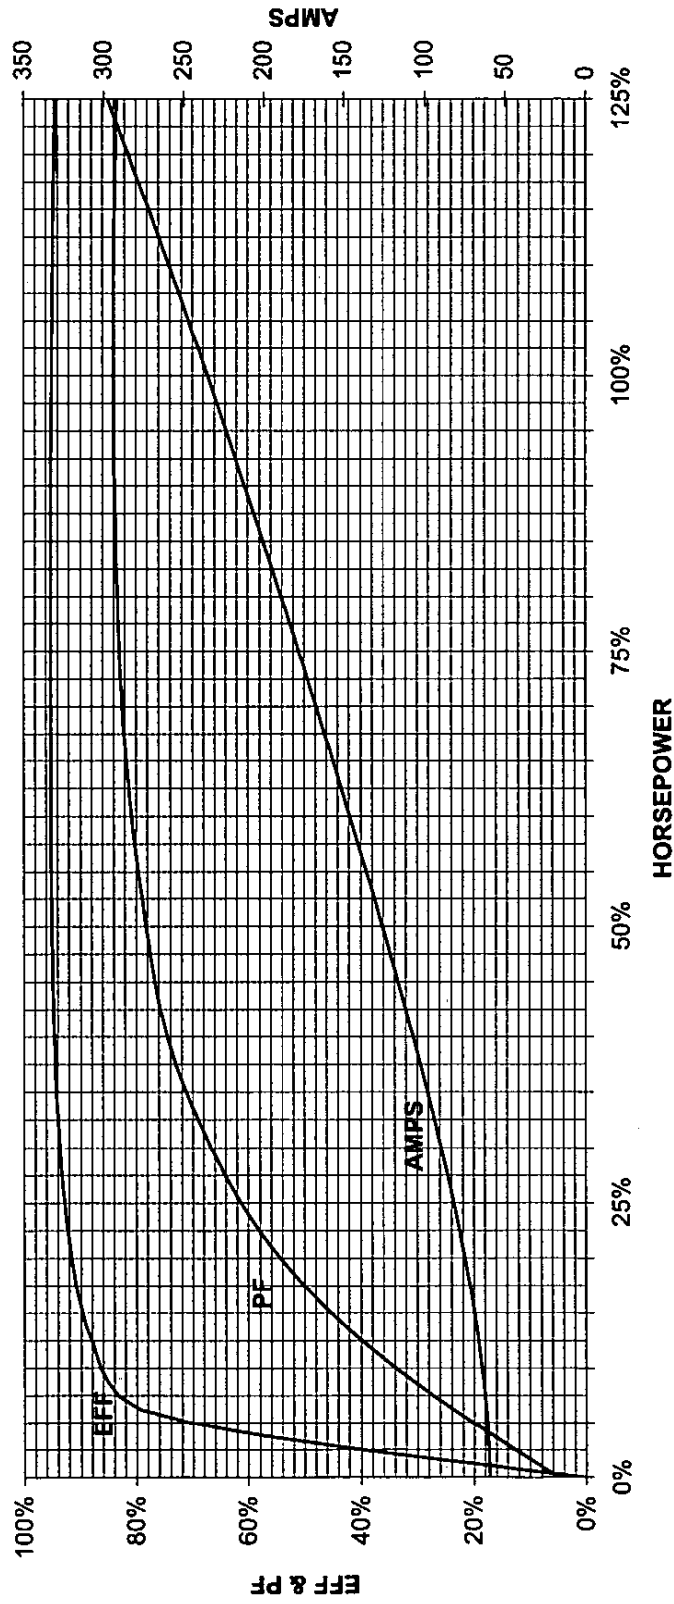
Siemens Energy & Automation, Inc.  
PERFORMANCE CURVE  
DP10

200 HP 1800 RPM 445 FRAME 460 VOLTS 3 PHASE NEMA DESIGN B
