Standard Recommended Practice

Recommended Practice for Prevention, Detection, and Correction of Deaerator Cracking

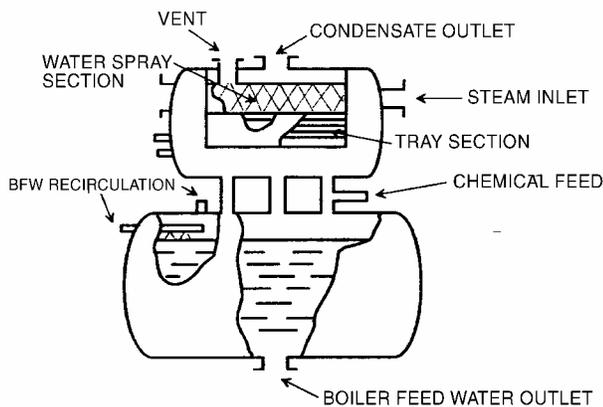
FIGURE 1a
Typical Mechanical Feedwater Deaerator

Two typical designs of mechanical feedwater deaerators are shown in Figures 1a and 1c. Figures 1b and 1d show the weld areas associated with each type of unit. The steam used in these systems raises feedwater temperature, which lowers the solubility of oxygen. With proper venting, the steam also serves as the "stripping gas," removing the oxygen from the system, and with the system shown, provides feedwater storage and proper mechanical conditions for the feedwater pump.

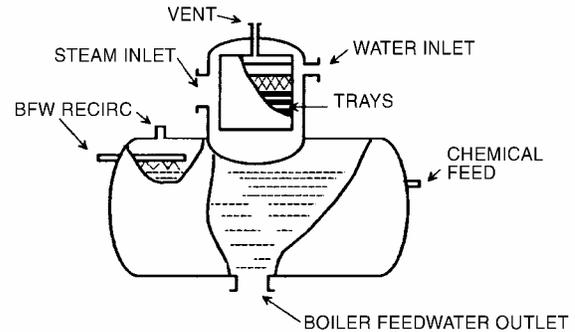
FIGURE 1c
Saddle-Type Mechanical Deaerator

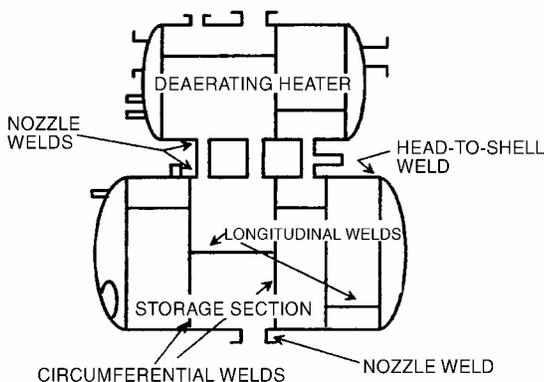
FIGURE 1b
Weld Areas Associated with Typical Unit

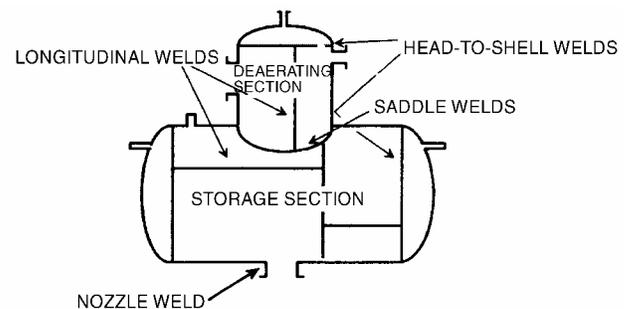
FIGURE 1d
Weld Areas Associated with Saddle-Type Unit

Where a vertical heater is welded directly to the storage vessel, the saddle weld is of particular interest because of the fabrication stresses possible.

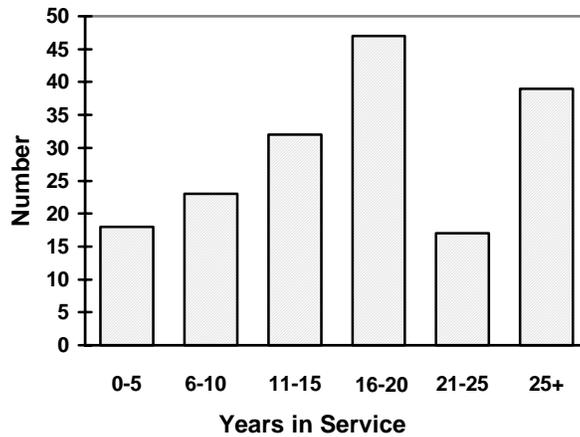
FIGURE 2
Deaerator Cracking Mini-Survey Sample Distribution by Years in Service

segment. Table 3 lists the definitions and provides an illustration of the terms used to describe the discontinuity types reported. Three categories were used to define the severity of cracks detected, with the most severe being Type C, which usually required repair by welding. Figure 2 shows the sample distribution as a function of unit age; Figure 3 illustrates the number of vessels in the total sample set that had incurred various degrees of cracking; Figure 4 shows the percent distribution of Type C discontinuities as a function of deaerator vessel age; and Figure 5 illustrates the total number of vessels with discontinuities as a function of vessel age. Overall, this survey supports initial observations that the deaerator cracking problem is not a function of vessel age, especially in the area of total cracks detected.

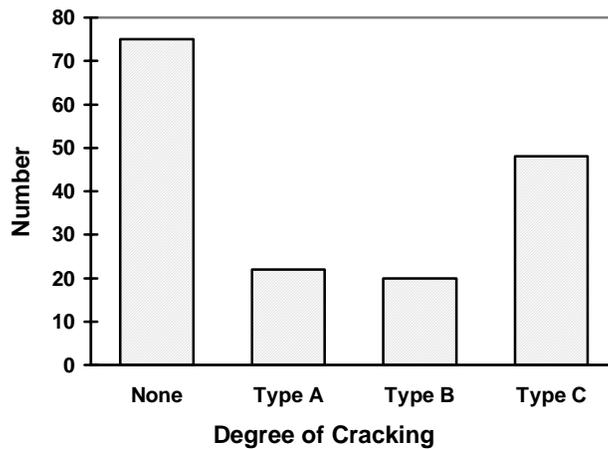
FIGURE 3
Cracking Distribution in Mini-Survey by Degree

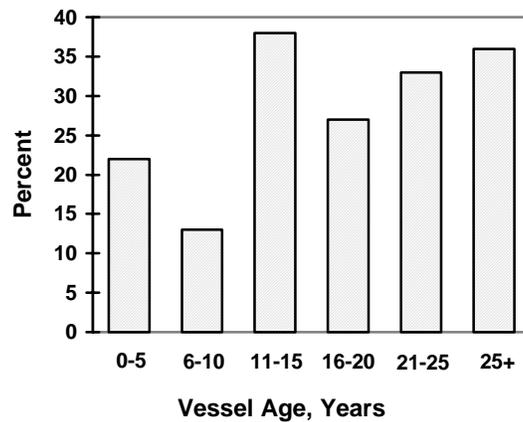
FIGURE 4
Type C Cracks Detected in Mini-Survey as a Percentage by Vessel Age

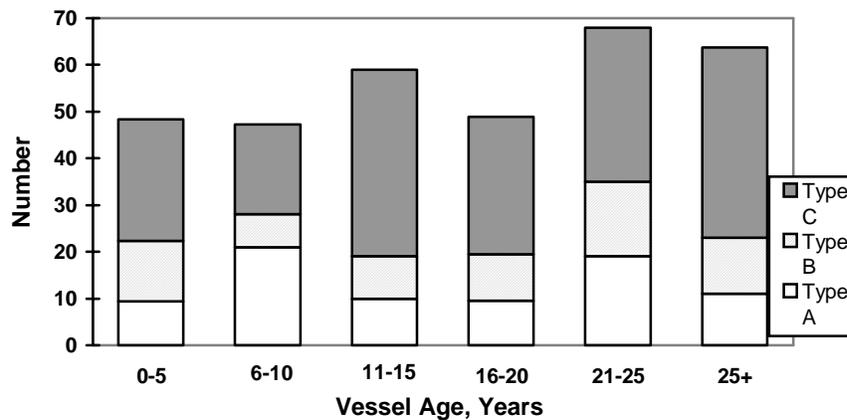
FIGURE 5
Total Cracks Detected in Mini-Survey by Vessel Age

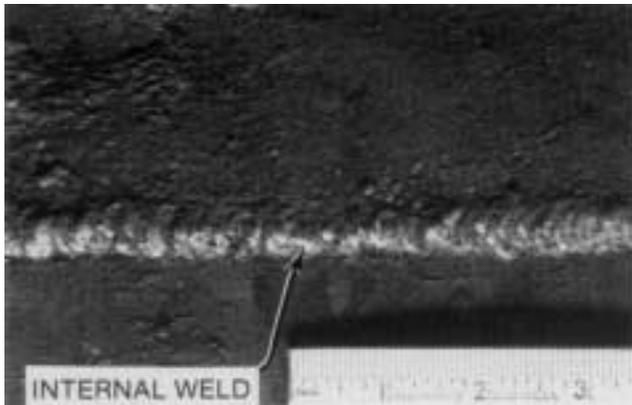
FIGURE D1
A Deaerator Head-to-Shell Internal Weld

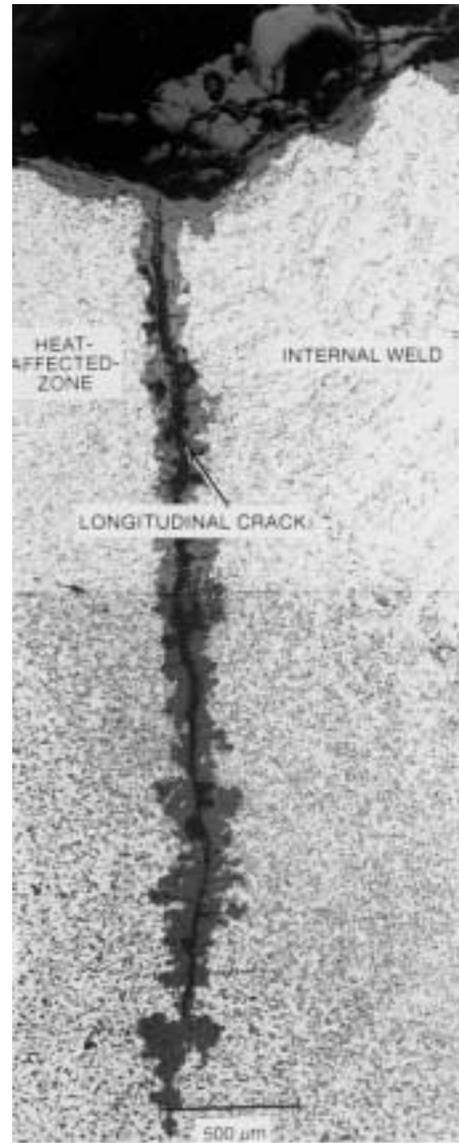
FIGURE D1a-1
Photomicrograph of the crack at the toe of the internal weld (unground) shown in Figure D1a.

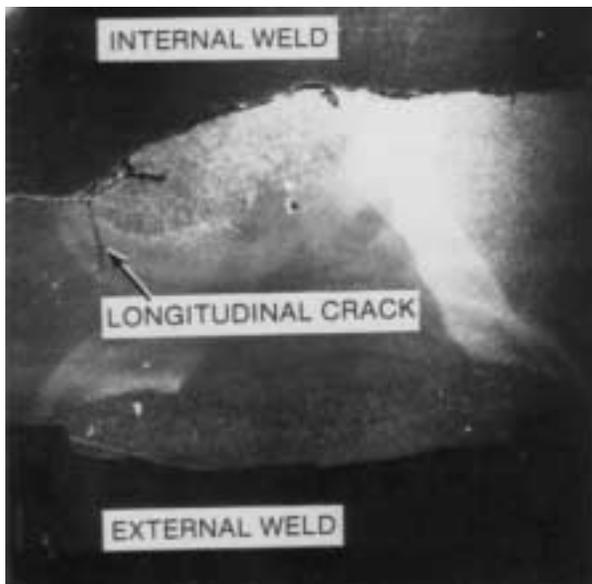
FIGURE D1a
A cross-section at a right angle to the weld section shown in Figure D1, showing both internal and external vessel welds and a longitudinal crack at the toe of the internal weld. 3X

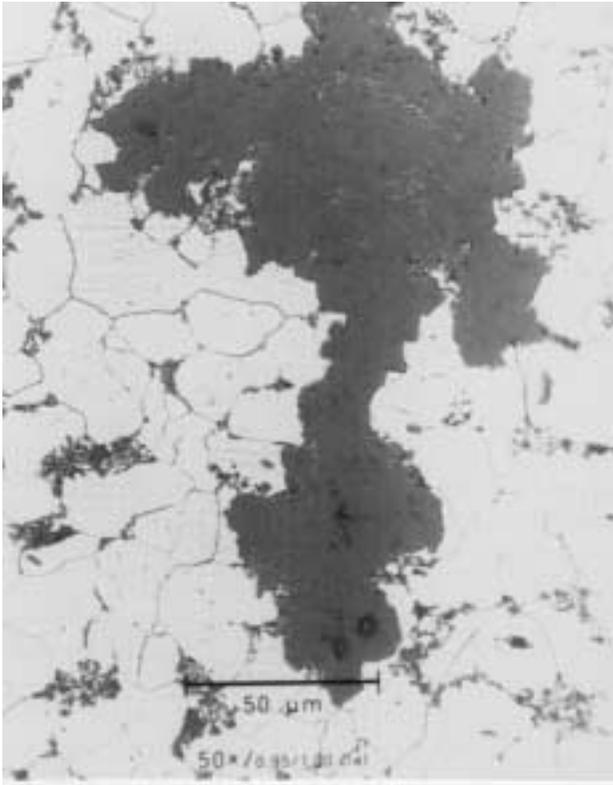
FIGURE D1a-2
The Tip of the Same Crack at Higher Magnification

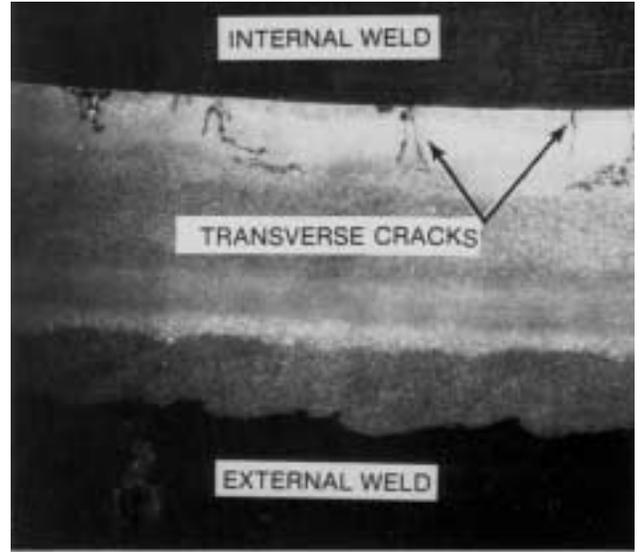
FIGURE D2a
A cross-section at a right angle to the transverse cracks shown in Figure D2. The cracks extend into the weld deposit and the heat-affected zone. 4X.

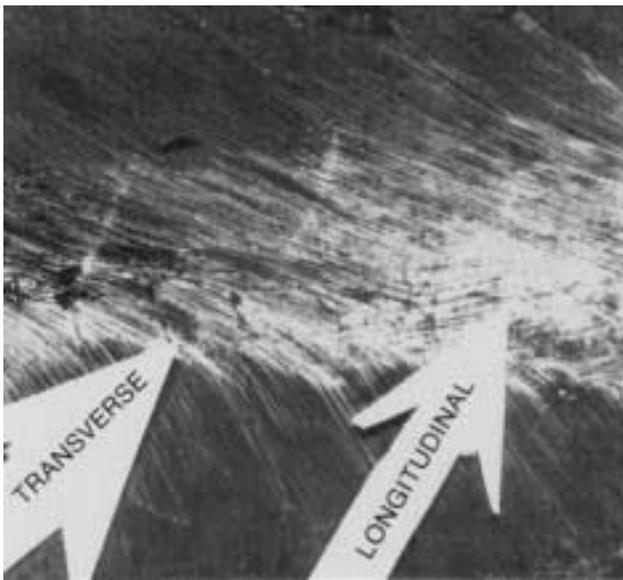
FIGURE D2
Another area of the same weld after grinding flush, shown at higher magnification (1.75X). Intersecting longitudinal and transverse cracks are revealed.

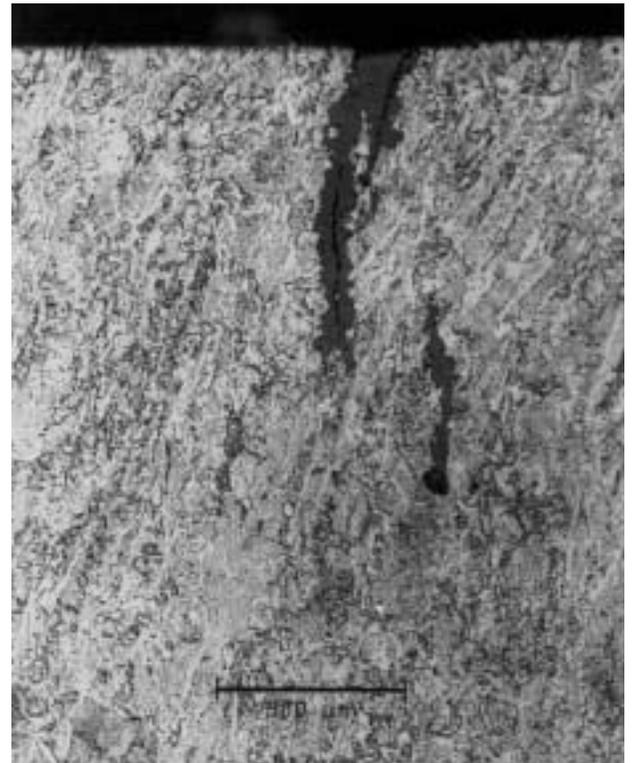
FIGURE D2a-1
Photomicrograph of one of the transverse cracks shown in Figure D2a.

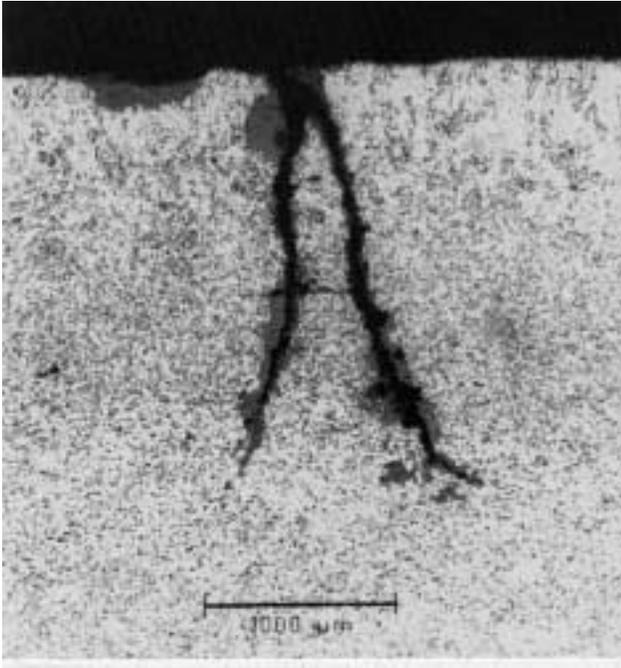
FIGURE D2a-2
Photomicrograph of another transverse crack.

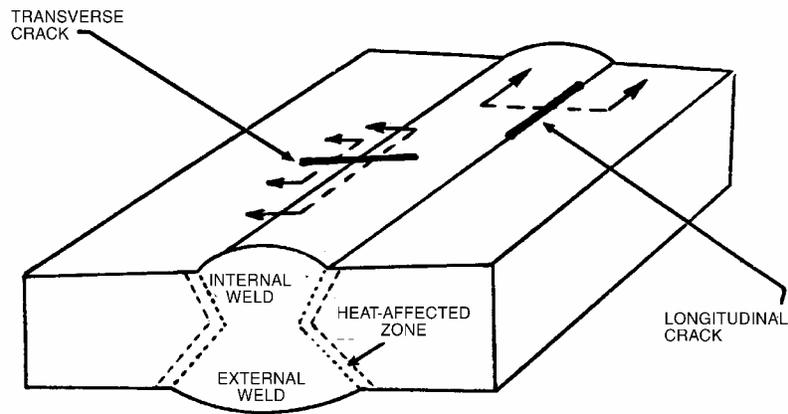
Appendix E: Illustration of Metallographic Cross-Sections at a Right Angle to the Longitudinal and Transverse Cracks

FIGURE E1
Metallographic Cross-Sections
