DETAIL 1 - GIRDER 1 REPAIR
ITEM 564.100001, 586.10
SCALE: 1/2" = 1'-0"

DETAIL 2 - GIRDER 1 REPAIR
ITEM 564.100001, 586.10
SCALE: 1/2" = 1'-0"

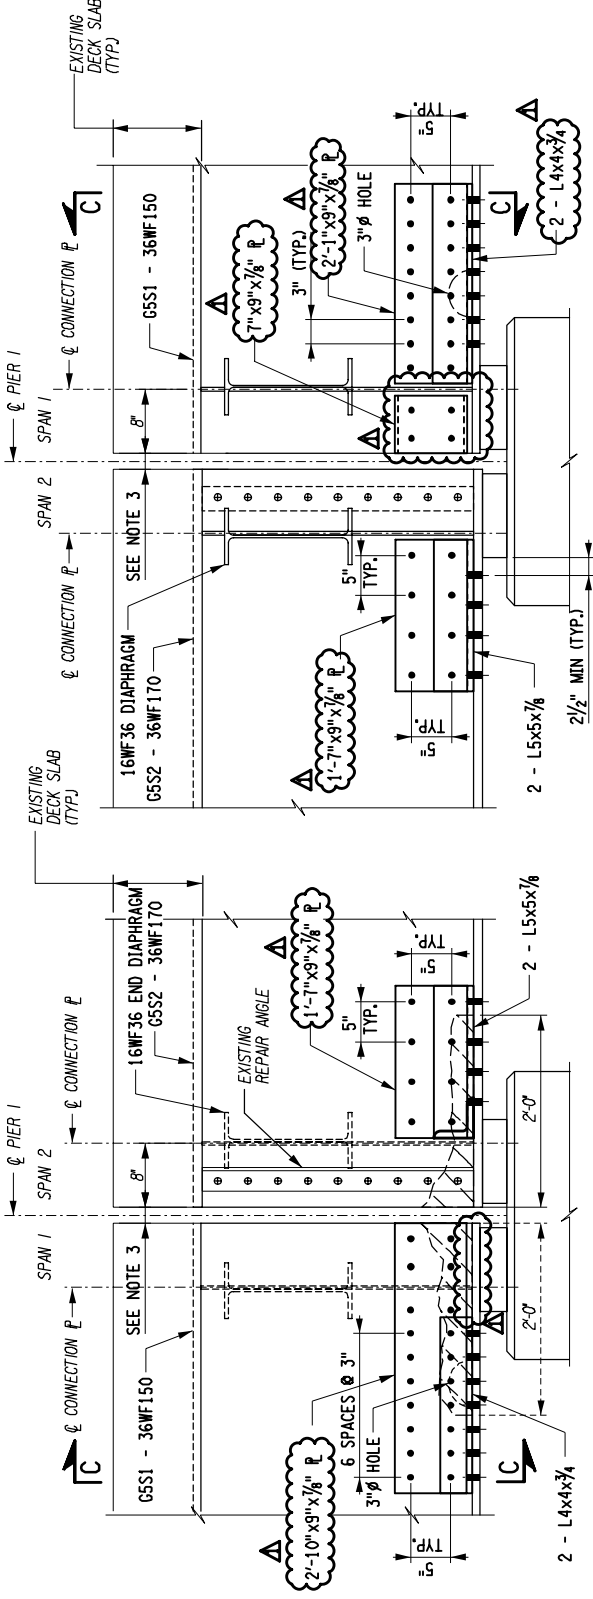
SECTION A-A
GIRDER 5

DETAIL 2 - GIRDER 5 REPAIR
ITEM: 564.100001, 586.10
SCALE: 1/2"=1'-0"

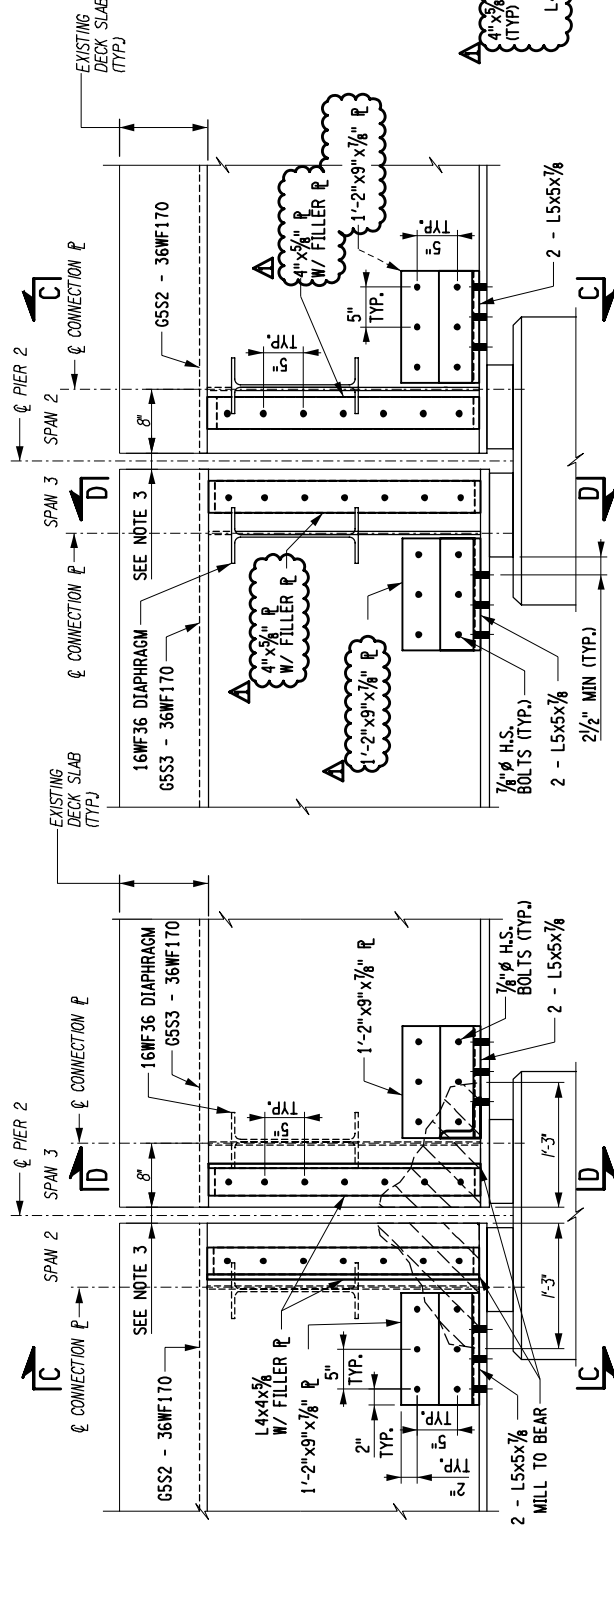
SECTION A-A
GIRDER 5

DETAIL 3 - GIRDER 5 REPAIR
ITEM: 564.100001, 586.10
SCALE: 1/2"=1'-0"

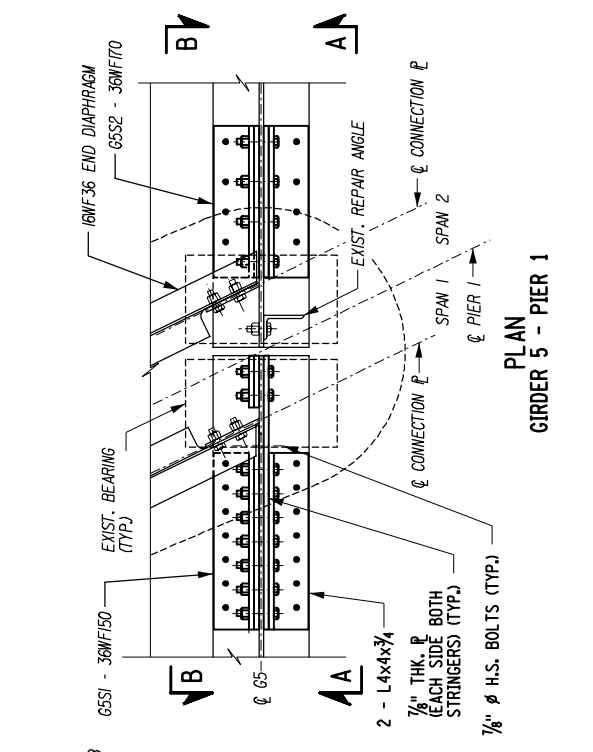
PLAN
GIRDER 5 - PIER 1

SECTION C-C (SHOWN)
SCALE: 1/2"=1'-0"

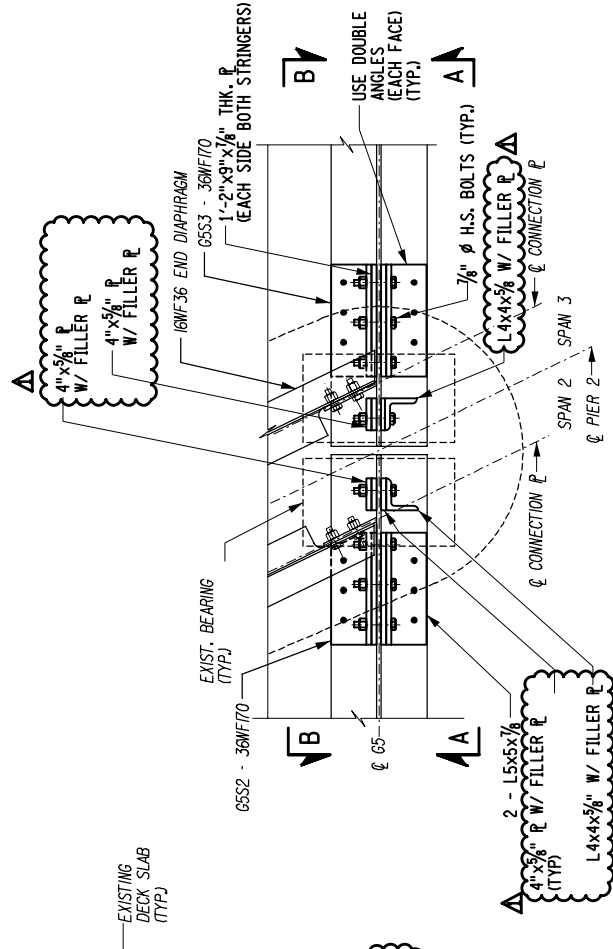
PLAN
GIRDER 5 - PIER 2

SECTION D-D
SCALE: 1/2"=1'-0"

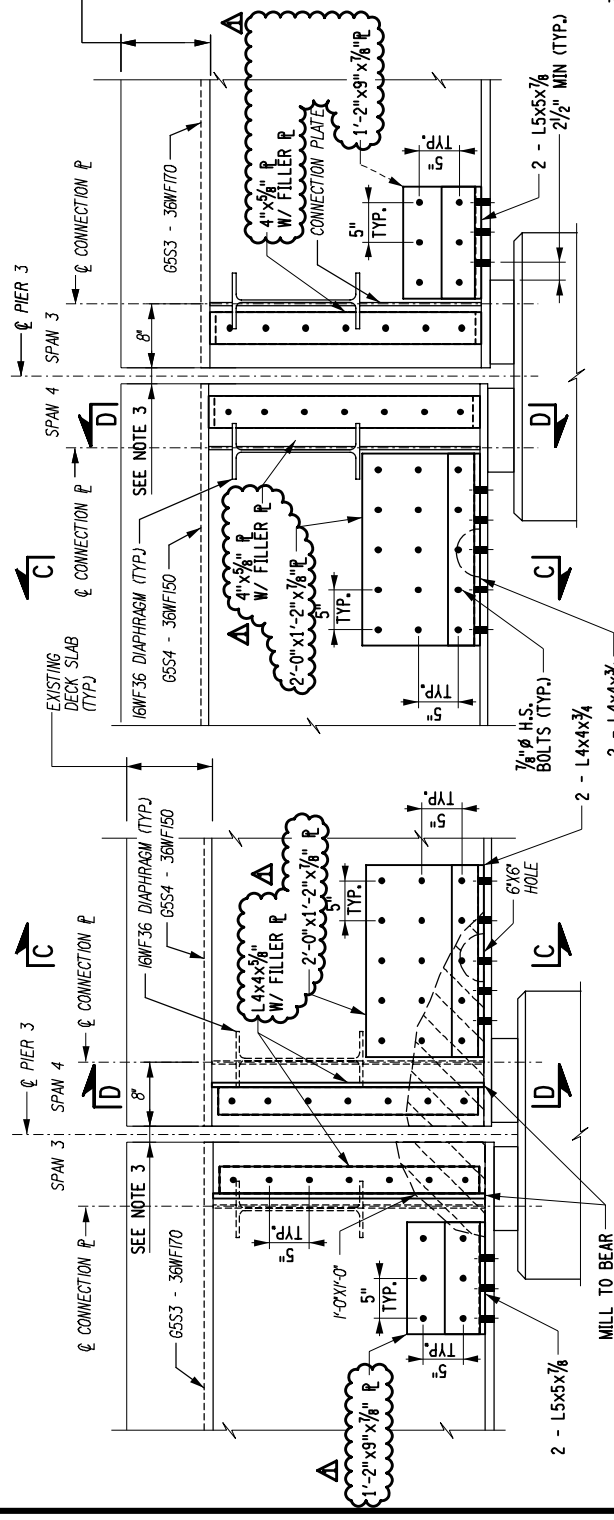
SECTION A-A
GIRDER 5

DETAIL 5 - GIRDER 5 REPAIR
ITEM: 564.100001 AND 586.10
SCALE: 1/2"=1'-0"

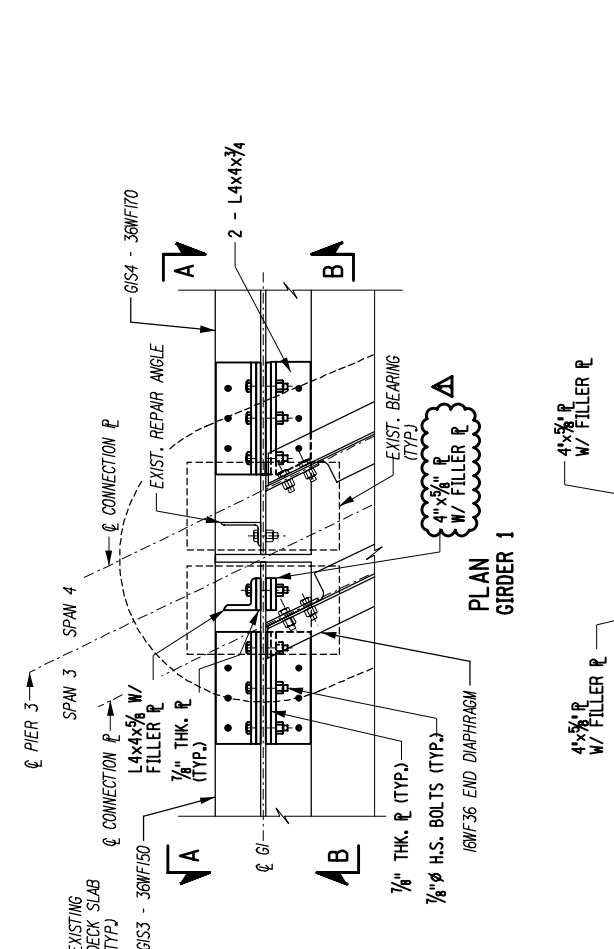
PLAN
GIRDER 1

SECTION C-C
SCALE: 1/2"=1'-0"

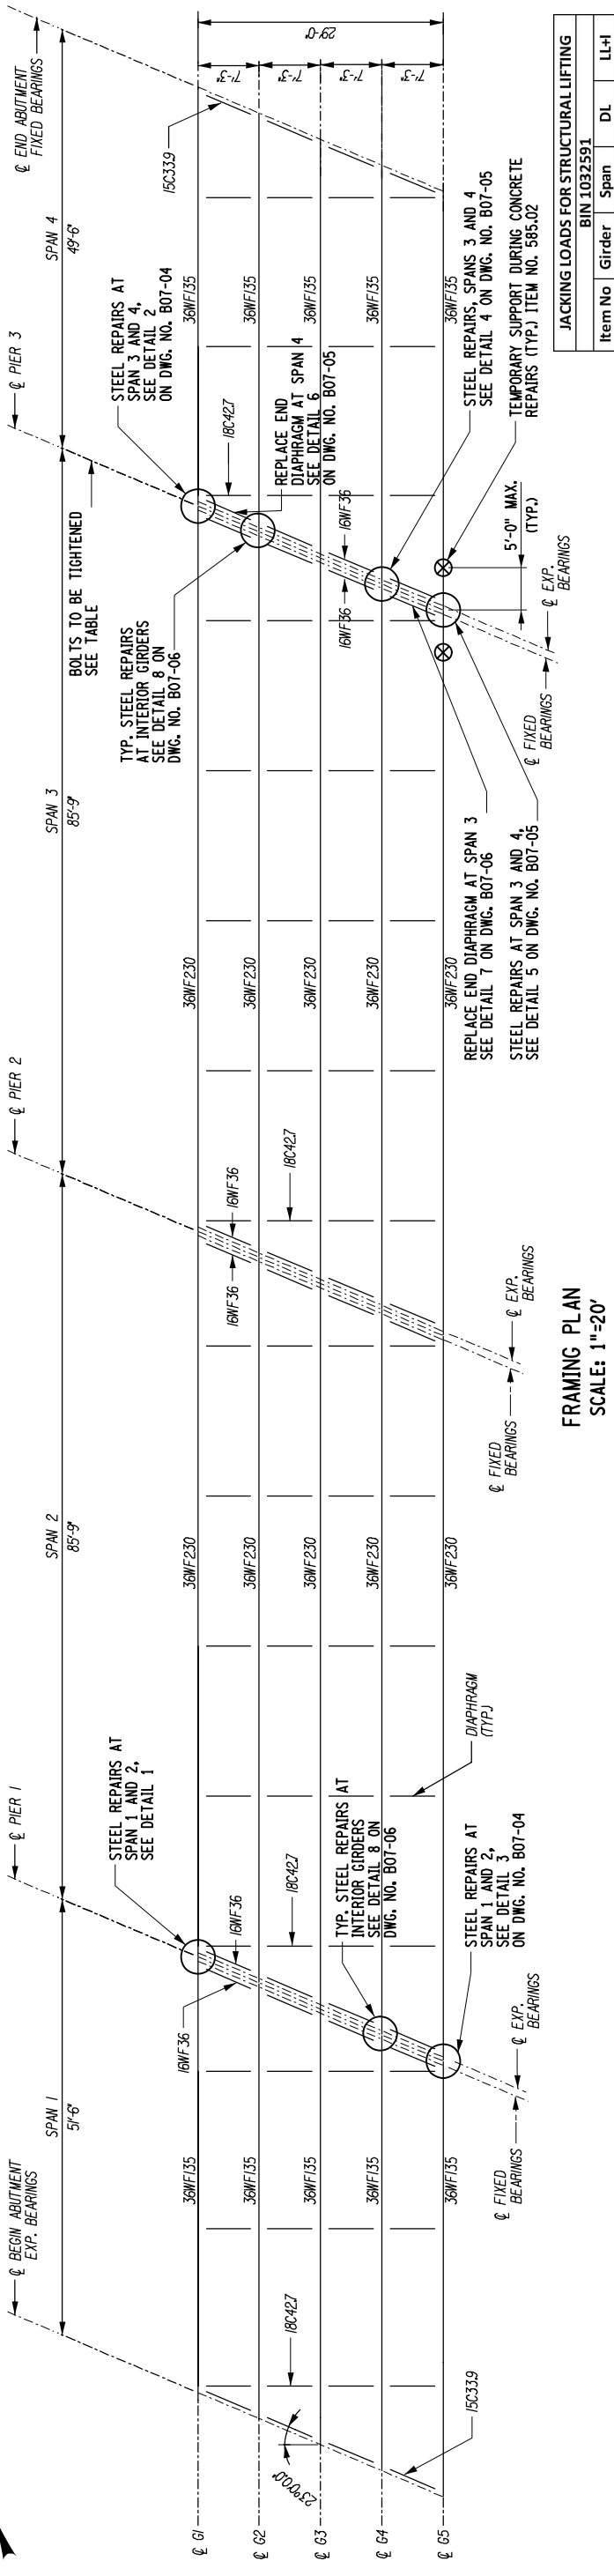
FRAMING PLAN
SCALE: 1"=20'

JACKING LOADS FOR STRUCTURAL LIFTING
BIN 1032591

Item No	Girder	Span	DL	LL+I
585.02	5	3	77.3	49.5
585.02	5	4	39.9	46.1

LOADS ARE IN KIPS.
ALL LOADS ARE WORKING LOADS.
LIVE LOAD IS HS-20.
IMPACT IS INCLUDED IN LIVE LOAD.

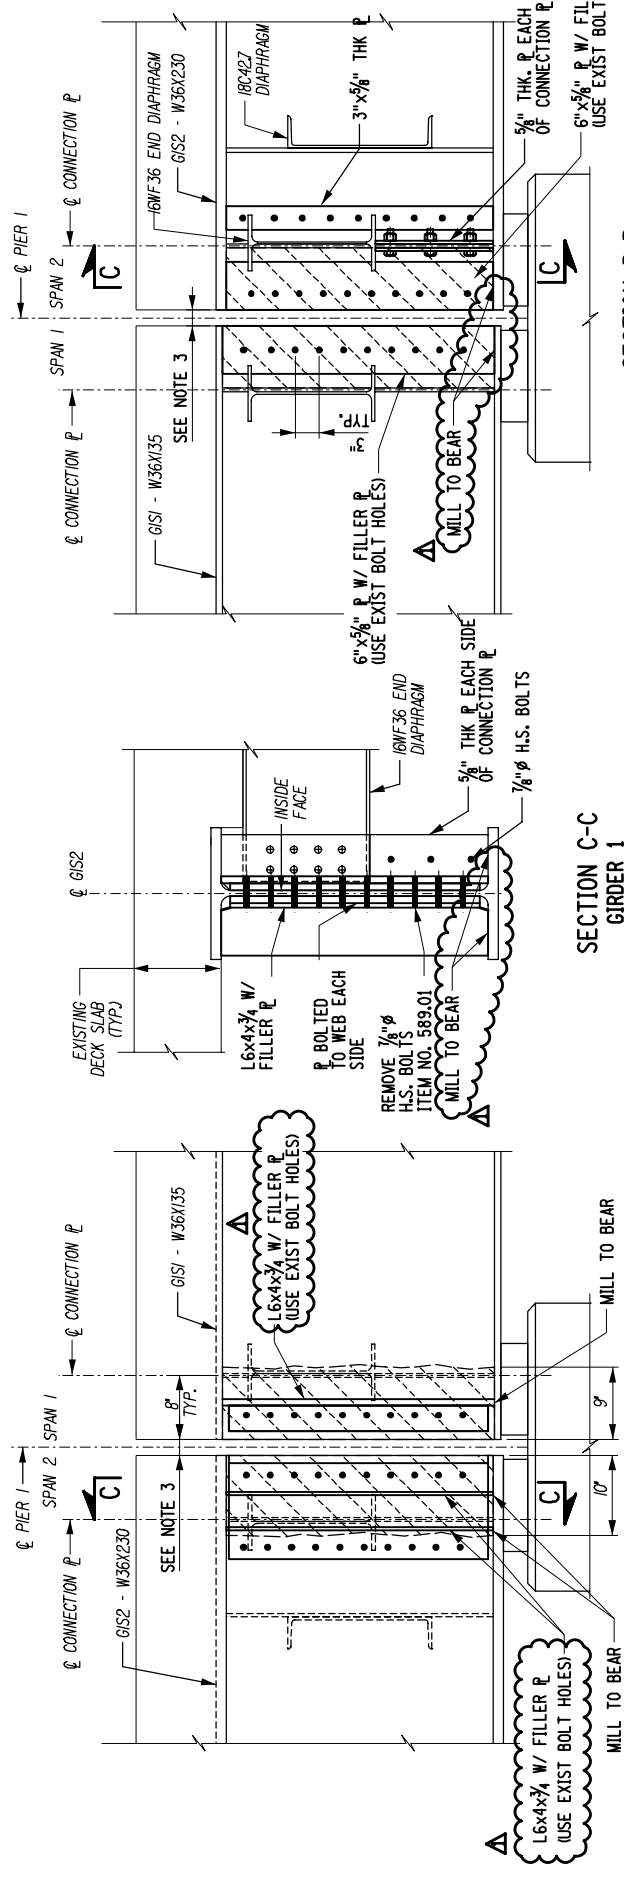
DETAIL 1 - GIRDER 1 REPAIR
ITEM: 564.100001, 586.10
SCALE: 1/2"=1'-0"

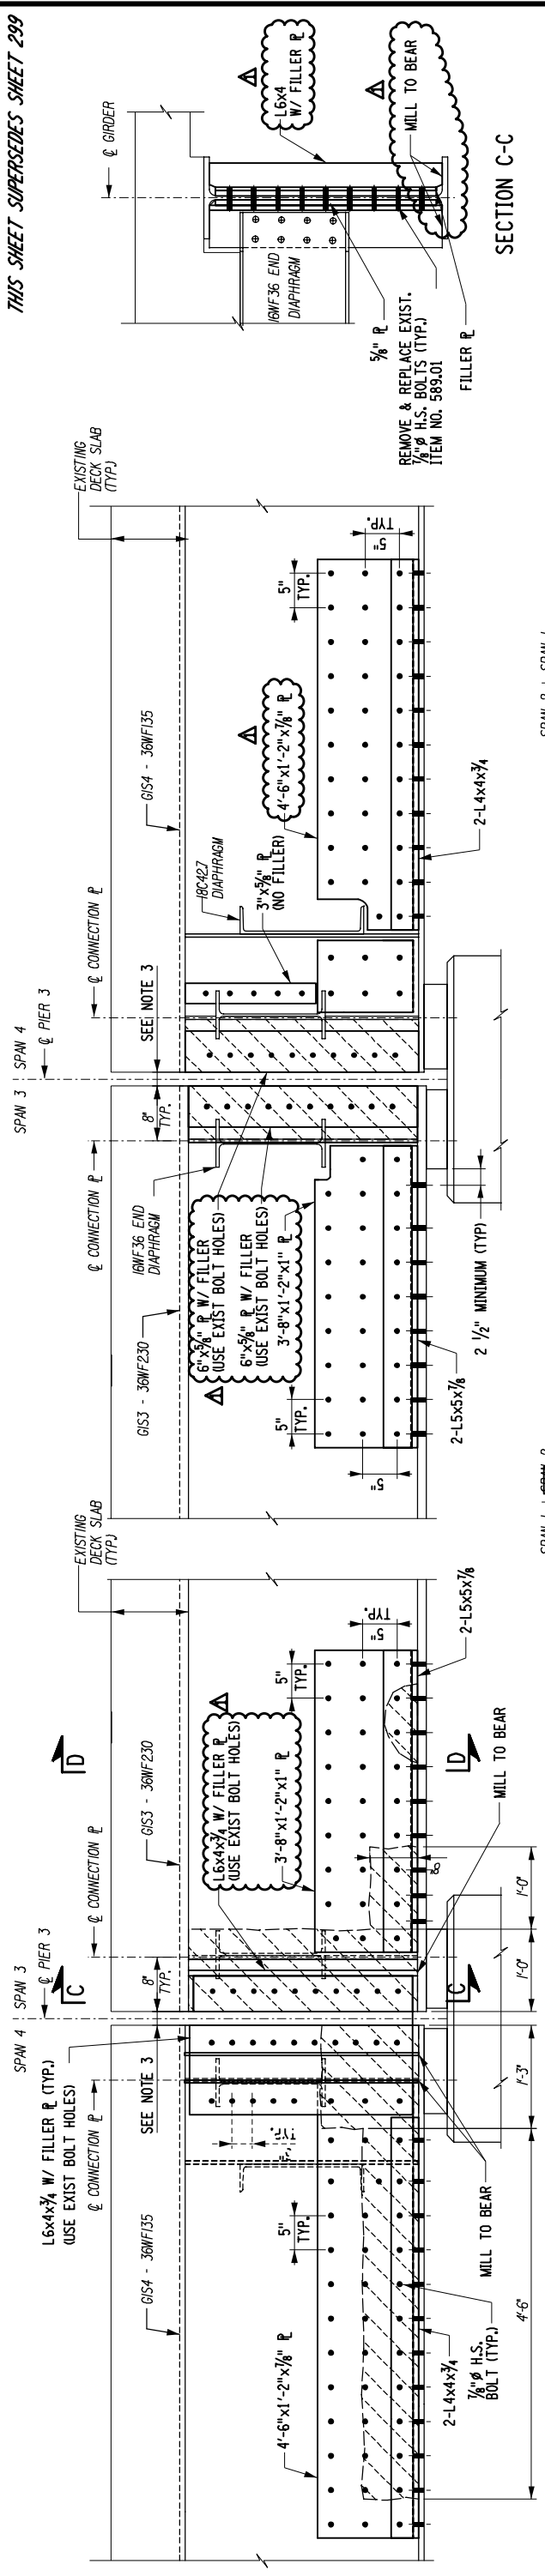
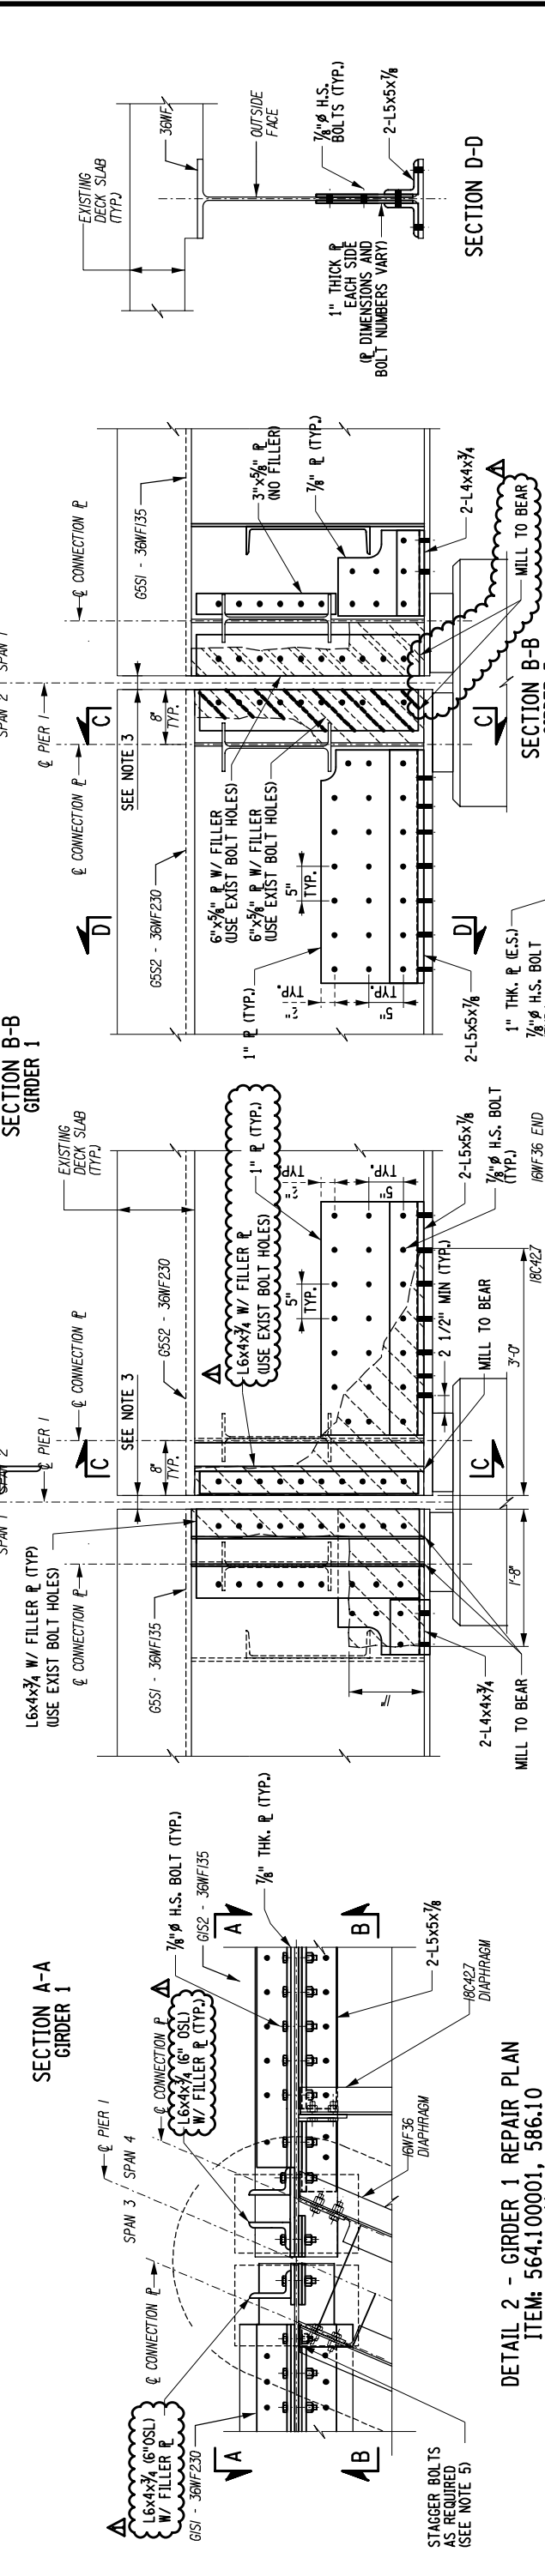
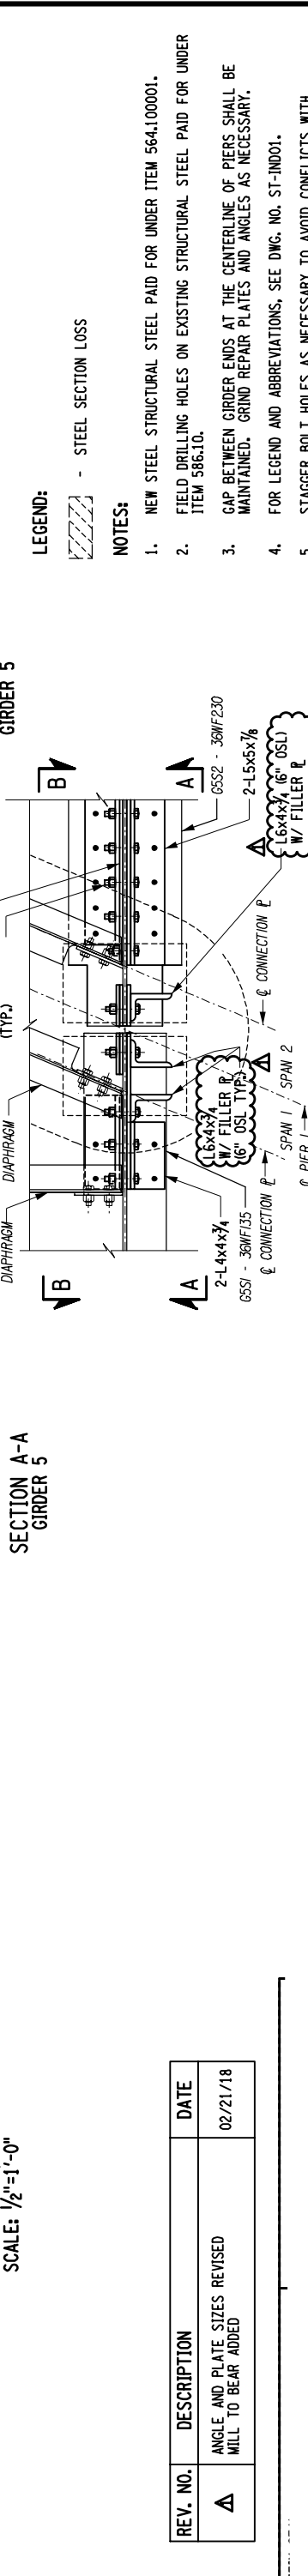
DETAIL 2 - GIRDER 1 REPAIR PLAN
 ITEM: 564.100001, 586.10
 SCALE: 1/2"=1'-0"

DETAIL 3 - GIRDER 5 REPAIR PLAN
 ITEM: 564.100001, 586.10
 SCALE: 1/2"=1'-0"

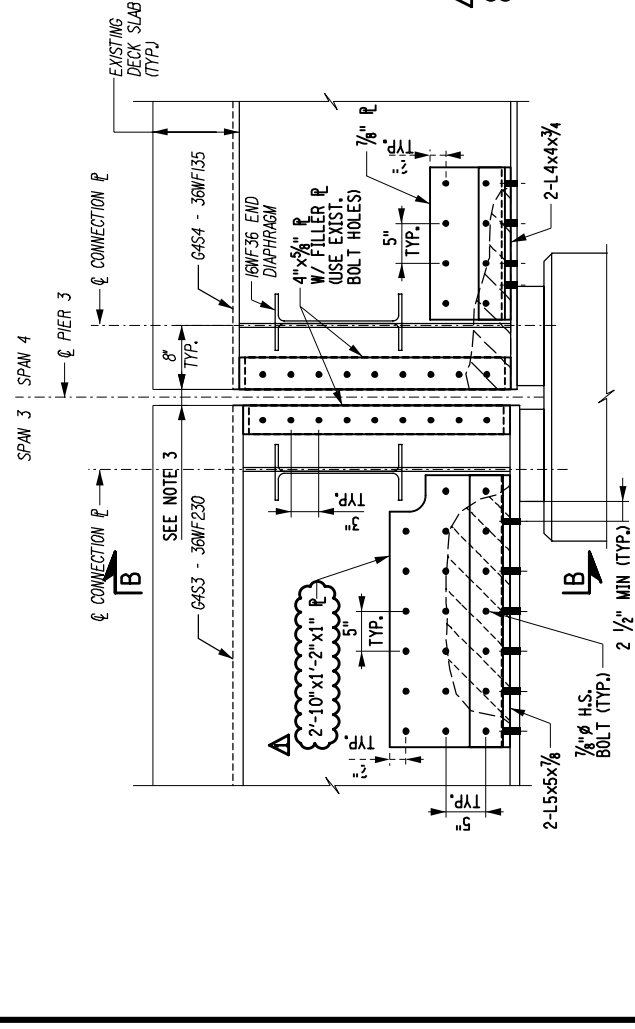
SECTION A-A
GIRDER 4

DETAIL 4 - GIRDER 4 REPAIR
ITEM: 564.100001, 586.10
SCALE: 1/2"=1'-0"

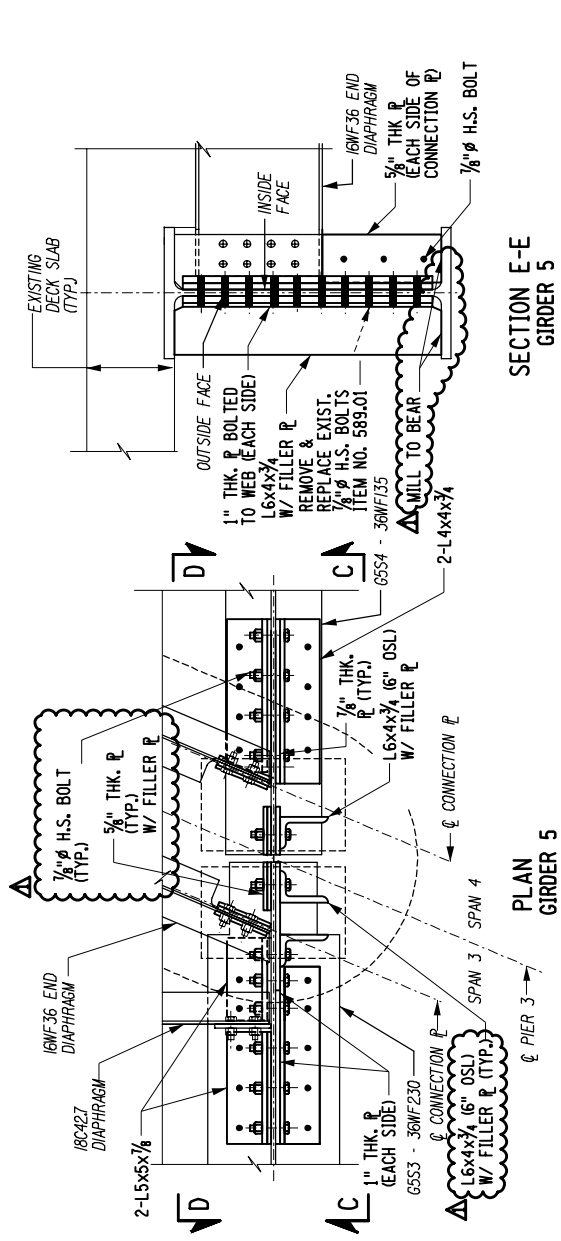
SECTION E-E
GIRDER 5

DETAIL 5 - GIRDER 5 REPAIR
ITEM: 564.100001, 586.10
SCALE: 1/2"=1'-0"
