Real size experiments of a car crash against a building column

Abstract

In this paper the device, procedures and instrumentation used in these experiments are described. Five experiments were done with this system and their results are presented here.

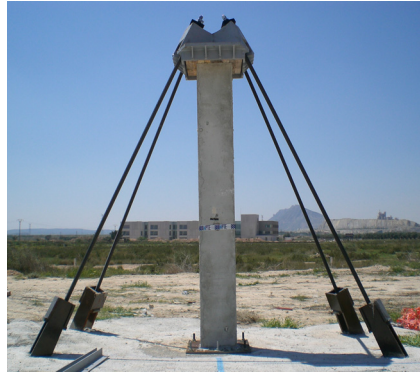
Figure 1: Test frame.

To apply the needed compression in the column, the frame shown in figure 1 was built. It consists on a foundation made with reinforced concrete that has 4 steel anchors and a steel upper part (figure 2). The compression in the column was

applied by 4 bar fixed to the 4 anchors and the upper part. The anchors in the foundation were set far from the bottom of the column, to allow the car to crash against the column. An anchor plate was placed in the middle of the foundation to allow the change of the column with a simple procedure.

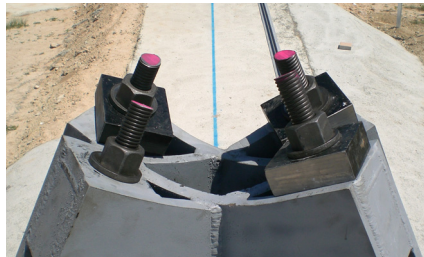
Figure 2: Foundation with four anchors during its construction (a) and upper part of the test frame (b).

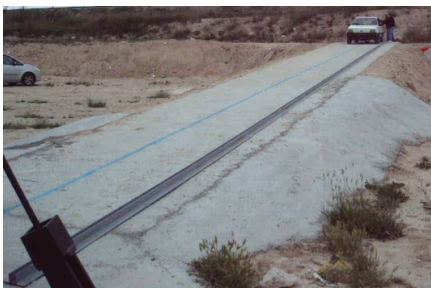
Figure 3: Ramp with metallic guide (a) and metallic wheel to maintain the direction of the car (b).

To provide the needed crash velocity in the cars without driver, a ramp was built. The slope and length of ramp was calculated to give a final velocity of 20 km/h starting from 0 at the top of the ramp. The ramp is 30 m long and has a slope of 8.3%. The fact that no driver is controlling the vehicle makes necessary to design a specific rail to maintain the direction. In figure 3(b) one can see how a metallic wheel is attached to the car in order to maintain it in the centre of the ramp (fig. 3).

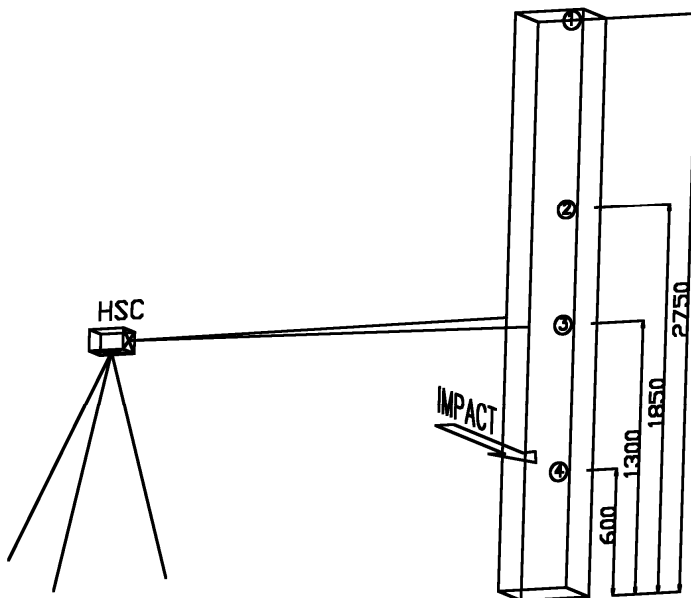
Figure 5: Location of points monitored (mm).

Additional devices used are: Signal conditioner (482A22 PCB Piezotronics) with 4 channels, sensor interface for accelerometers (PCD-300A Kyowa) with 4 channels, sensor interface for linear displacement sensor and strain gauges (Spider8 HBM). Four points in the column were selected to be analyzed with these sensors. These points are located in the opposite face of the impact at 0.6 m (impact), 1.3 m (maximum displacement expected, 1.85 m and 2.75 m (upper part) high (figure 5).

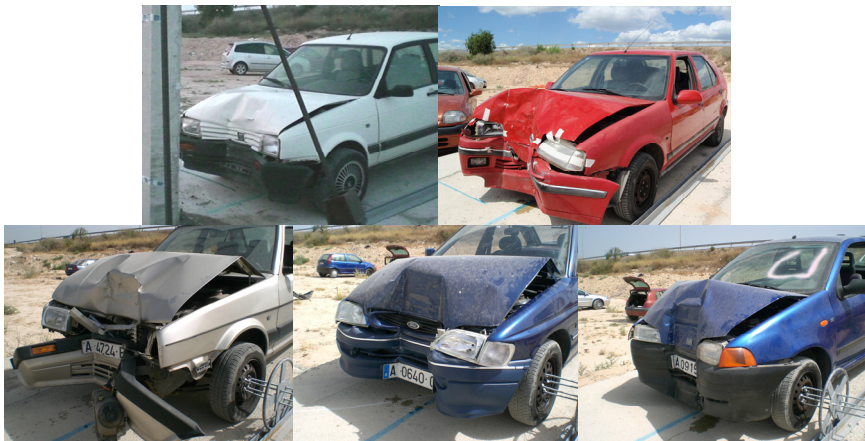
Figure 6: Final car condition after the experiments: Seat Ibiza, Renault 19 Chamade, Seat Málaga, Ford Escort, Fiat Punto.

All the five cars used in the experiments show noticeable plastic deformation (fig. 6). The maximum displacement of the frontal part in each car was measured (fig. 7) and the values are shown in table 2.

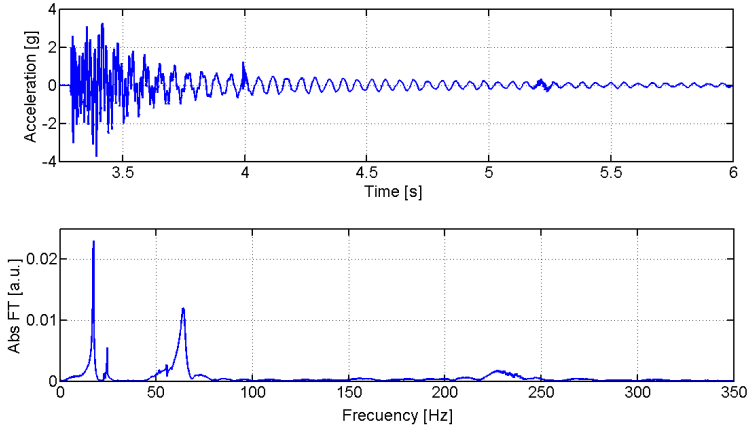
Figure 8: Recorded acceleration in the fourth experiment and Fourier transform.

An example of registered acceleration is shown in fig. 8. The graph shows the data from the accelerometer located at point 3rd in 4th impact and its Fourier transform. For a more accurate visualization of the behaviour during the impact, an enlarged view of the first time period of the impact is shown in fig. 9. From this figure it is clear that there are two different behaviours. During the first 120 ms of recording, the signal is very irregular and no pattern can be observed. However, from time 120 ms, a harmonic wave can be matched to the acceleration. The first part may correspond with the time during the car is pushing against the column while the second part corresponds to a free vibration of the column after car rebounds. This behaviour was observed in all the experiments and can be also seen with the HSC as we show in fig. 10. The duration of the irregular part coincides in both the accelerometer and the camera registers so the duration of loading in the column can be set in 120 ms approximately (figs. 9, 10).

In fig. 8 one can see that the frequencies of the pillar are 17.3 Hz and 64 Hz. A small peak at 17.4 can also be observed. These frequencies agree with the ones obtained from the HSC, as we show in fig 11. This feature was observed not only for this experiment but also for all of them (table 4). The camera show also very noisy data from 100 Hz, but this is done to flickering in the image and no reliable data can be obtained in this region for the presented setup.

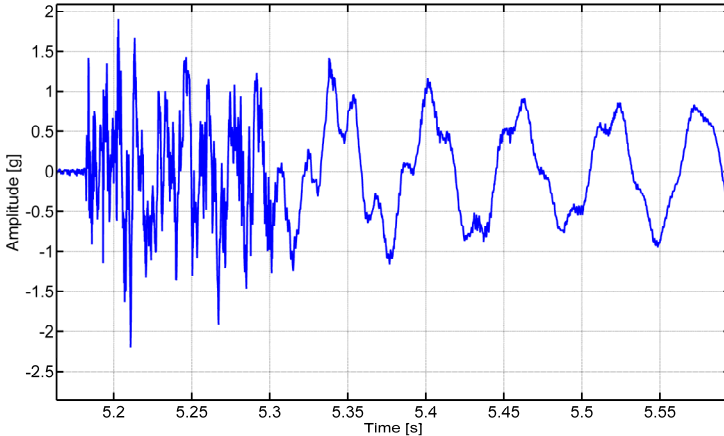
Figure 9: Detail of the recorded acceleration shown in fig. 8 – signal during the first time of the impact.

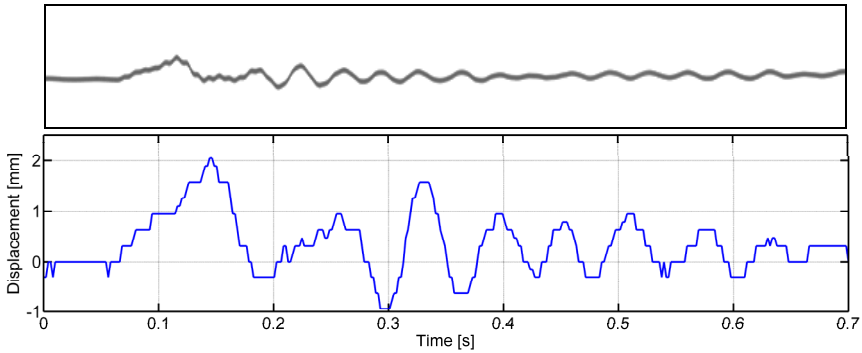
Figure 10: Results obtained from HSC in fourth experiment (top) and numerical reconstruction of this signal (bottom).

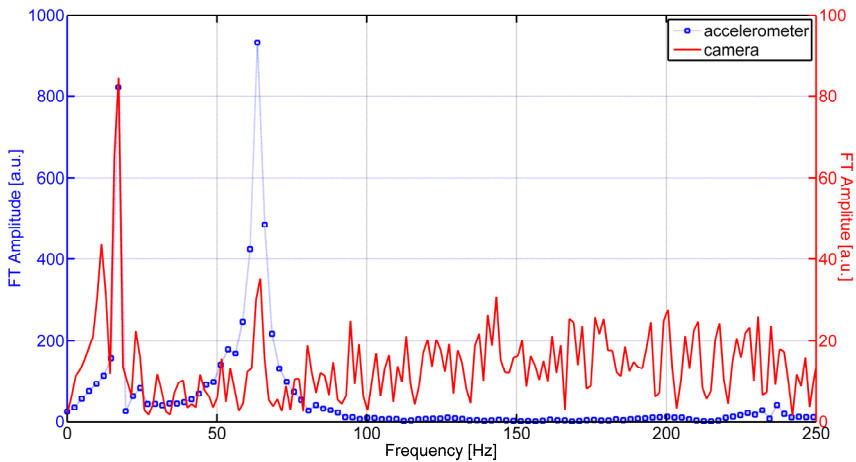
Figure 11: Fourier transform of LDS and HSC signal from the second impact.

Although the data were also taken with LDS, the obtained frequencies do not always agree with those from the accelerometers. Thus, data from these devices were not considered and camera results were taken as real displacement data. We would also like to emphasize that the observed frequencies are decreasing with successive experiments, what agree with the fact that the bars lose load with the time and the crashes.
