Effects of Pile Driving Through a Full-Height Precast Concrete Panel Faced, Geogrid-Reinforced, Mechanically Stabilized Earth (MSE) Wall

R. Berg, F.ASCE¹, and C. Vulova, M.ASCE²

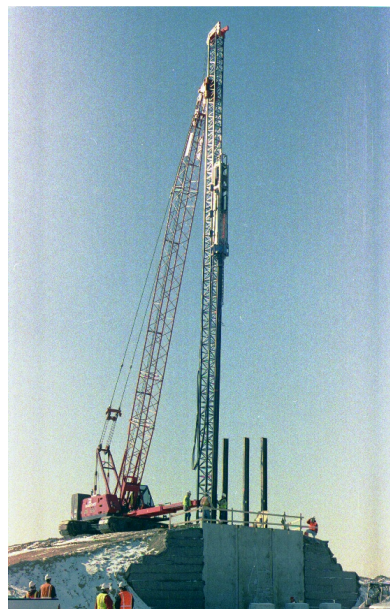
Figure 1. Pile diving through a full-height precast concrete panel faced geogrid-reinforced MSE wall.

Full-scale testing (Figure 1), to investigate the feasibility of this alternative construction technique for the Colorado E-470 project, was conducted in November 2000. The effects of pile driving on wall behavior were investigated on an instrumented 4.6-m (15-ft) high, 8.2 m (27 ft) long wall, with full-height precast concrete face panels, silty sand wall fill, and HDPE geogrid soil reinforcement. Four

A mechanically stabilized earth (MSE) retaining wall with full-height precast concrete panels and uniaxial high density polyethylene (HDPE) geogrid soil reinforcements was selected for the test, see Figure 1. An elevation and a plan view of the structure are shown in Figure 2.

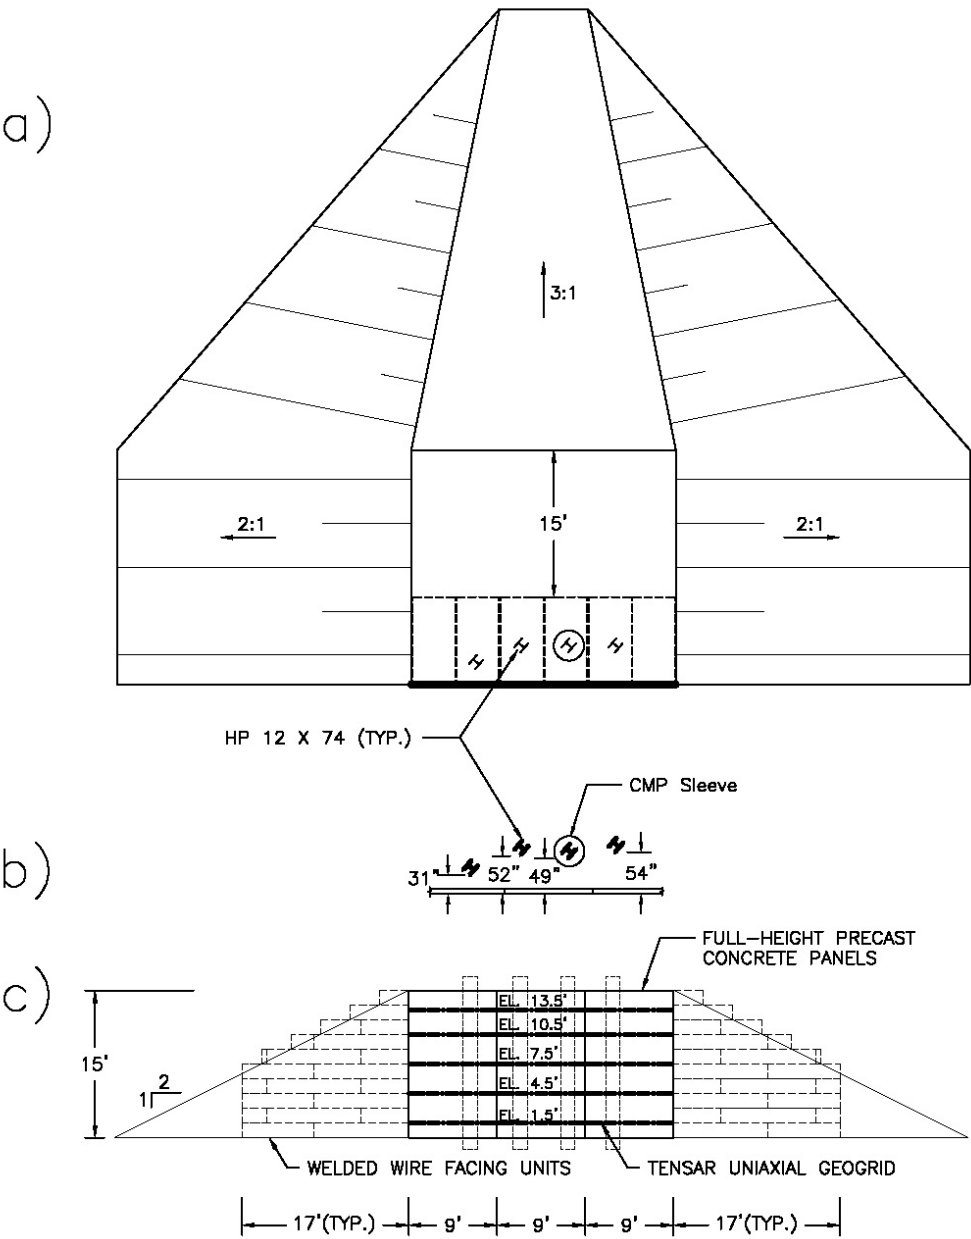
Figure 2. Field-scale test bridge abutment structure: (a) plan view; (b) pile location in plan view; (c) elevation view.

Piles and Driving Equipment. Four steel HP 12 x 74 piles were driven through the abutment reinforced mass after the wall was backfilled to the top. The piles were driven at a distance from the back of the panels varying from 0.8 m (31 in) to 1.4 m (54 in) (Figure 2b). Each pile had identical drive points fillet-welded to the toe (Figure 3). A Manitowoc 222 pile driver was used to install the piles. A hydraulic pile hammer, Junttan HHK6 (Figure 1), with a maximum energy of 72 kN-m (53 ft-kip). One of piles was installed through a 0.6-m (2 ft) sleeve extending 2 m (7 ft) beneath the top of wall.

Wall Design. The design of the test wall was based on the National Concrete Masonry Association (NCMA) design guidelines. The soil reinforcement was under-designed to exaggerate the effect of driving piles through the reinforced fill on the face panels. The geogrid elevations are noted on Figure 2c. A typical cross section is shown on Figure 4.

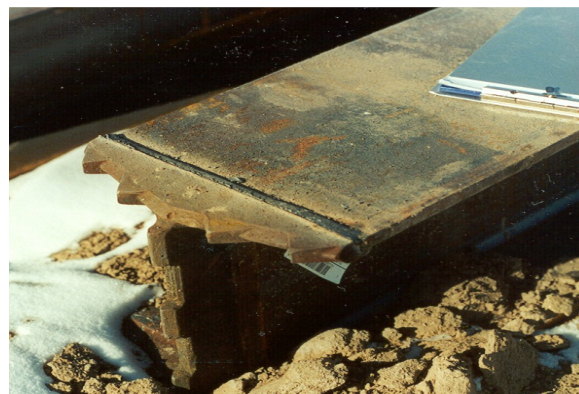
Figure 3. Pile drive point attachment.

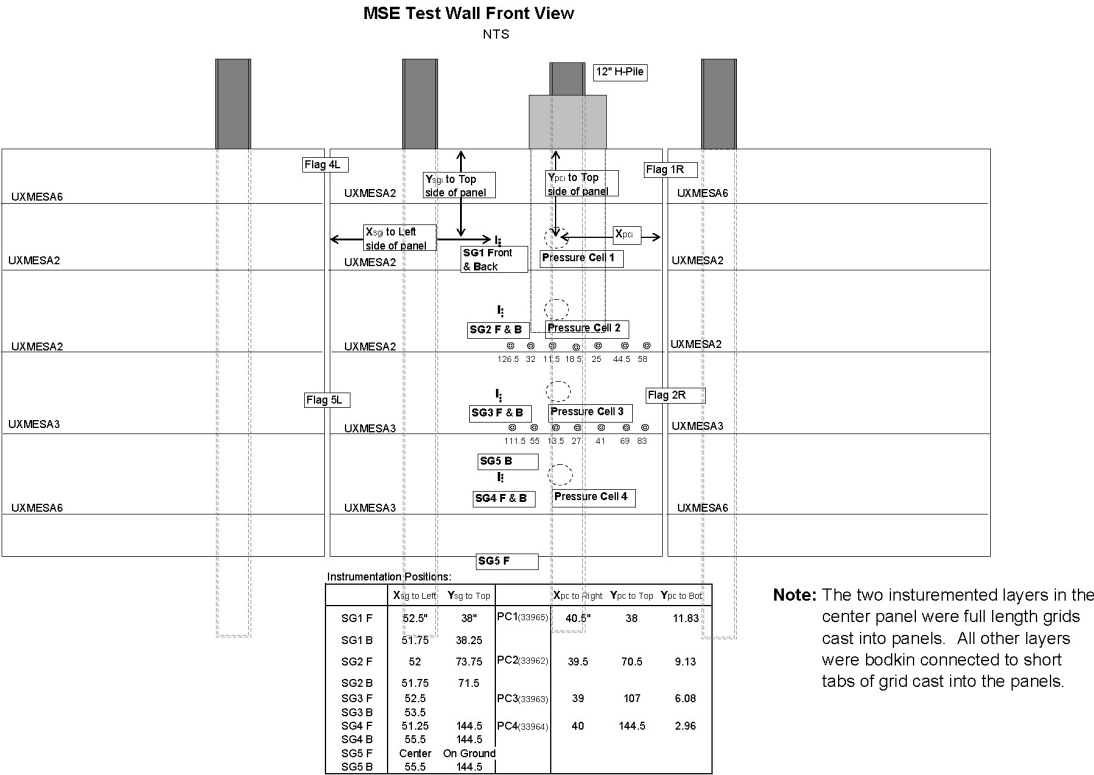
Figure 4. Instrumentation and geogrid layout.

Instrumentation. Locations of the instruments to monitor the abutment during construction and pile driving are noted in Figure 4. Also noted in Figure 4 are the geogrid soil reinforcements used in the center and outer panels and the location of the 10-foot deep sleeve used with the one pile. Instruments and measurements are discussed below, under Observations During Pile Driving.

Pile Driving. The four steel HP 12 x 74 piles were driven through the reinforced mass in a sequence right-to-left looking at the front elevation view of Figure 4. The centerline of the project piles are detailed to be 1.6 m (10.3 ft) back from the front face of the wall panel. The first three demonstration piles were installed at approximately the project design distance behind the wall panel. The fourth pile was installed at a distance of 1.0 m (3.3 ft) back from the front face of the wall panel. This pile was driven closer to increase the effect of pile driving on the facing panel.

Measurements. *Contact Earth Pressure Cells.* Four pressure cells were used to measure and monitor total stress lateral soil pressure against the backside of the center facing panel. The cells are illustrated on Figure 4 as dashed-line ovals and are labeled Pressure Cell 1 through 4. The four cells were mounted to the back of the center precast concrete facing panel in a vertical line, and in front of the planned location of one of the piles to be driven. Design and measured pressures before and after pile driving are summarized in Table 2. Only small variations in pressure (-3.5% to +13.5%) were noted after pile driving. Measured pressures were significantly less than design pressures, except at PC2. Pressures at PC2 were likely effected by the adjacent corrugated metal pile sleeve.

Panel Survey Flags. Four measuring tape lengths, or flags, were mounted to the facing panels at the adjacent panel joints. These flags extended perpendicular to the facing panels and were used to measure and monitor batter of the panels. The four flags are labeled Flag 1R through 5L and their locations shown on Figure 4.

Soil Reinforcement Extensometers. Telltales constructed from threaded metal rods and PVC pipe sleeves were used to measure the extension of the geogrid reinforcement along its length. The telltales were installed on two layers of geogrid at El. 1.4 m (4.5 ft) and El. 2.3 m (7.5 ft). The telltale locations are shown on Figure 4.

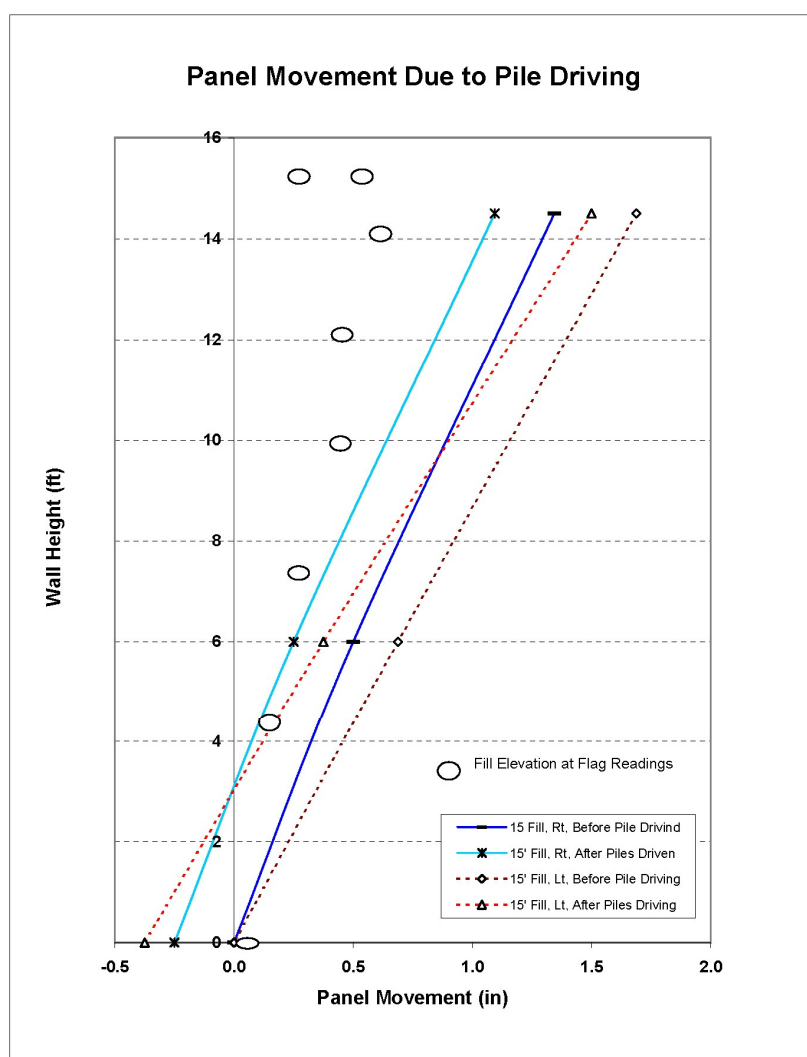
Figure 5. Measured lateral rotations and toe translation.

The average facing panel batter as erected, after backfilling and after pile driving are illustrated in Figure 5. The facing rotates during backfilling, as expected, and only a small rotation was observed due to pile driving. A small translation of the toe, approximately 6 mm (1/4-in) was recorded.

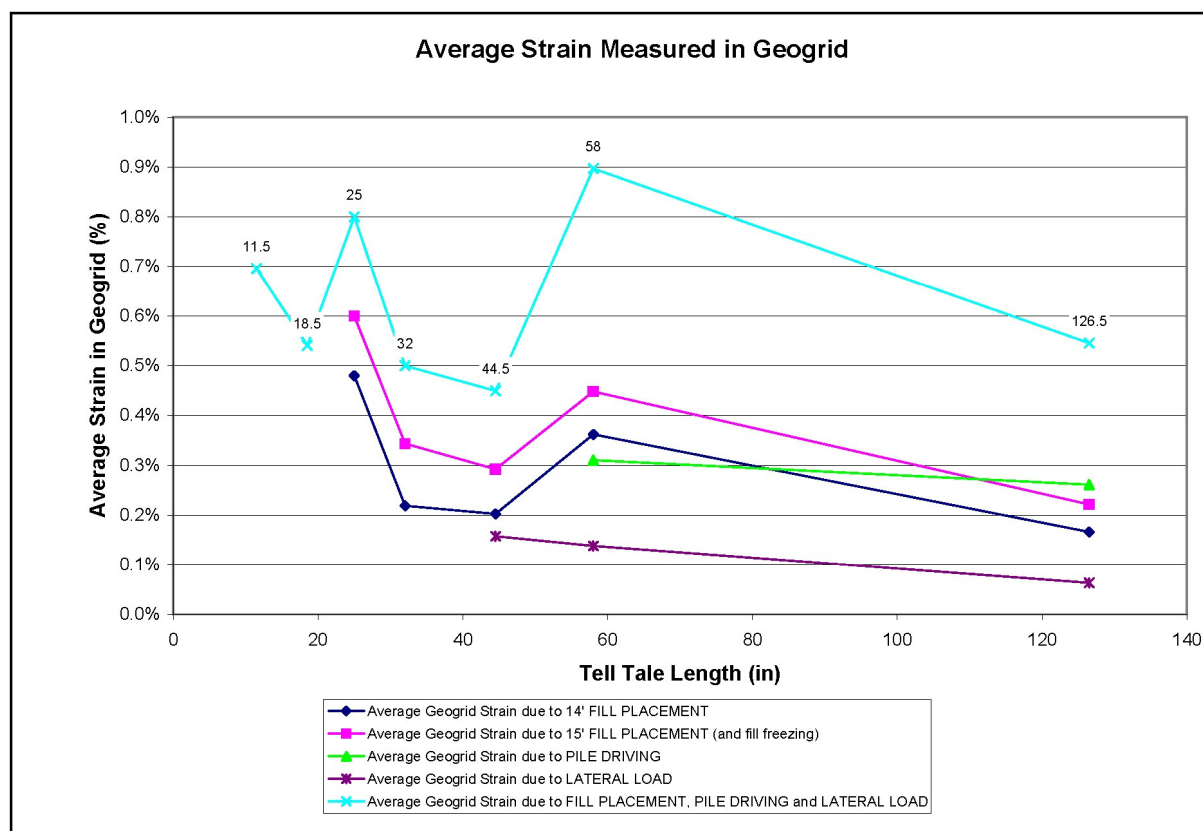
Figure 6. Average geogrid strain at 2.3 m (7.5 ft) for different construction stages.

The soil reinforcement telltale readings were used to calculate the change in the length for different conditions and the average strains in the geogrid. The computed average strains in the geogrid for different stages of the construction are shown in Figure 6 for the 2.3-m (7.5-ft) elevation. The telltale readings that were within the accuracy tolerance of 2-3 mm (1/8"-1/16") were ignored.

The average strains measured in the geogrid generally did not exceed 0.9%, which indicates significantly less tensile load on the reinforcements than the design loads. The average strain induced by the pile driving was 0.31 %, and the maximum average strain induced by the lateral loading on the pile was 0.16 %. The maximum average strain due to fill placement, pile driving and lateral loading was measured at the 58-inch-long tell-tale at elevation 2.3 m (7.5 ft). Maximum average strain of 0.6% due to fill placement and effects of fill freezing was measured at the 25-inch-long tell-tale at

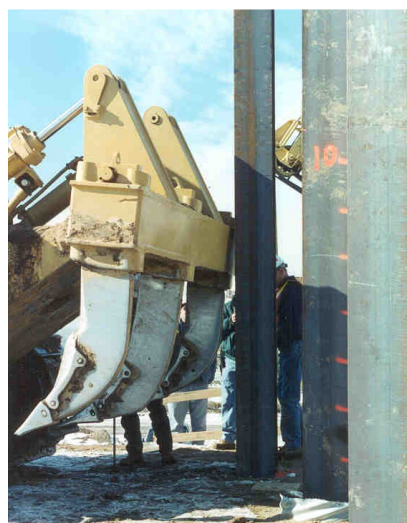
Figure 7. Applying lateral load to pile.

After installing the four piles, a large lateral load was placed on the first pile (Figure 7). This loading was applied to observe response of the facing panel, and to investigate possible elimination of the 3-m (10 ft) long sleeves. The loading pushed the pile 75 mm (3 in) outward. The load was released and an additional rotation of 6-mm (1/4-in) at the top of wall was measured. No visual affects on the wall face were noted.

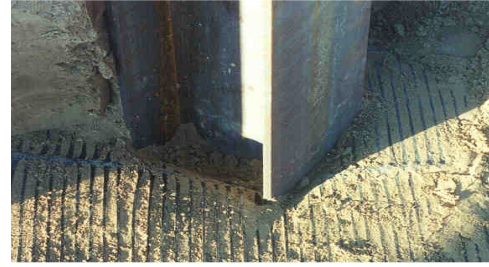
Figure 8. Penetration of pile.

through the geogrid (Figure 8). The geogrid was not damaged outside of the pile footprint. Neither excessive rotation nor excessive lateral movements were observed during the driving of all four piles. Nor was damage to the full-height concrete facing panels observed.

(4) The effects of pile penetration on the HDPE geogrid reinforcement were observed at the end of the experiment. It was observed that the HDPE geogrid was cleanly cut by the steel H-piles and was not damaged outside of the pile footprint.
