Pressure Vessel Failure during Hydro Test

Nanjing Yuchuang Co, China

28th November 2007

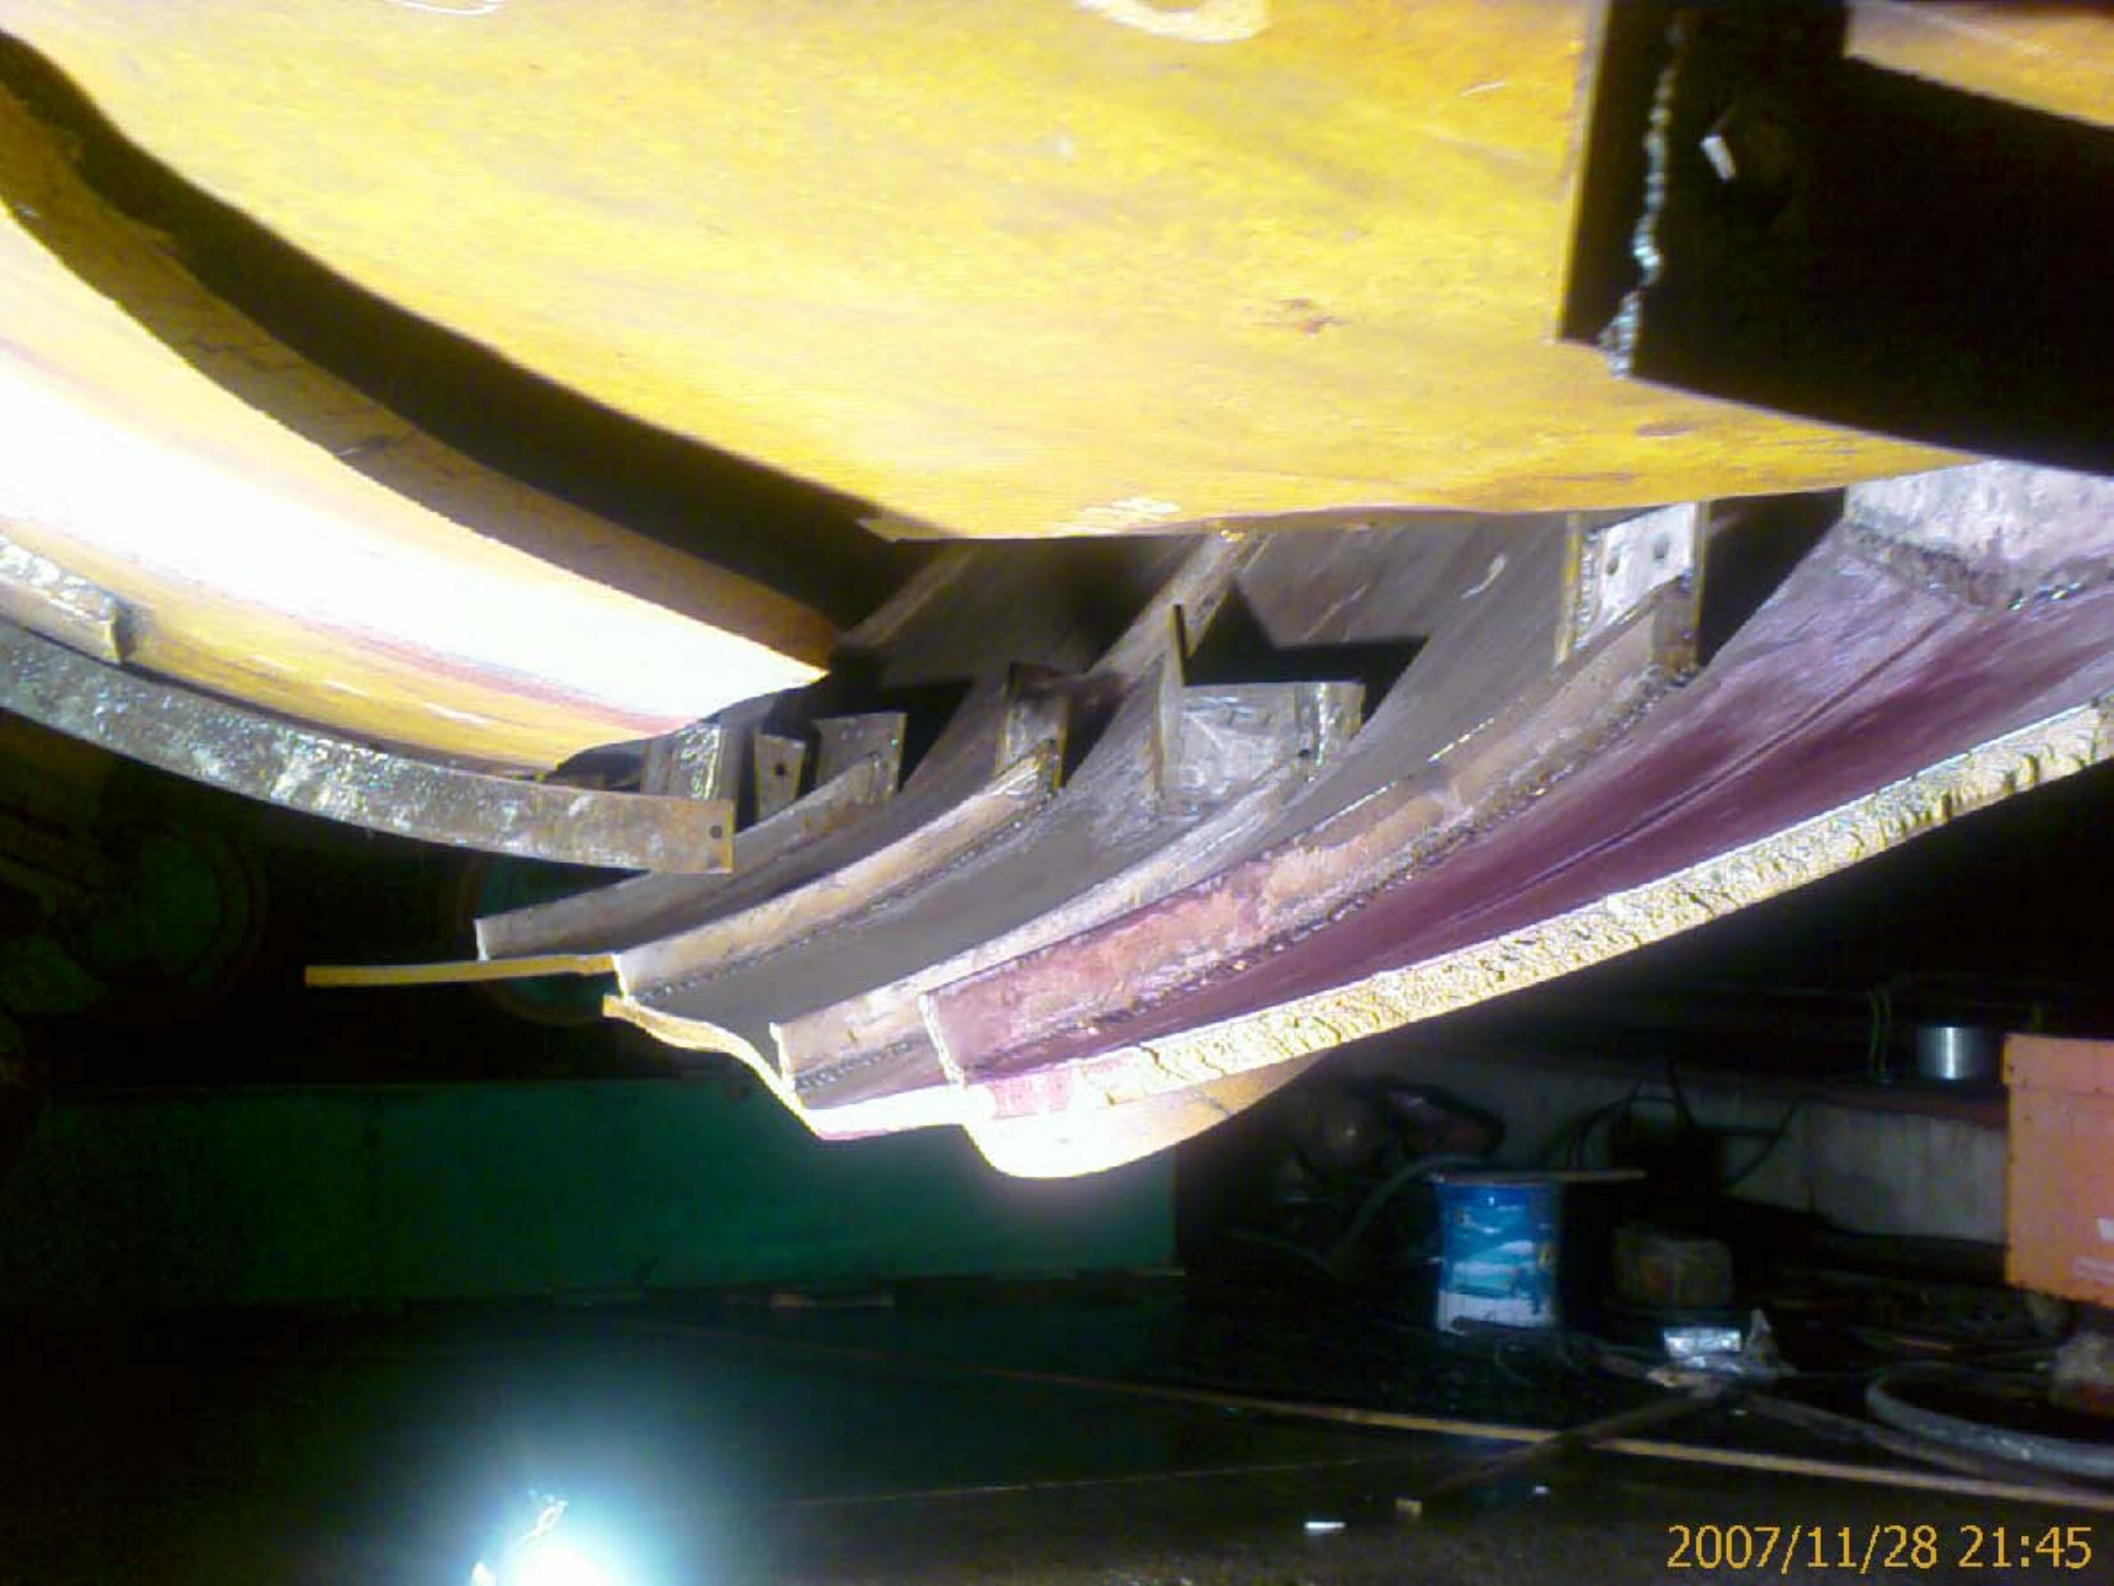
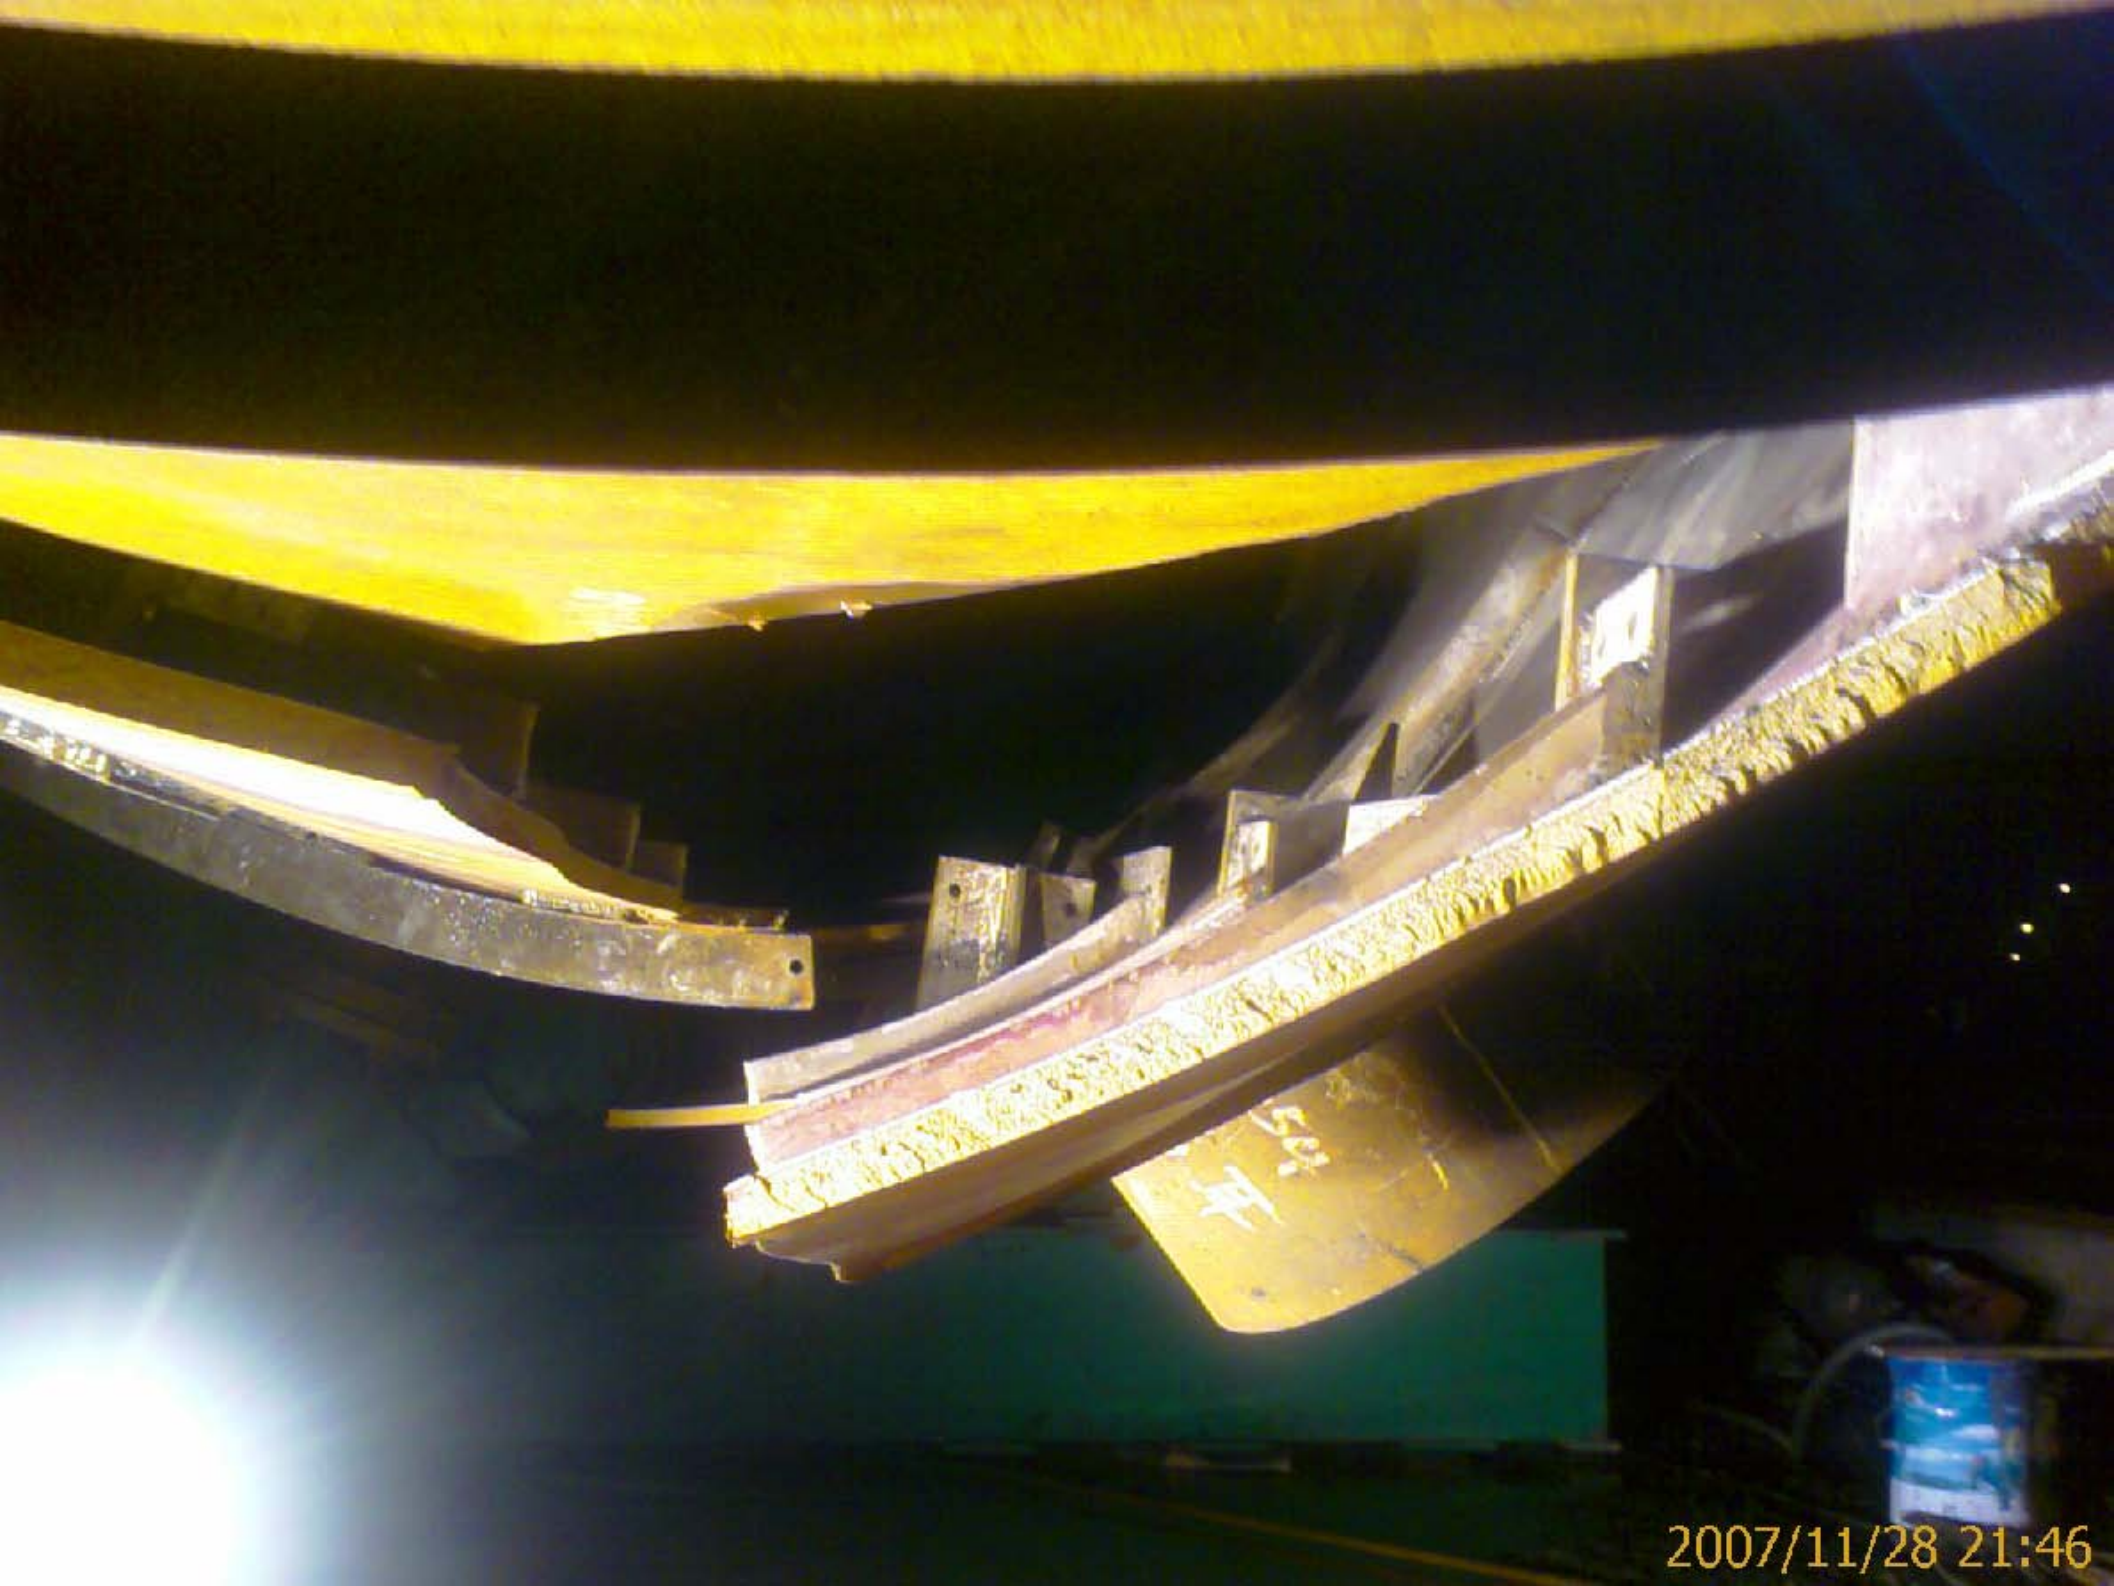
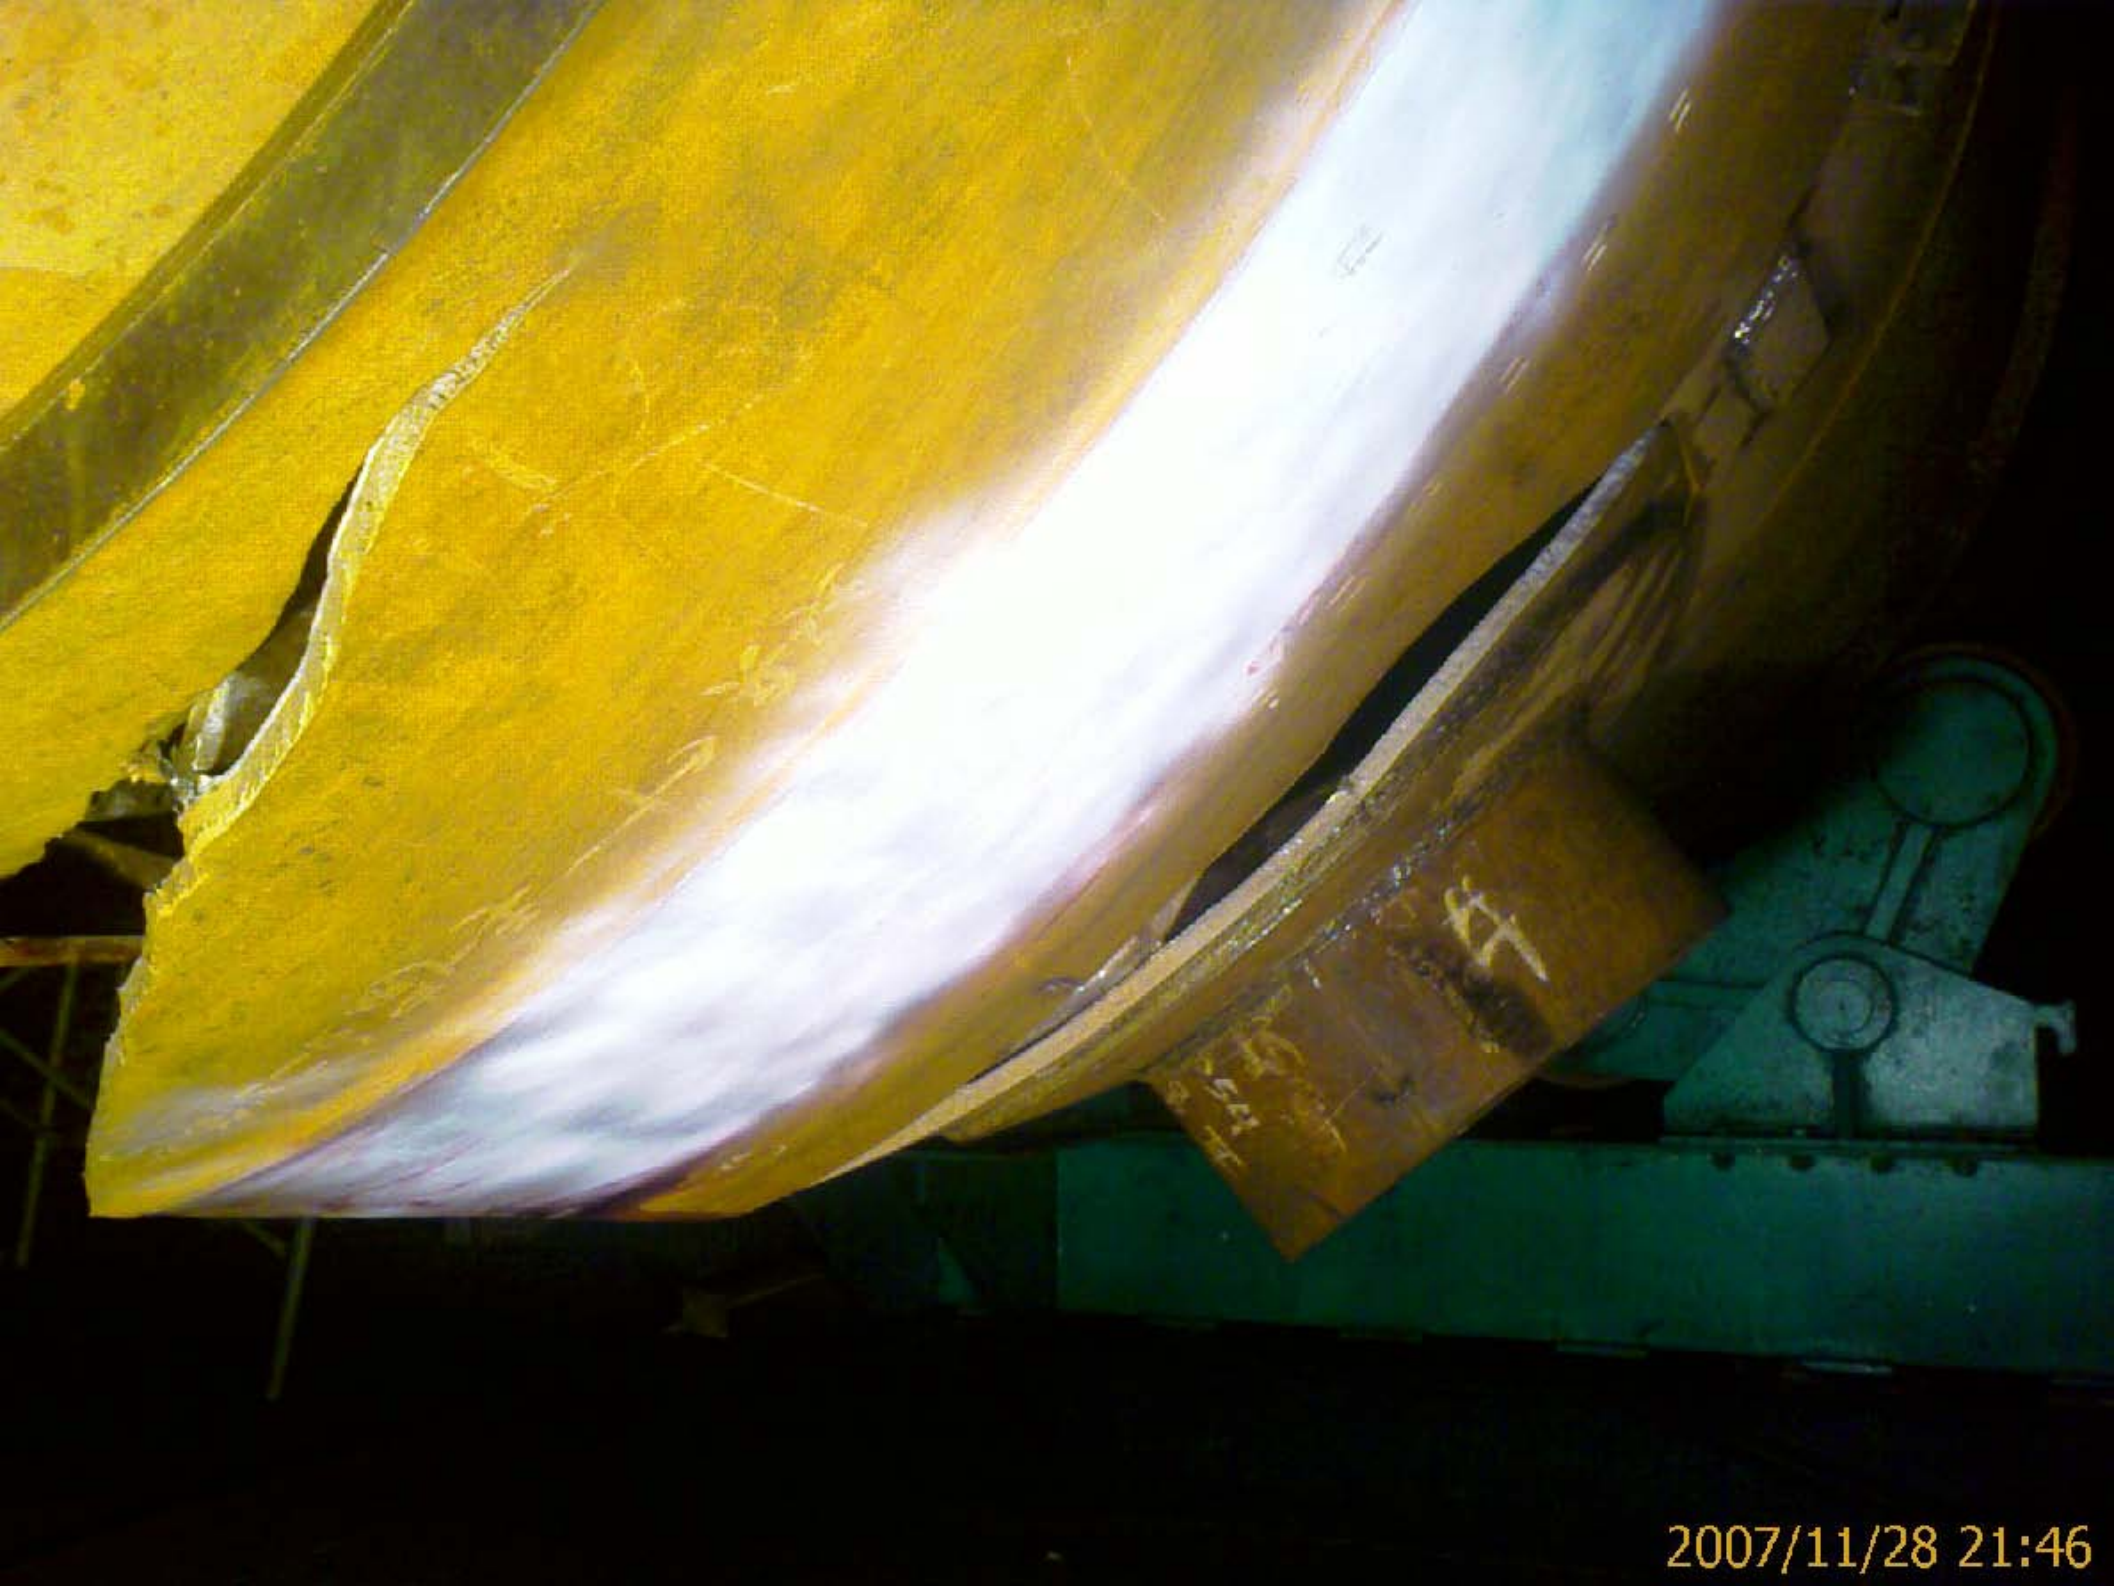
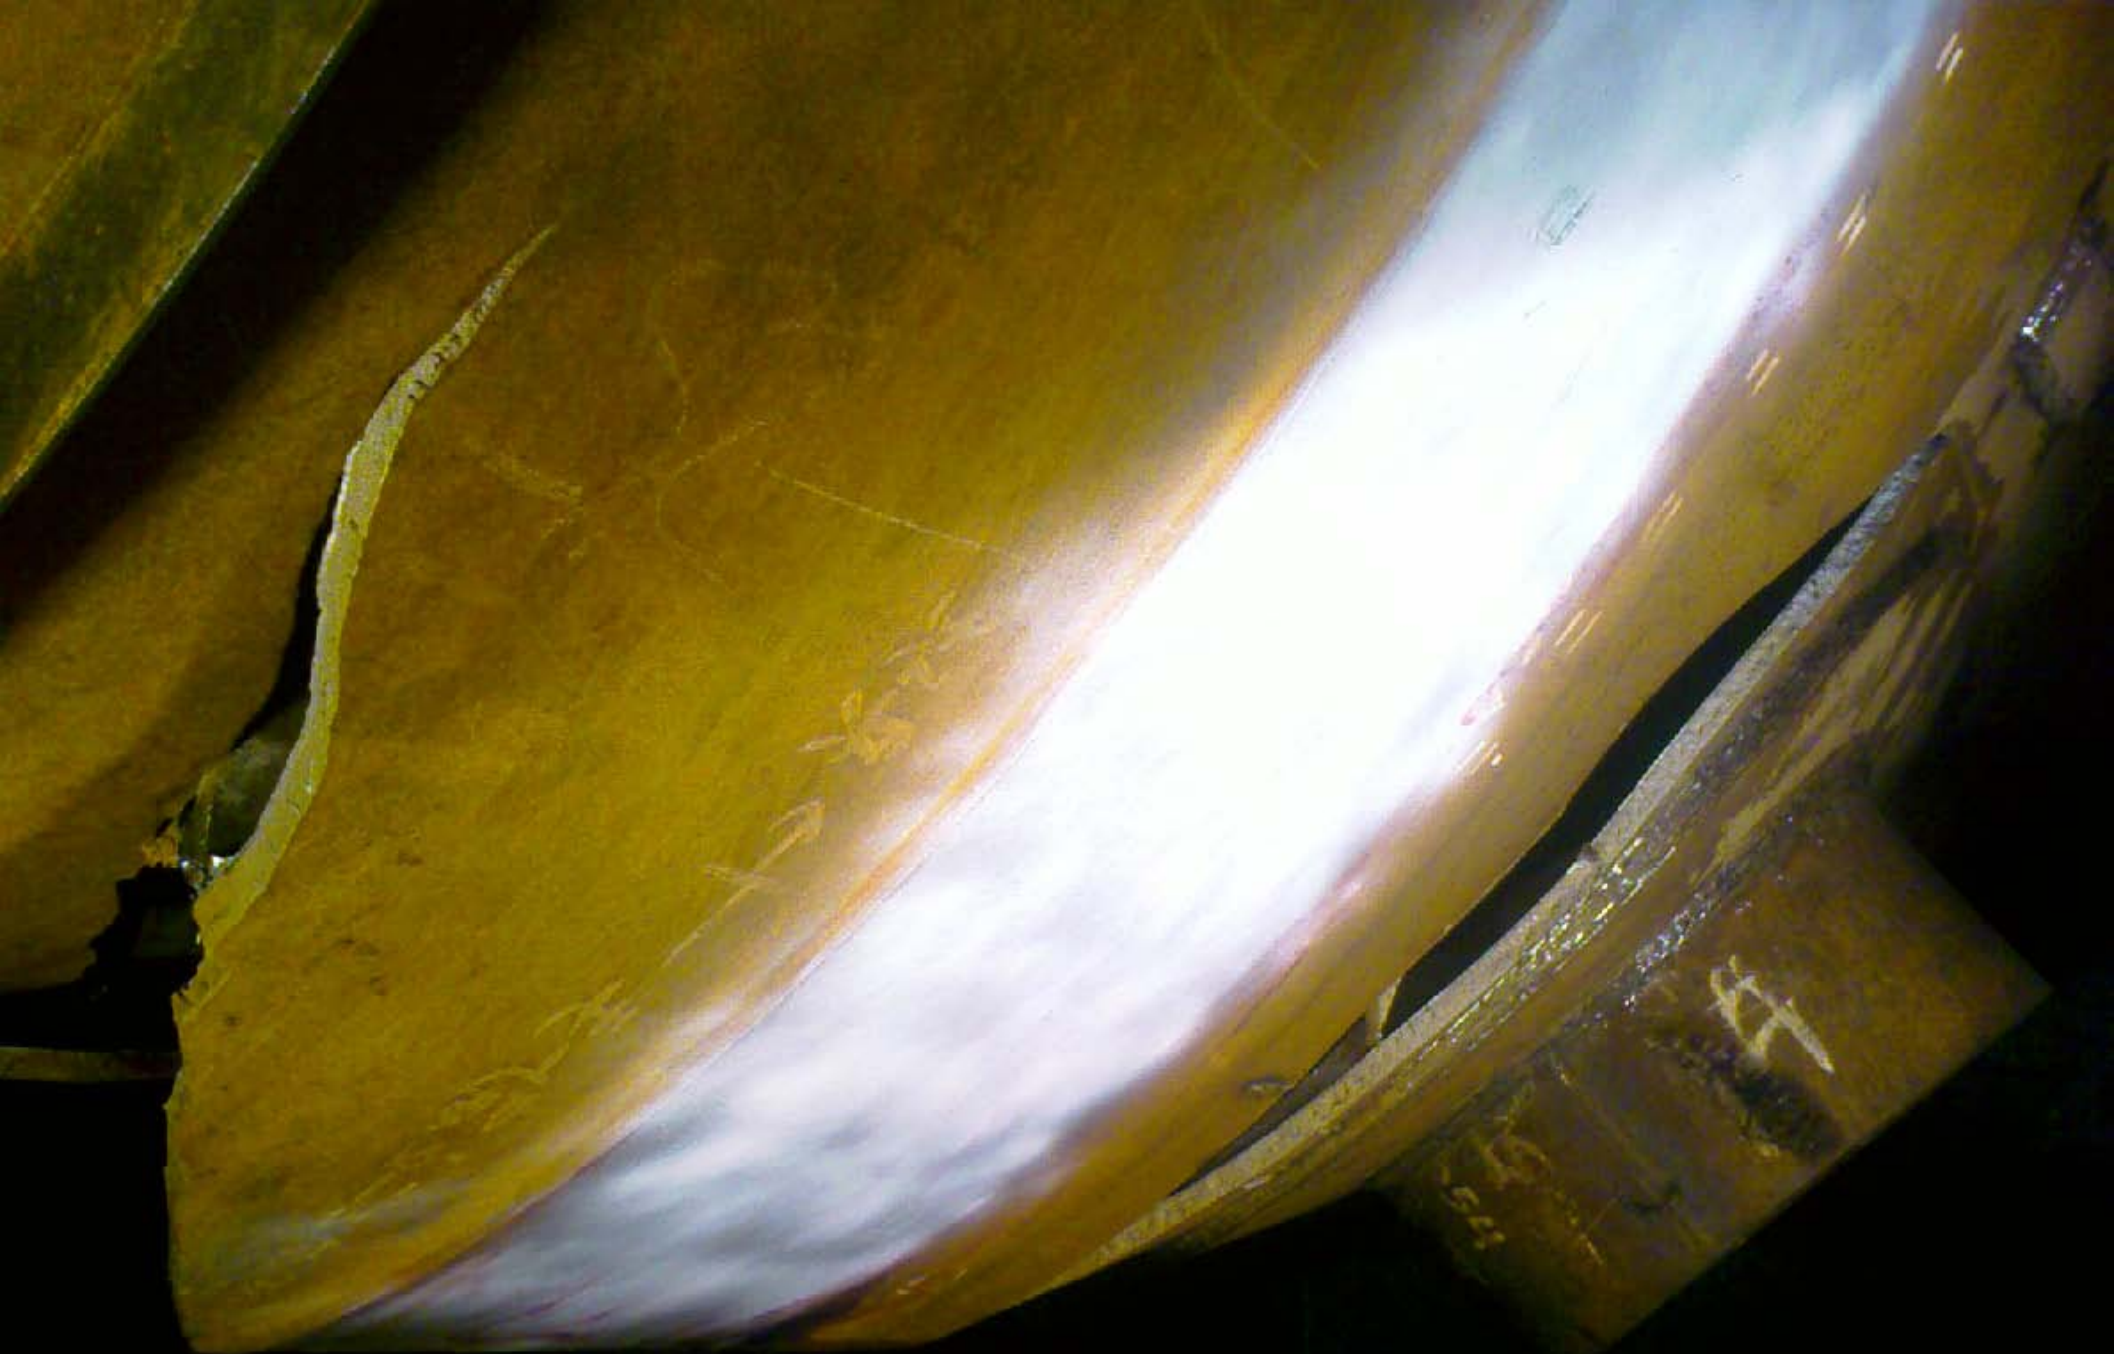
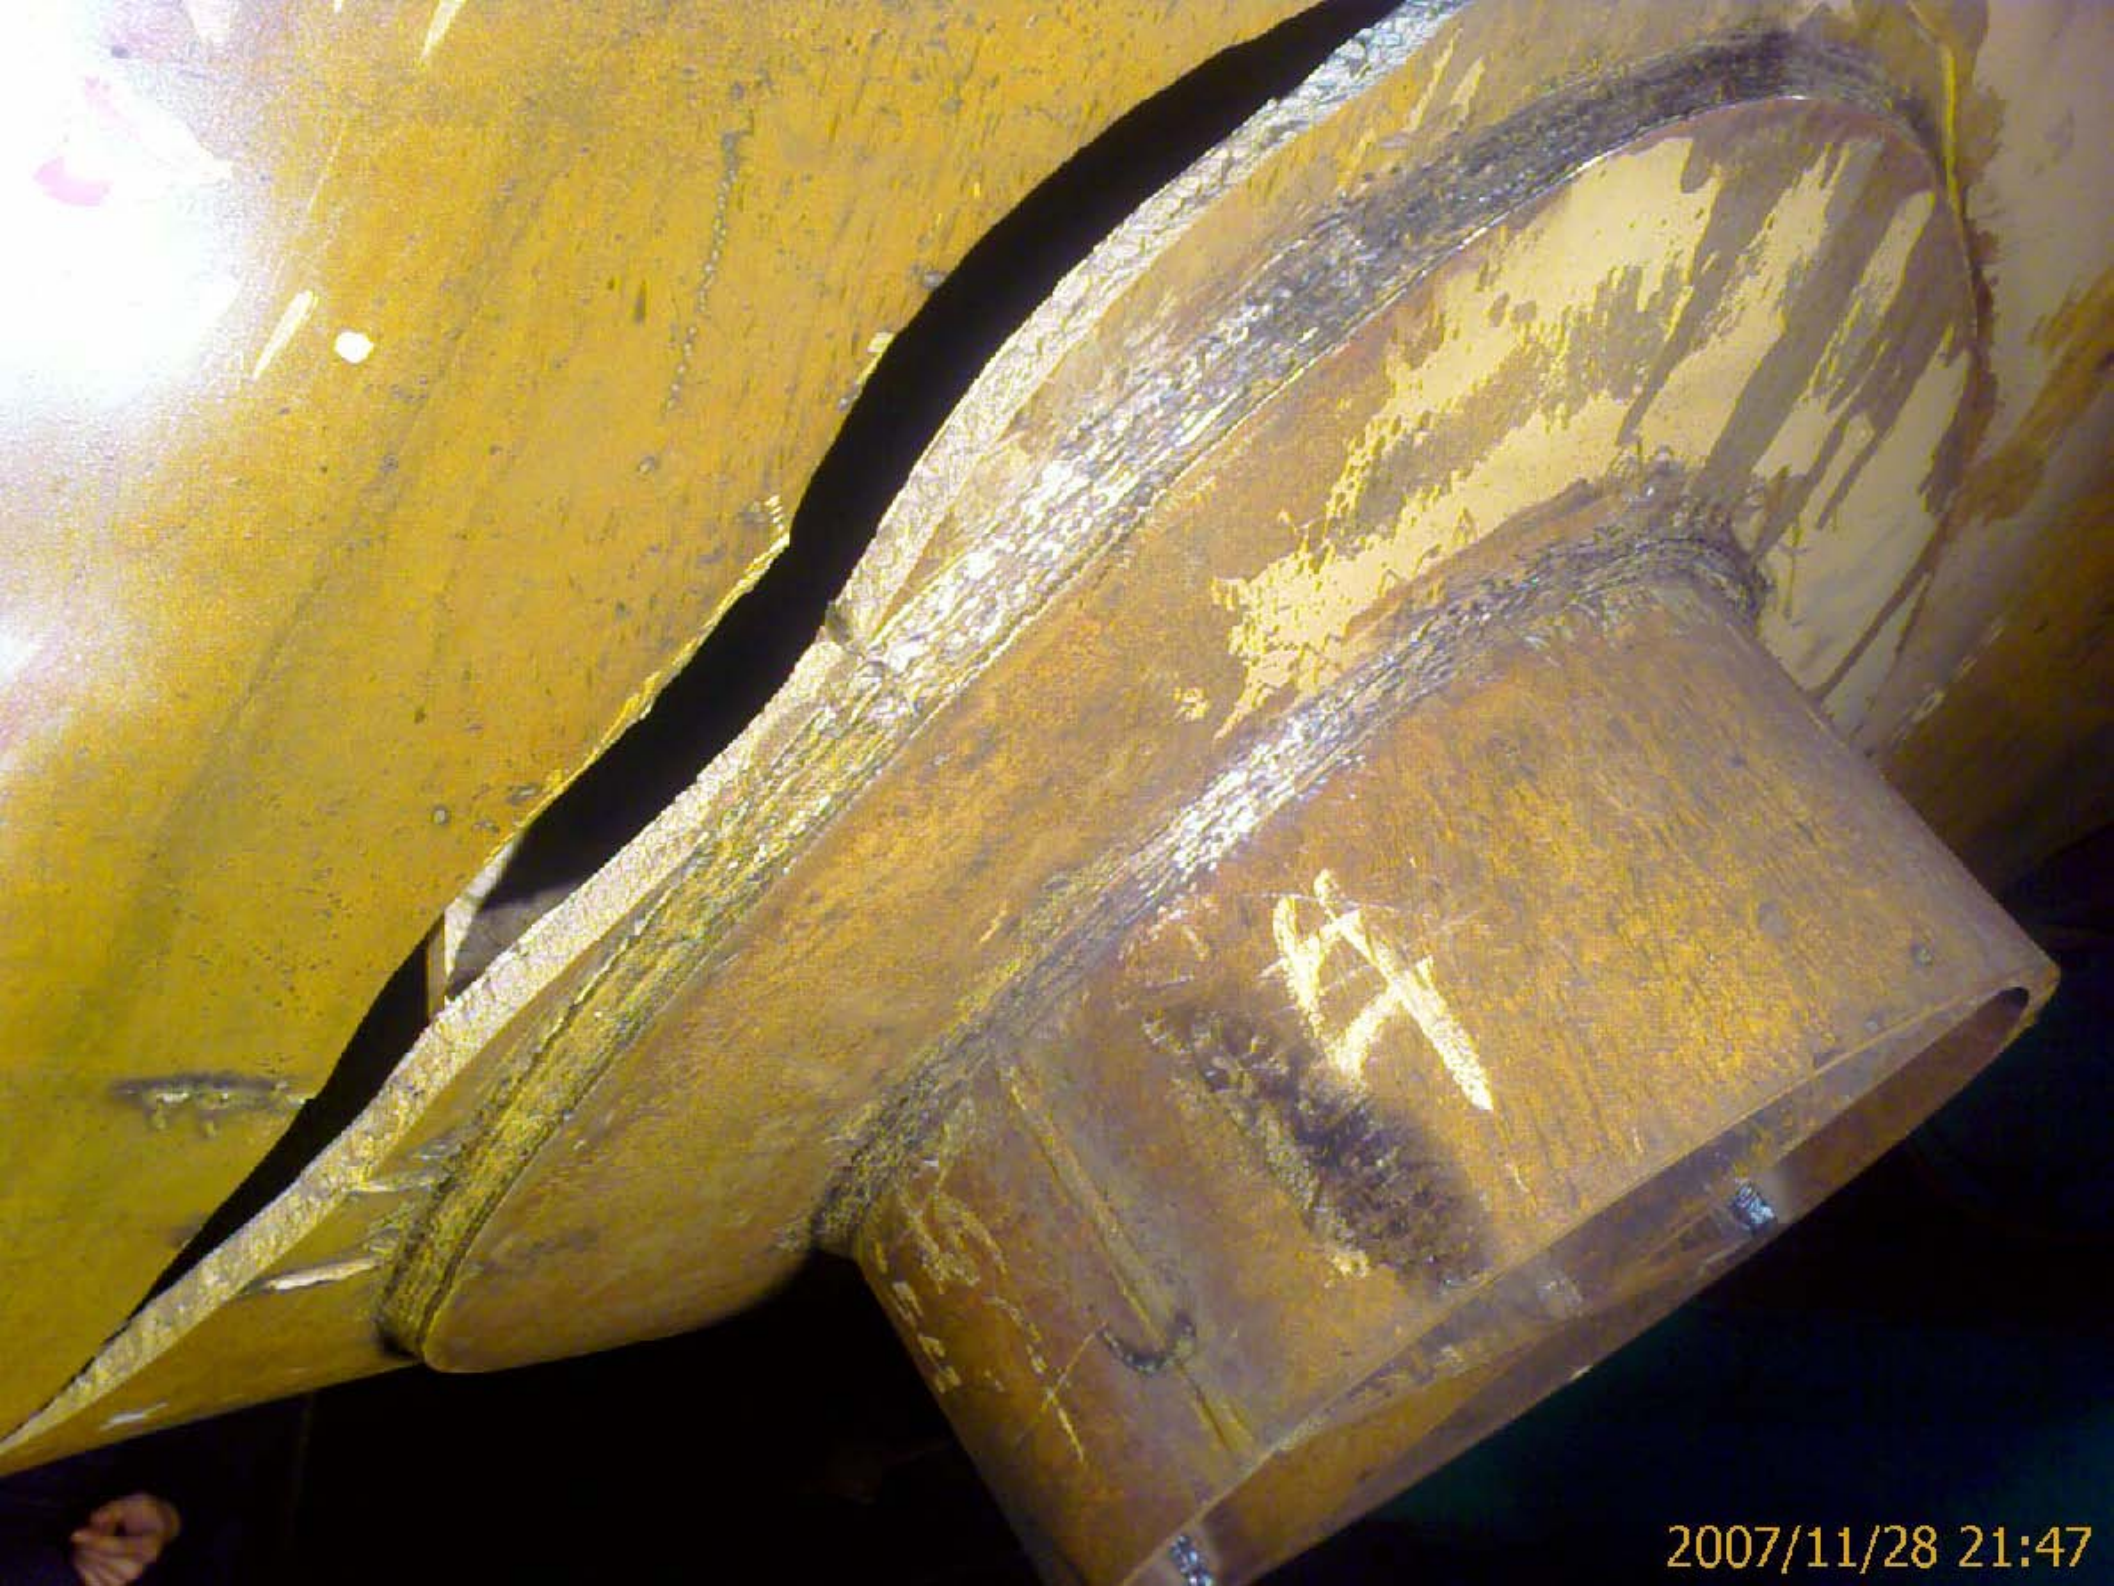
Please find attached a couple of photos of a pressure vessel that recently failed whilst under hydrotest during post fabrication testing. This vessel was manufactured by Nanjing Yuchuang Co. in China and the plate was of Chinese mill origin. Unfortunately this is another example of serious equipment/material failures with equipment being sourced out of the rapidly developing economies such as China, Eastern Bloc and others. These examples are becoming almost a weekly occurrence now and are exhibiting failure modes not seen in the mature manufacturing economies since the 1930's. Again we need to ensure vigilance in the acceptance of manufacturers and once more I stress the need to know where the base materials are sourced from.

Apparently this pressure vessel had reached fifty percent of the required test pressure when the shell ruptured. A metallurgical failure report is not available however from the photographs a number of observations could be made regarding the quality of the material and the welding. If you check out the welding (undercut/poor visual/arc strikes) it is unlikely that this vessel would have been conforming to any Pressure Vessel code, let alone be ready for a hydro.

As others have said in relation to this particular failure example I bet there would be more than the one contributing factor ("The Material") associated with this failure.
