Figure 2-4. Mercury Levels Detected at WRF Treatment Process Units

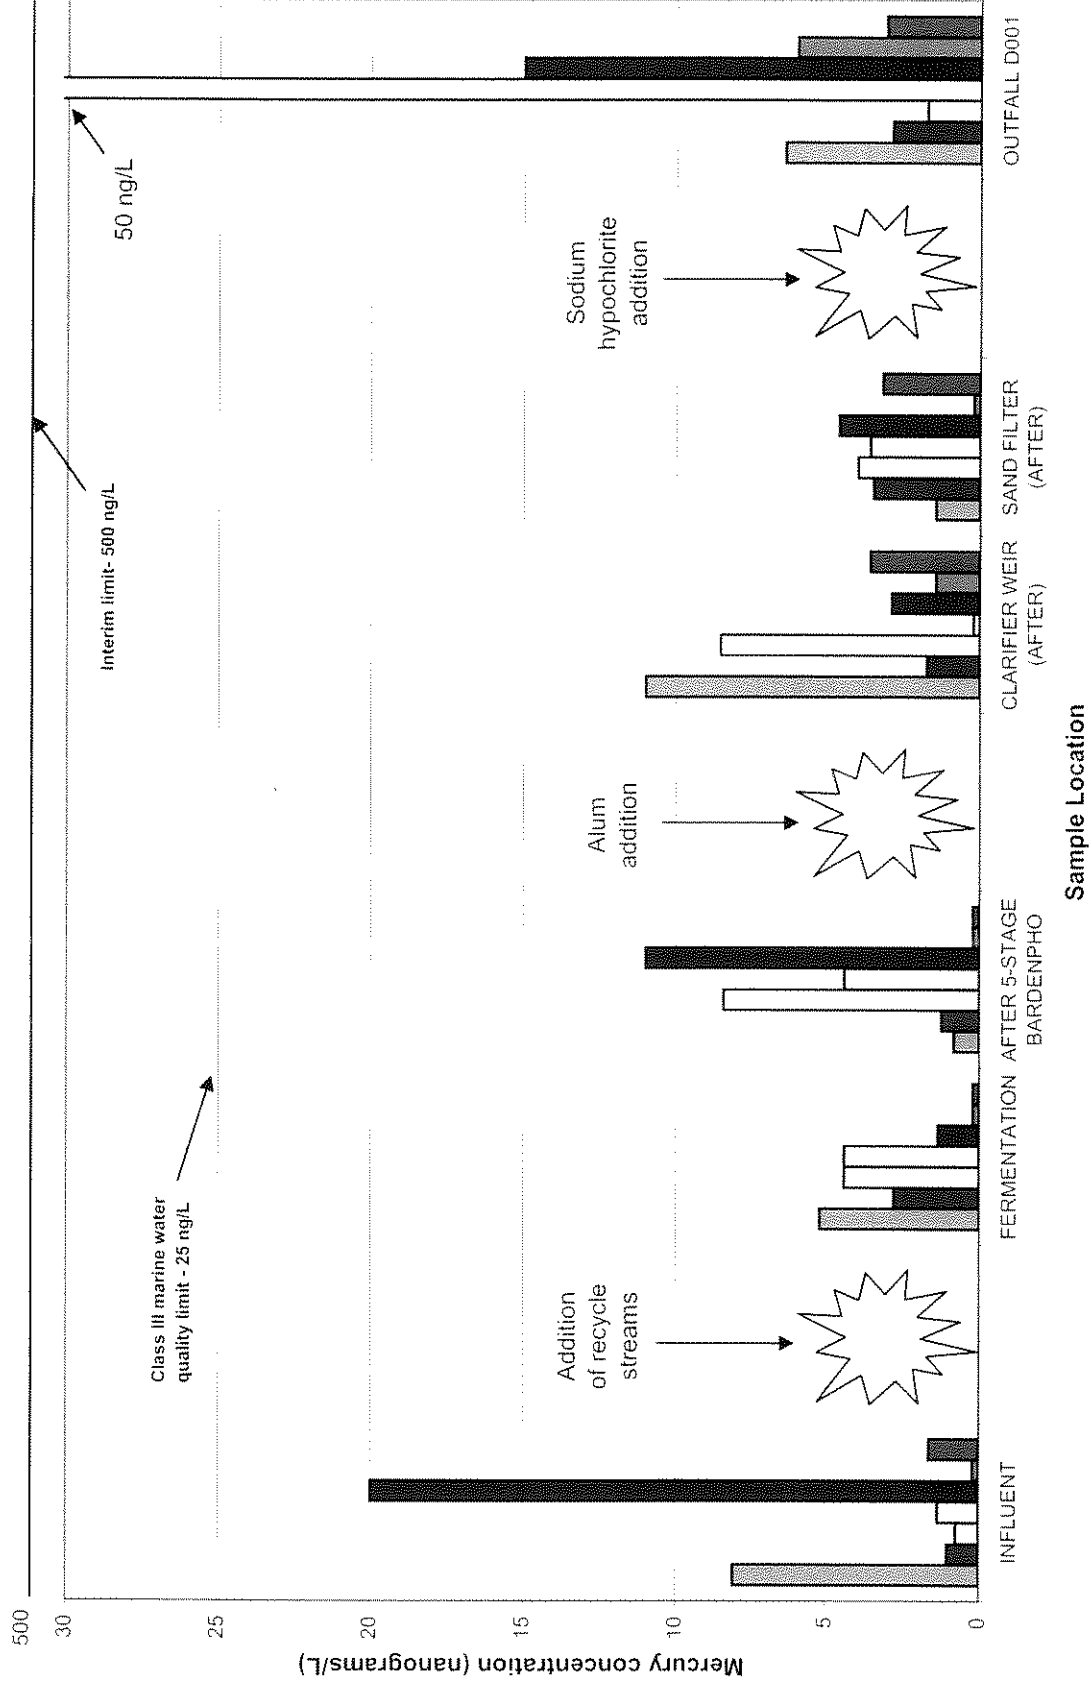
■ Sample Event #1 ■ Sample Event #2 □ Sample Event #3 □ Sample Event #4 ■ Sample Event #5 ■ Sample Event #6 ■ Sample Event #7
