What Is Most Important When Designing And Installing Copper Piping Systems?

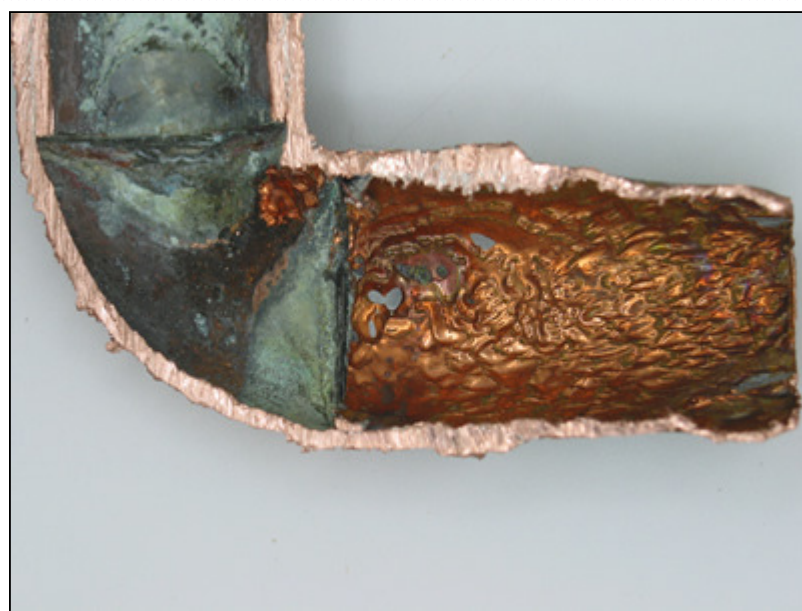
Burrs left on the inside of the tube can cause interruption of smooth flow resulting in localized high water velocity and cavitation. Immediately downstream of the unreamed tube end local flow pressure will be drastically reduced, allowing air bubbles entrained in the water to escape and scour the tube/fitting wall, creating pits that may eventually cause failure.

Example of Erosion Corrosion

Bear in mind that this condition is not peculiar to copper tube, but can affect other materials as well. However, when erosion-corrosion does occur in copper tube it is readily identifiable by the horseshoe shaped pitting throughout the inside of the tubes which is the distinctive signature of damage caused by erosion-corrosion.
