TENSILE STRESSES  
DUE TO  
TORSION

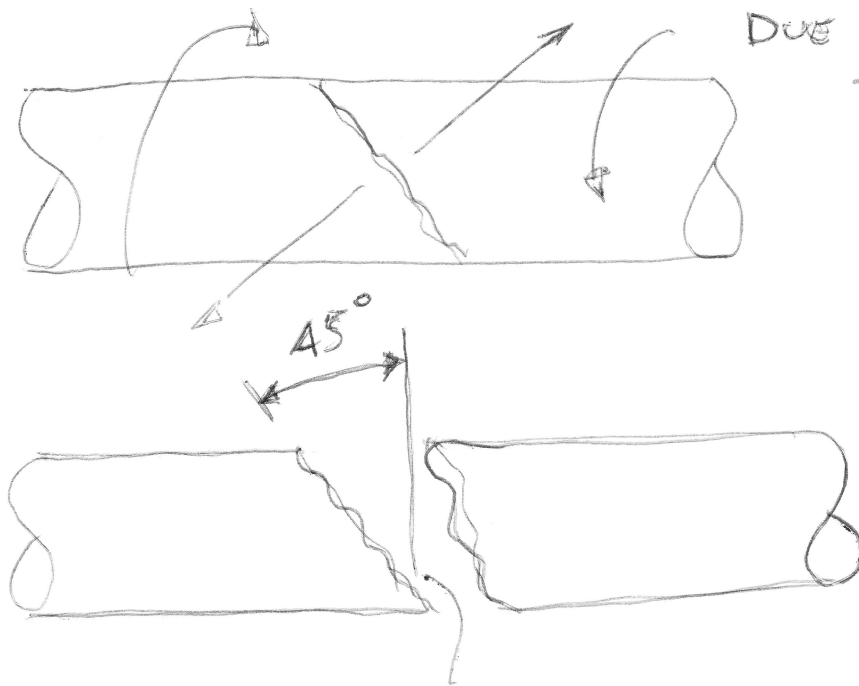
FRACTURE  
SURFACES  
APPROX 45°
