Suggested Practices for Avian Protection On Power Lines: The State of the Art in 2006

PIER FINAL PROJECT REPORT CEC-500-2006-022

Avian
Power
Line
Interaction
Committee

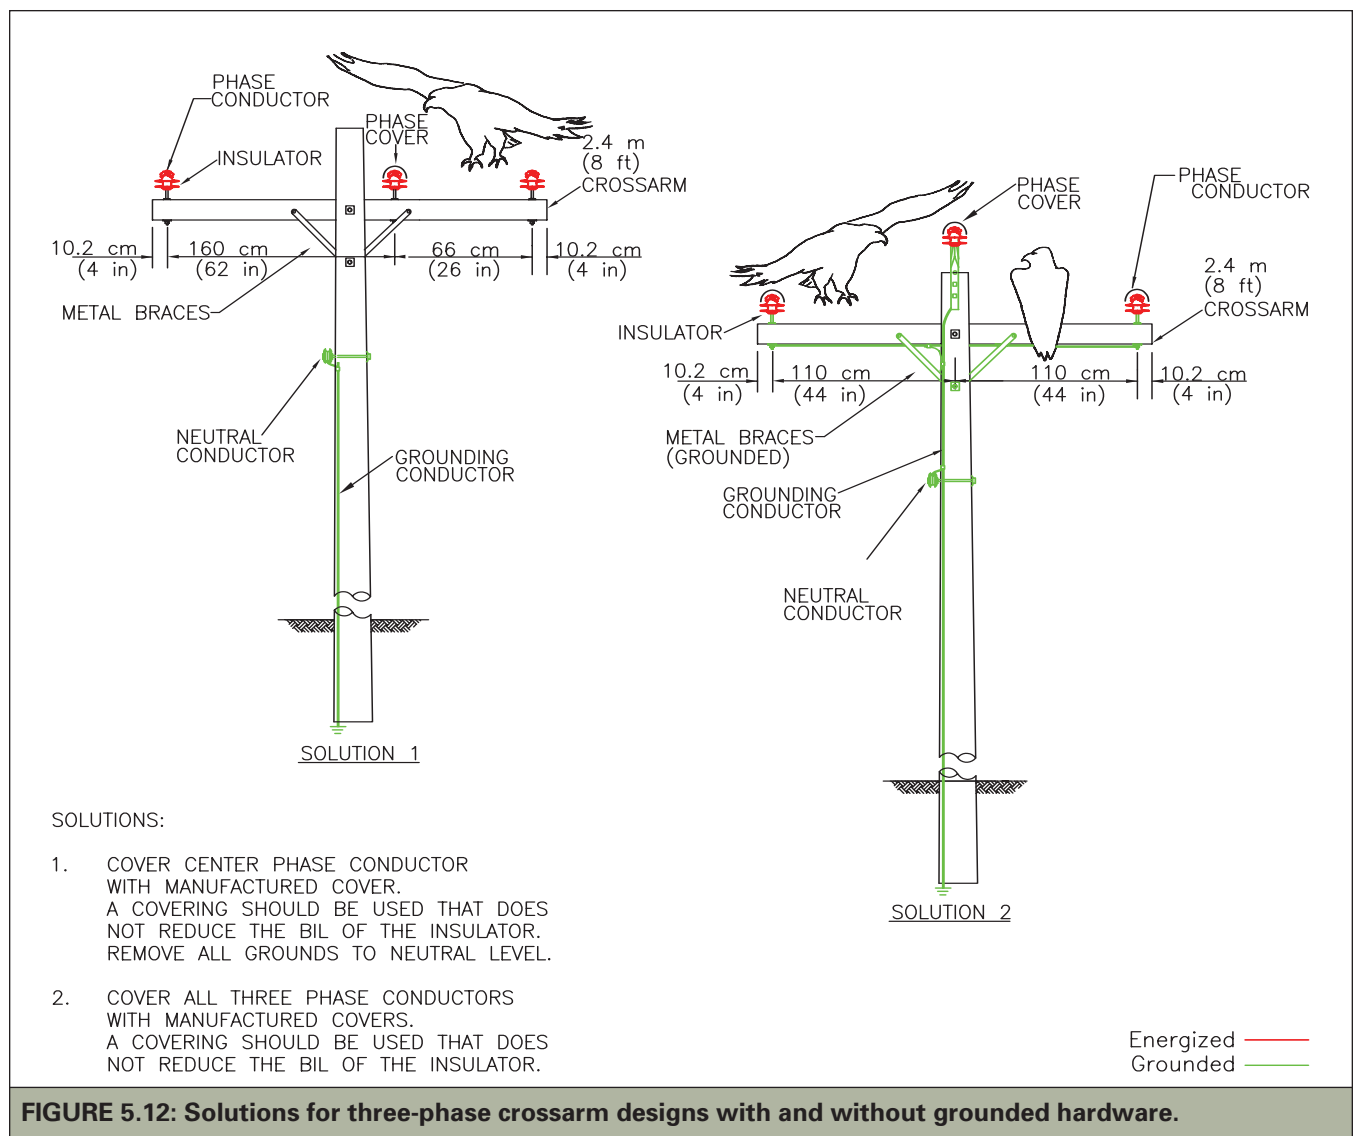
FIGURE 5.12: Solutions for three-phase crossarm designs with and without grounded hardware.

- Install covers over the insulator and conductor on the center phase and remove bonding down to the neutral (Figure 5.12, Solution 1). For further information on the use of cover-up products, see [Precautions](#) (page I02).
- If bonds are not removed, install phase covers over all three insulators and conductors (Figure 5.12, Solution 2).
- For pole-top pin construction, the crossarm can be lowered and/or replaced with a longer crossarm (Figure 5.13).²⁸ A 2.4-m (8-ft) crossarm should be lowered 104 cm (41 in) to achieve 150-cm (60-in) conductor separation. A 3-m (10-ft)

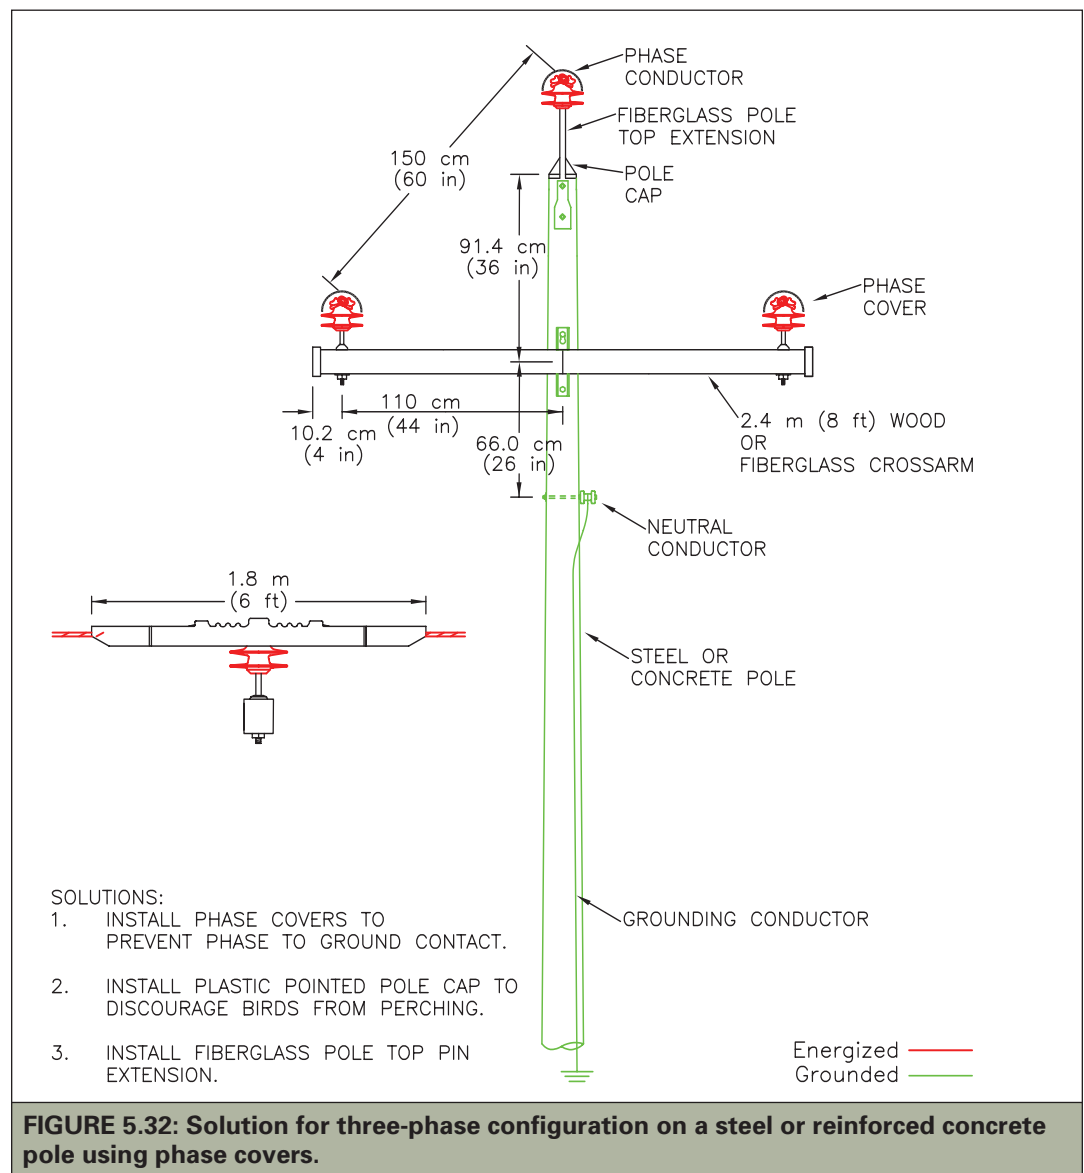
FIGURE 5.32: Solution for three-phase configuration on a steel or reinforced concrete pole using phase covers.

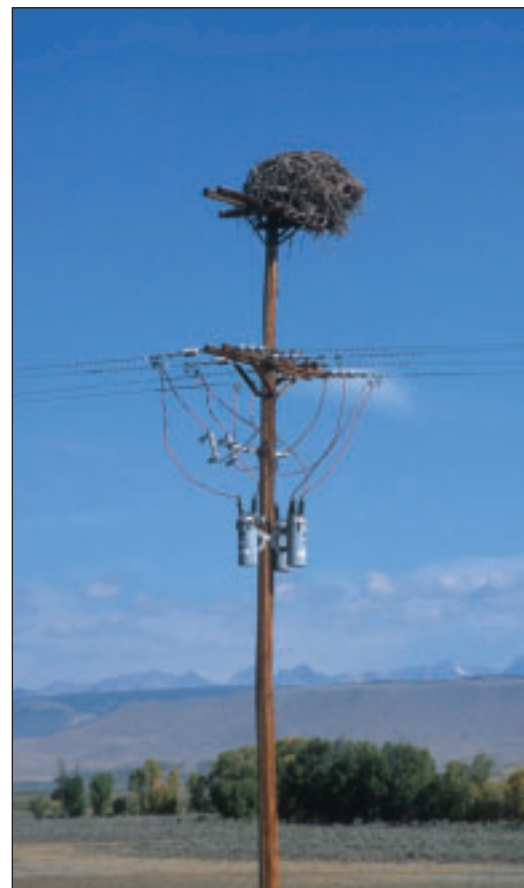
FIGURE 6.16: Osprey nest in Wyoming atop double dead-end pole. Nesting material that may drop onto the conductors or equipment poses fire, outage, and equipment damage risks.
