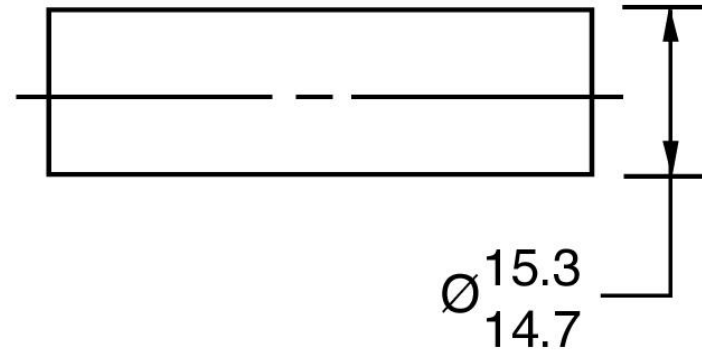
Worst case actual mating envelope is 15.3

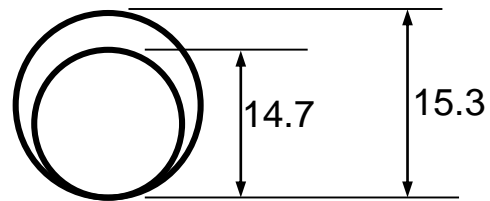
Minimum size is 14.7

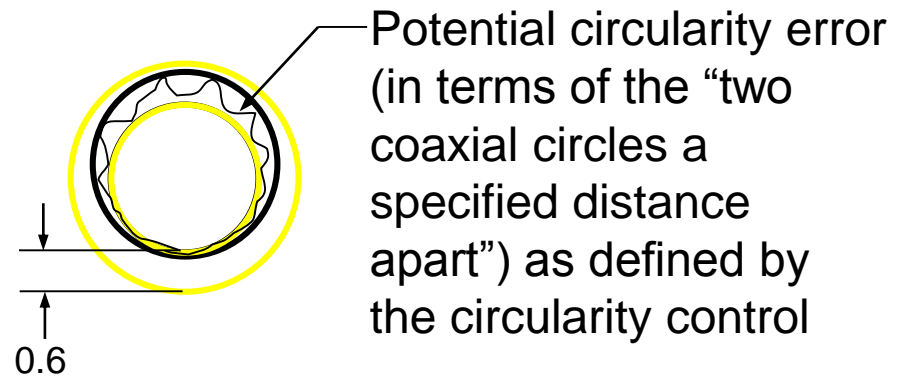
Potential circularity error (in terms of the “two coaxial circles a specified distance apart”) as defined by the circularity control
