UNDERPINNING ANCHORING REPORTS

HELICAL PIER® FOUNDATION SYSTEMS CASE HISTORIES

Bulletin 01-9608
Rev. 9/99

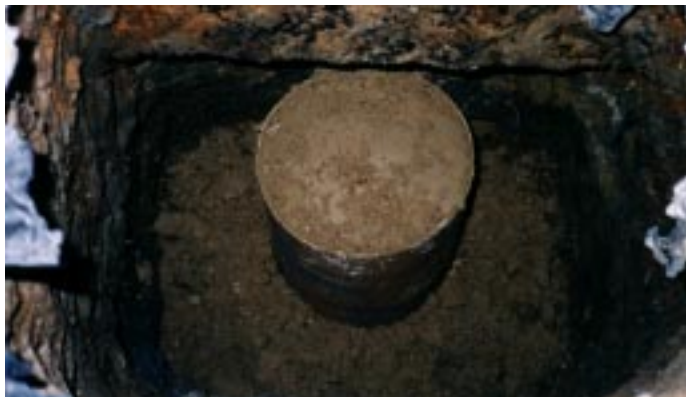
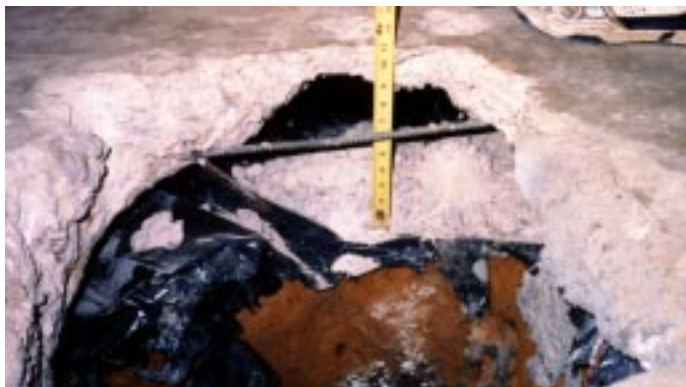
This home is a three-story brick with approximate loads expected in excess of 3000 lb. per linear ft. This home was constructed on a creek bank in North Dallas. The lay of the land was such that water drained toward the creek and under and around the home. A French drain was installed to assist in water removal, but the home had experienced both settlement and upheaval causing extensive damage to the structure.

It was decided to use the Chance HELICAL PIER[®] Foundation Systems anchors on the interior grade beam. A 10" helix on a 7' shaft was installed using extension material to a depth of 20' to attain a bearing capacity of 25 Kips. The shaft of the anchor would then be encased by a sonotube with a foot-bracket encased in high strength concrete. This would provide the lift platform to use to raise the interior of the home in conjunction with the lift on the exterior grade beam. The lift was effected to 9" as indicated in the bottom photo.

A class "c" fly ash slurry was pressure injected to consolidate loose soil and to fill voids between the bottom of the slab and the soil beneath that was created by the lifting process.

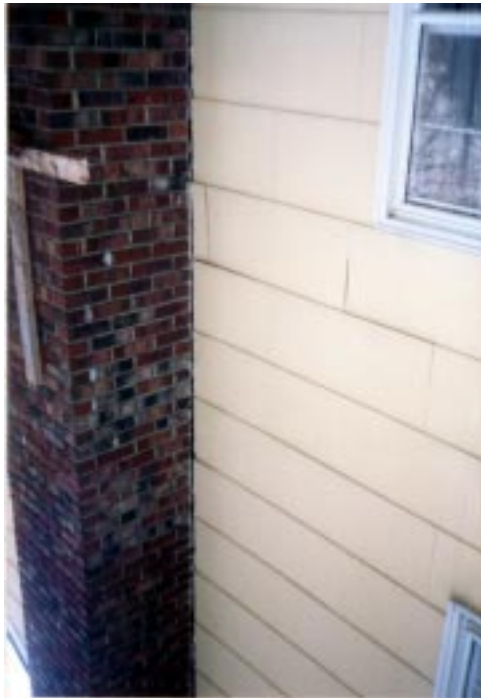
The two-story chimney had moved away from the side of the house $2\frac{1}{4}$ in. at the top. At about 4 ft. from ground level the chimney had moved away from the house $\frac{5}{8}$ in. Two 10 in. HELICAL PIER[®] Foundation Systems anchors were installed to 19 ft. depths at the corners of the chimney. The anchors were installed to 2,500 ft.-lb. of torque and the Chance lifting brackets were attached to the foundation of the fireplace.

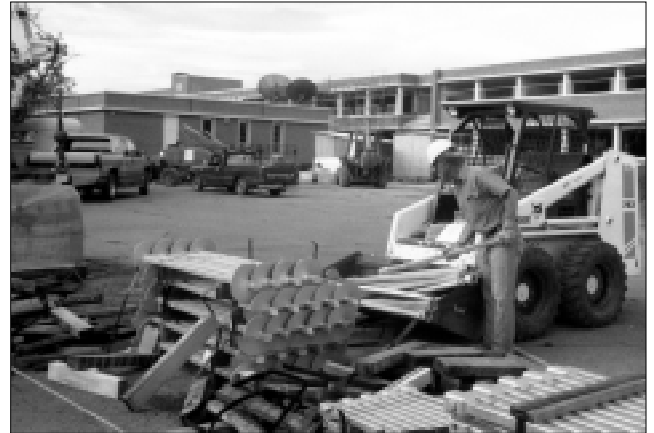
Screw anchors and extensions being moved into the Montrose High School

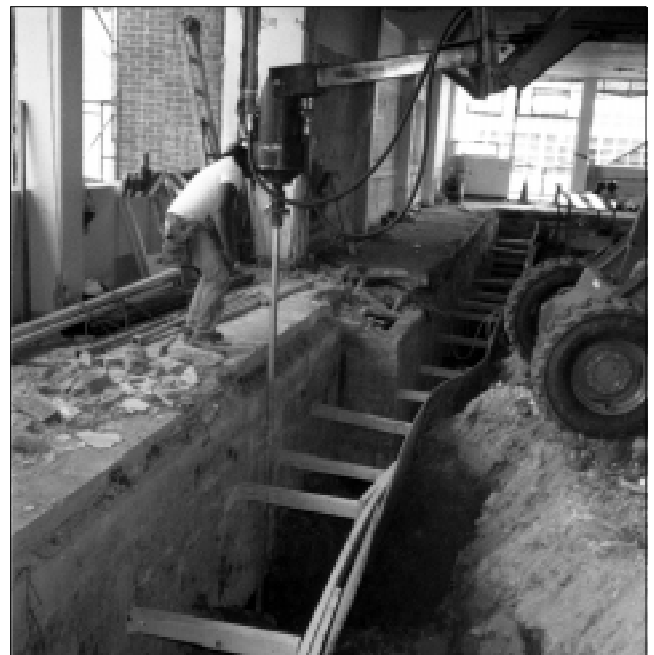
5,000 ft.-lb. hydraulic drive attached to skid loader installs screw anchor along side a utility vault

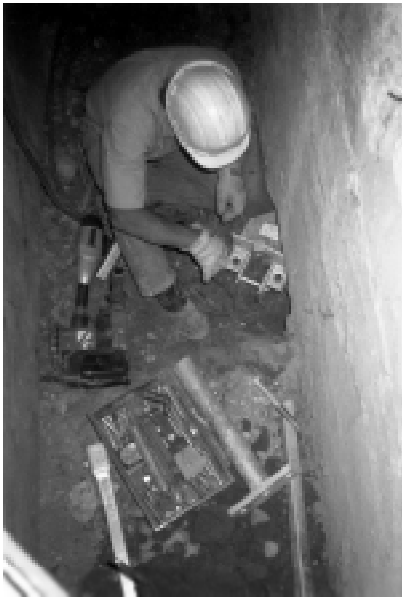
Underpinning bracket being assembled onto Chance HELICAL PIER® Foundation Systems anchor and under utility vault

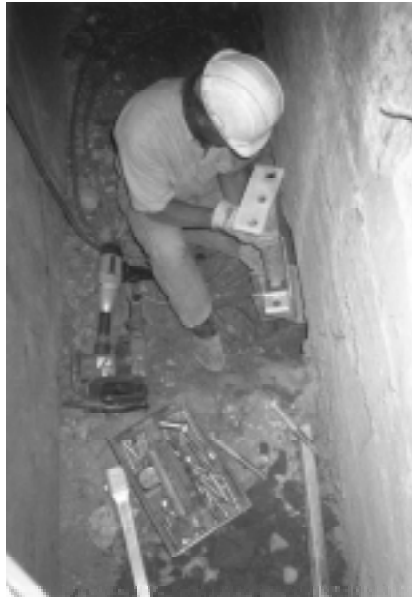
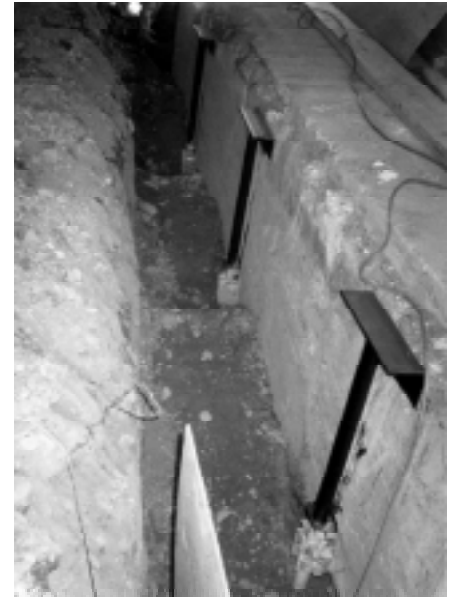
Pipe and flange assembly was welded onto the underpinning bracket's T-pipe to give added bearing area for the new 7" structural slab

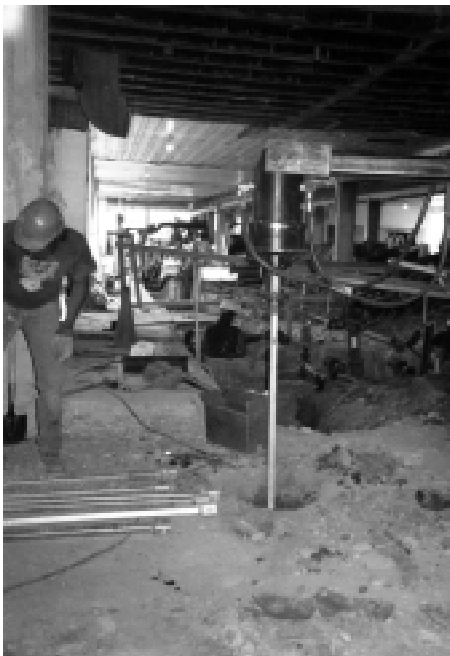
Chance anchor being installed in slab area on a 10' grid

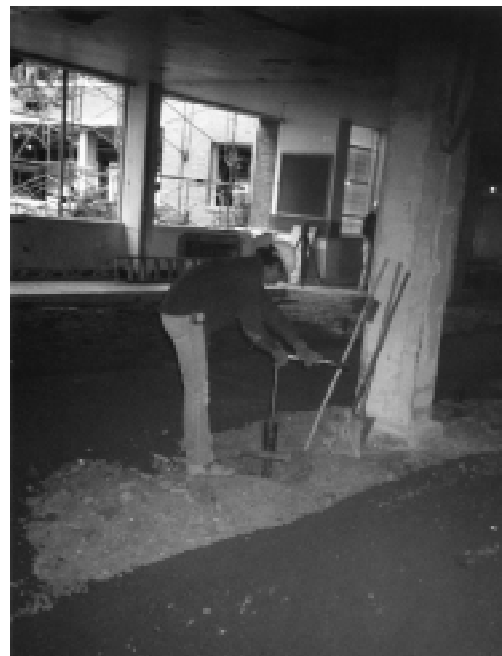
Fabricated cap with bolt allowed for precise adjustment with a laser level providing a reference point

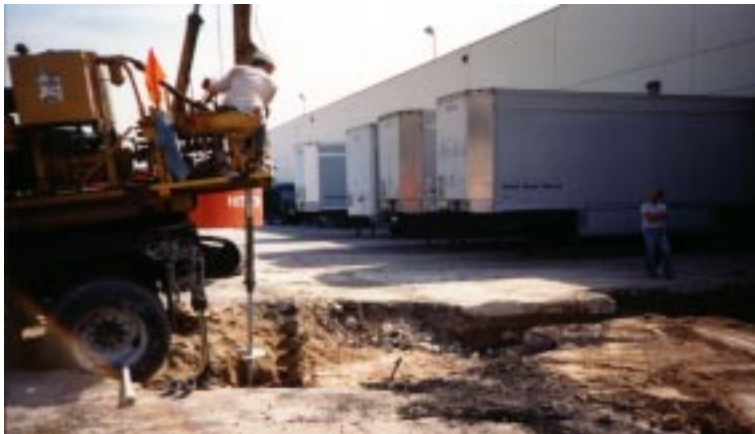
Type SS175 anchors were driven into the ground with a bed mounted digger truck.

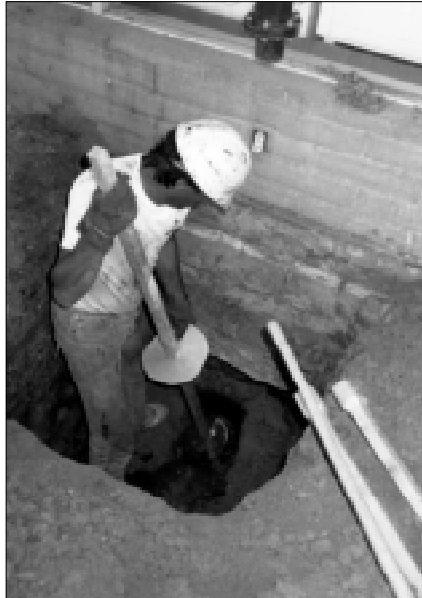
**Anchor being spotted
next to foundation**

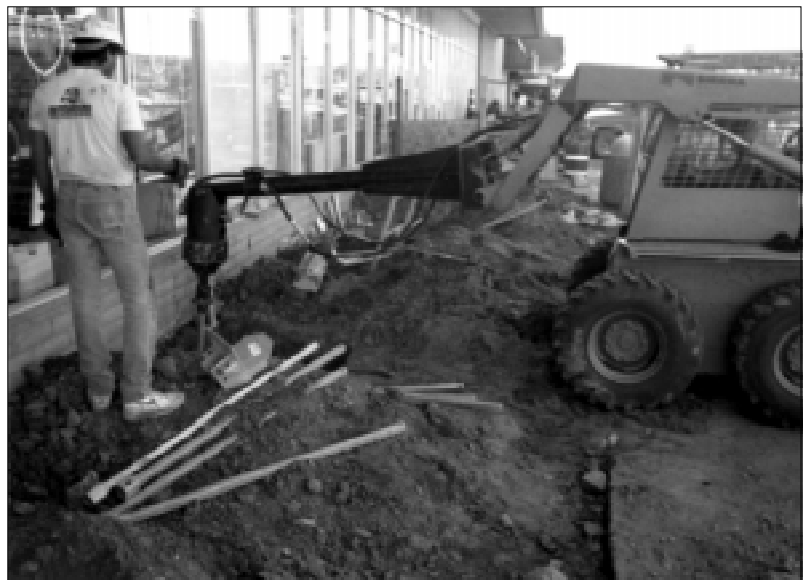
Skid loader driving screw anchor to 40'

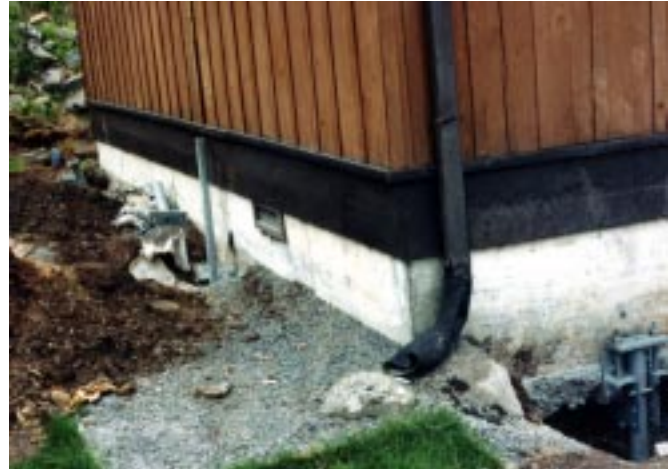
Twelve screw anchors were installed on the outside.

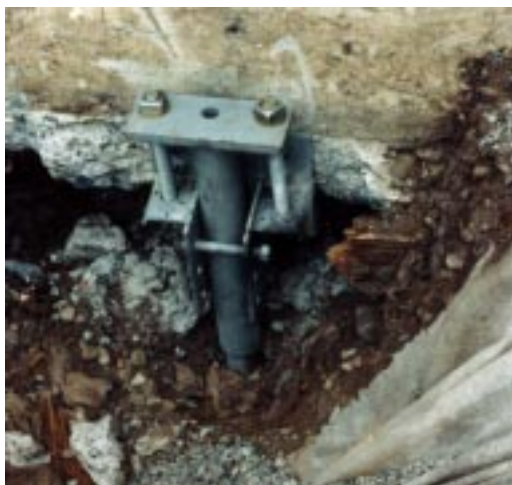
HELICAL PIER underpinning bracket

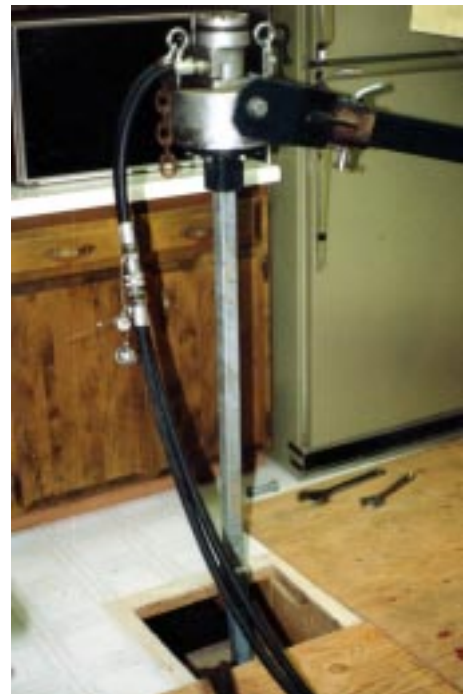
Portable hydraulic driver installing screw anchor through kitchen floor →

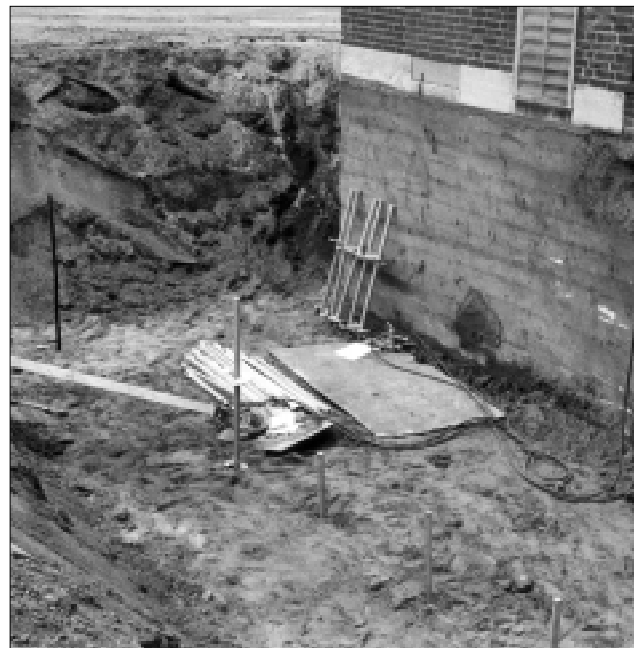
Job Description:

Repair:

A HELICAL PIER[®] Foundation Systems anchor was designed to increase the capacity of the existing foundation for the boiler room wall as well as support interior columns. This system was considerably less disruptive than traditional underpinning panels.

Each Type SS5 anchor consisted of a two helix (8- and 10-inch diameters) lead section followed by 5-foot extensions and, finally, a foundation-repair bracket. Installation depth varied from 7 to 22 feet. Once installed, the anchors transferred the additional load placed on the walls down through the loose fill and into the native fine to medium sand below.

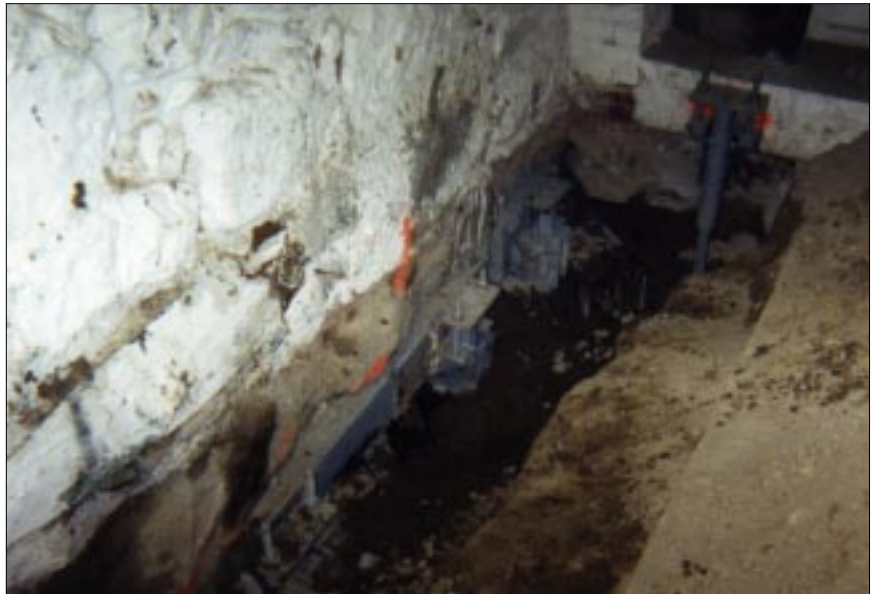
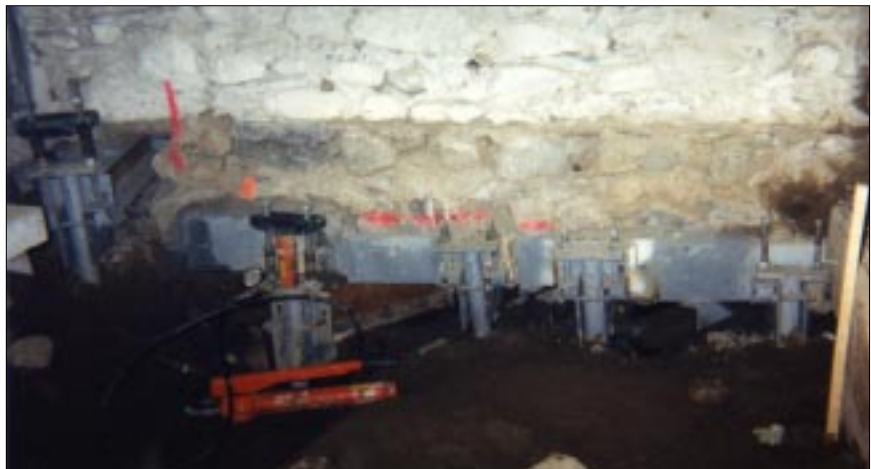
Job Description:

Repair:

To prevent the wall from collapsing, HELICAL PIER[®] Foundation Systems anchors were used to support the interior wall during and after construction of the elevator. Five anchors also were used on an adjacent exterior wall to prevent lateral movement from soil pressure pushing in on the wall after the existing concrete slab and soil were removed.

Each anchor was installed to a minimum of 2,500 ft.-lb. for a bearing capacity of 25,000 pounds. 8" x 8" angles were fixed on top of the foundation repair brackets above each anchor and set under the wall, with high-strength grout filling the voids. This was done on both sides of the wall.

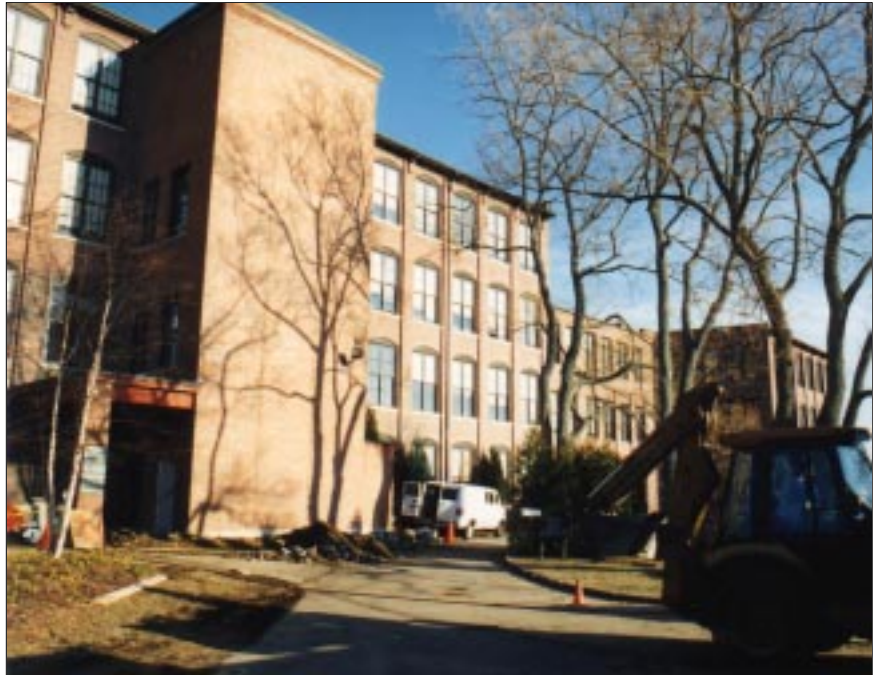
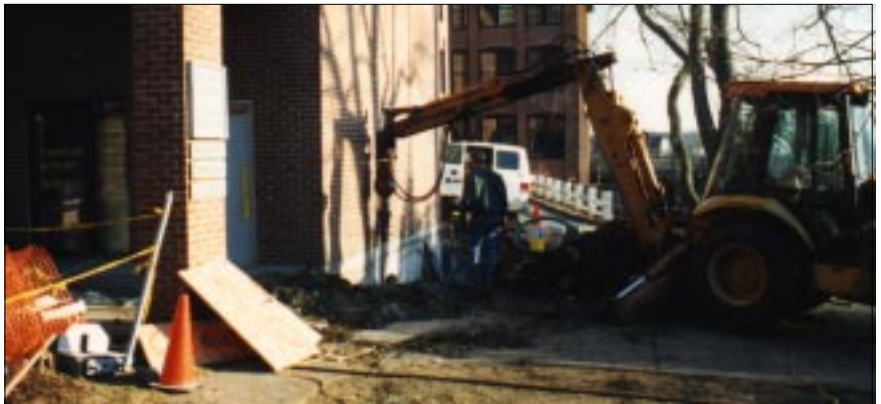
Job Description:

Repair:

Twelve SS175 foundation anchors were installed to a 15-foot depth. A Case 580E backhoe with a 10,000 ft.-lb. hydraulic drive head was used to screw the anchors into the soil. Heavy-duty foundation repair brackets were installed on top of the anchors and fastened to the bottom of the foundation. Five SS5 foundation anchors with standard foundation repair brackets were installed inside the elevator pit.

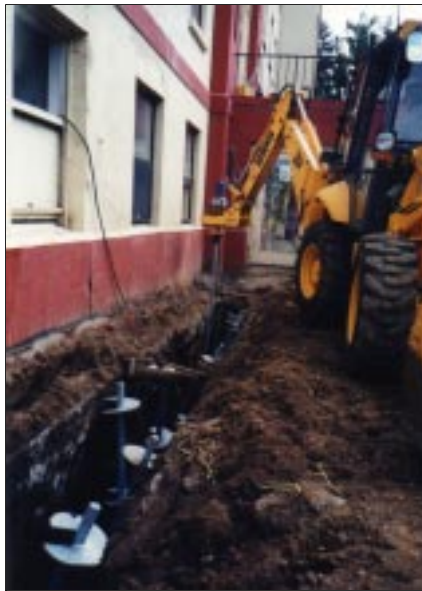
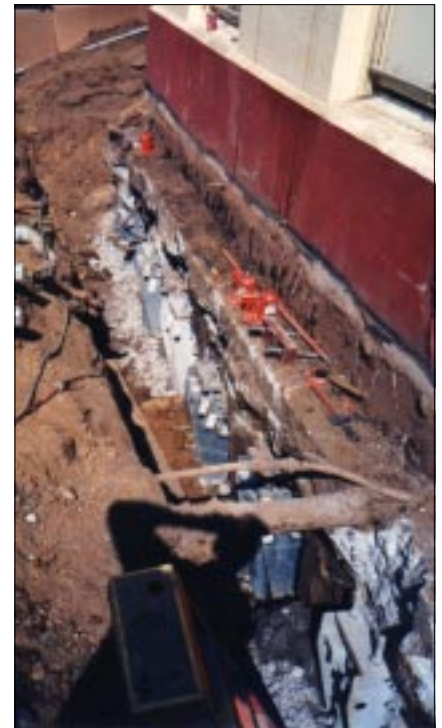
Problem:

Repair Solution:

fit under and bolt to the side of the foundation. The load of the structure is transferred from the foundation to the anchor via the bracket. For new construction, a T-shaped piece is fitted over the end of the anchor. Reinforcing steel is then tied or welded to the bracket before being cast into a concrete grade beam.

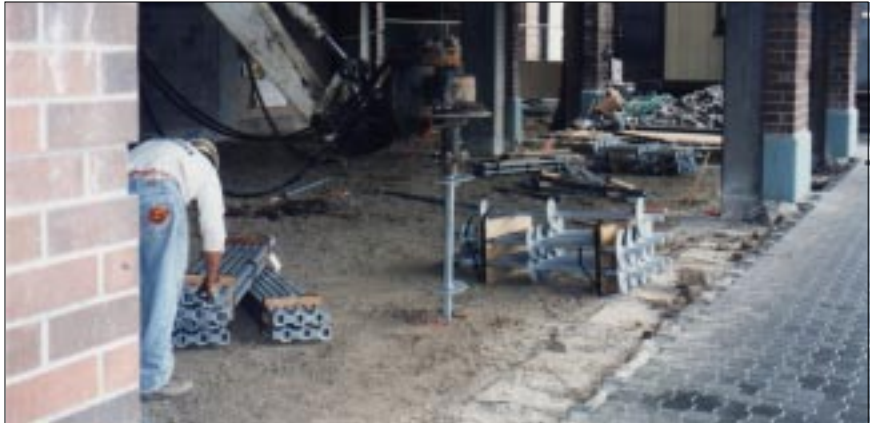
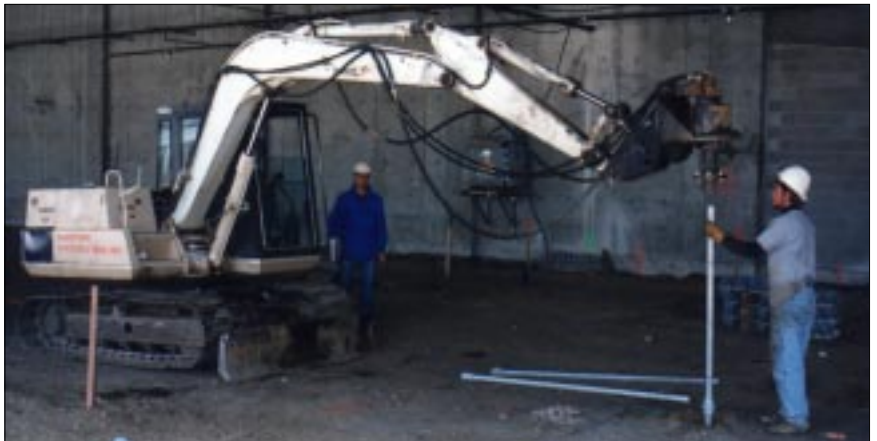
Problem:

Repair solution:

The design load was 45 kips. Three compression tests were conducted to 75 kips. Net deflection was less than $\frac{1}{4}$ inch. The three-helix (8-, 10-, 12-inch diameters) anchors were installed 31 to 36 feet into a very dense sand layer with blow counts to 60. Minimum installation torques of 8,000 ft.-lb. were achieved.

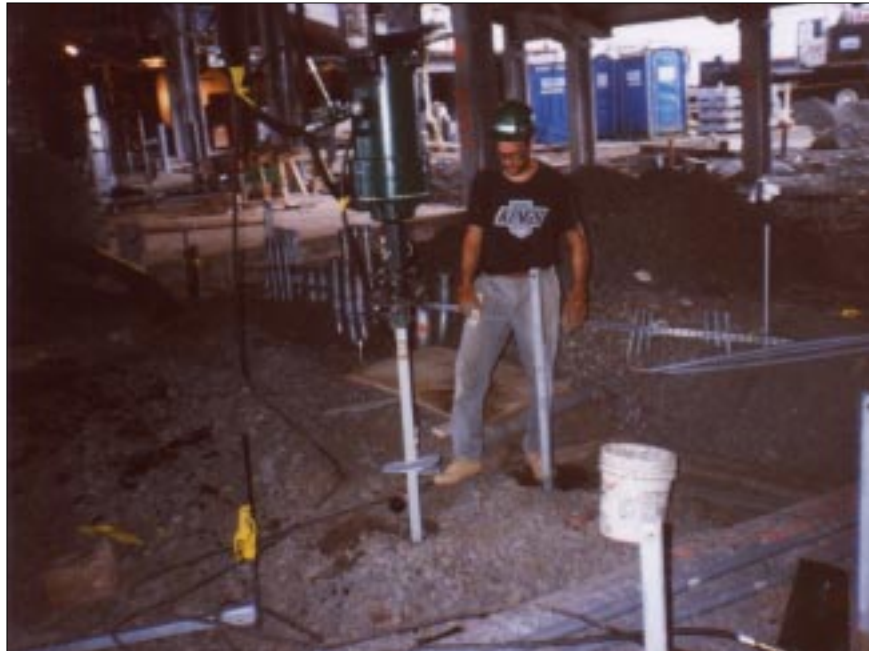
Job Description:

Repair Solution:

Chance SS175 HELICAL PIER[®] Foundation Systems anchors were used to support the structural equipment pads which required a 10-kip working load per anchor.

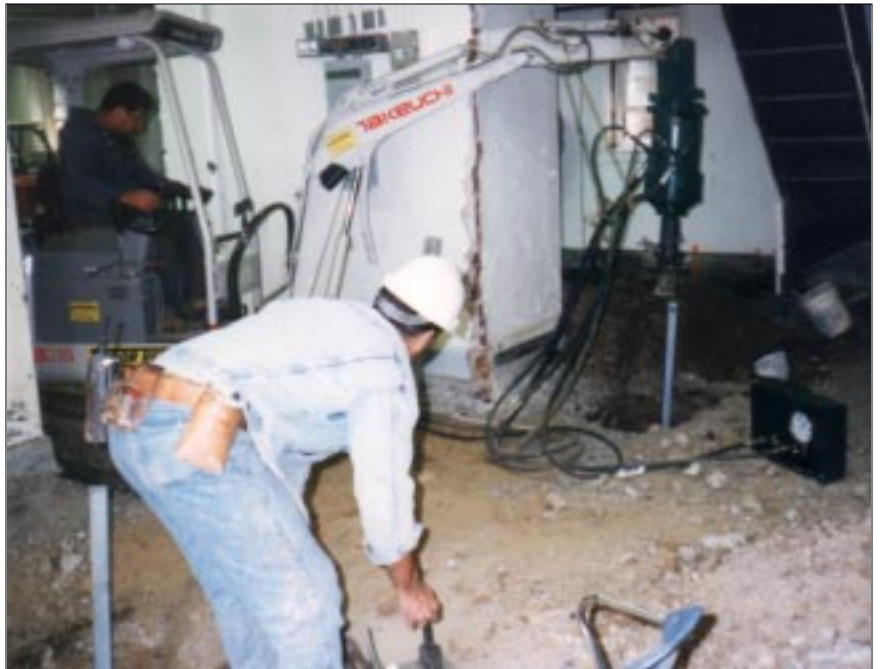
Replace existing bi-level basement slab and retaining walls with pile supported structural slab on grade and wall footings.

Repair:

D'Angelo Bros., Inc. was selected as the pile contractor using Chance SS200 screw anchors. Each pile consisted of a lead section with three helices (6-, 8-, and 10-inch diameters) and 15 vertical feet of extension to reach the required decomposed mica schist bearing stratum. Torque ranging from 8,000 to 10,000 ft.-lb. was achieved during this installation using a 10,000 ft.-lb. drive head hung off a mini excavator that fit through the 44"-wide door opening and under the 7-foot ceiling. The drive head was powered by a hydraulic power unit stationed outside the building and engaged by hand-held remote.
